GEOTECHNICAL ENGINEERING REPORT

MOSSY OAKS DRAINAGE IMPROVEMENTS PROJECT

PORT ROYAL, SOUTH CAROLINA

INSIGHT NUMBER 19-0001

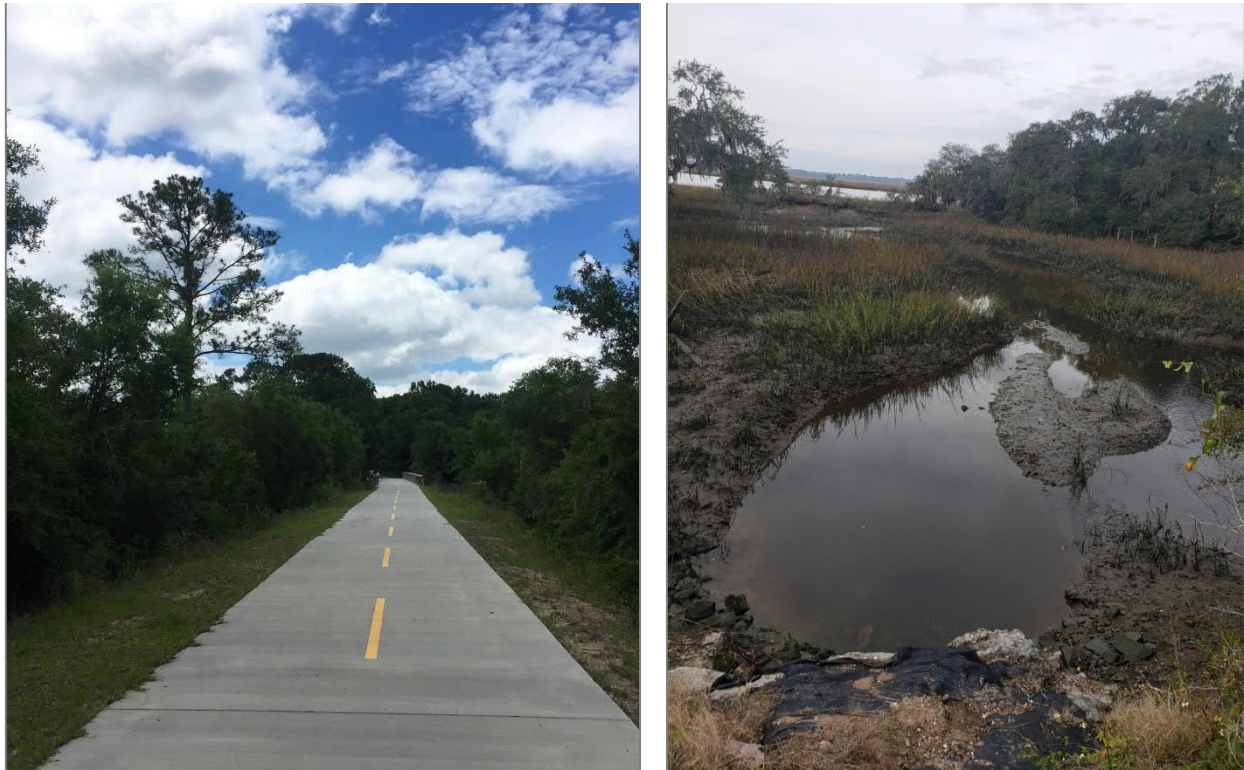
Figure 1. Spanish Moss Trail and Conditions at Basin #2 Outfall Culvert (Looking West)

Approximate coordinates of the causeway at Basin 1 are 32.4069, -80.6985 and at Basin 2 are 32.3960, -80.7023. Figure 1 shows conditions of the causeway.
