ASBESTOS SURVEY REPORT

**89 E. Howe Road
Tallmadge, Summit County, Ohio 44278**

Subject: *Asbestos Survey Report for the Property Located at 89 East Howe Road, City of Tallmadge, Summit County, Ohio 44278.*

2.0 FACILITY CONSTRUCTION INFORMATION

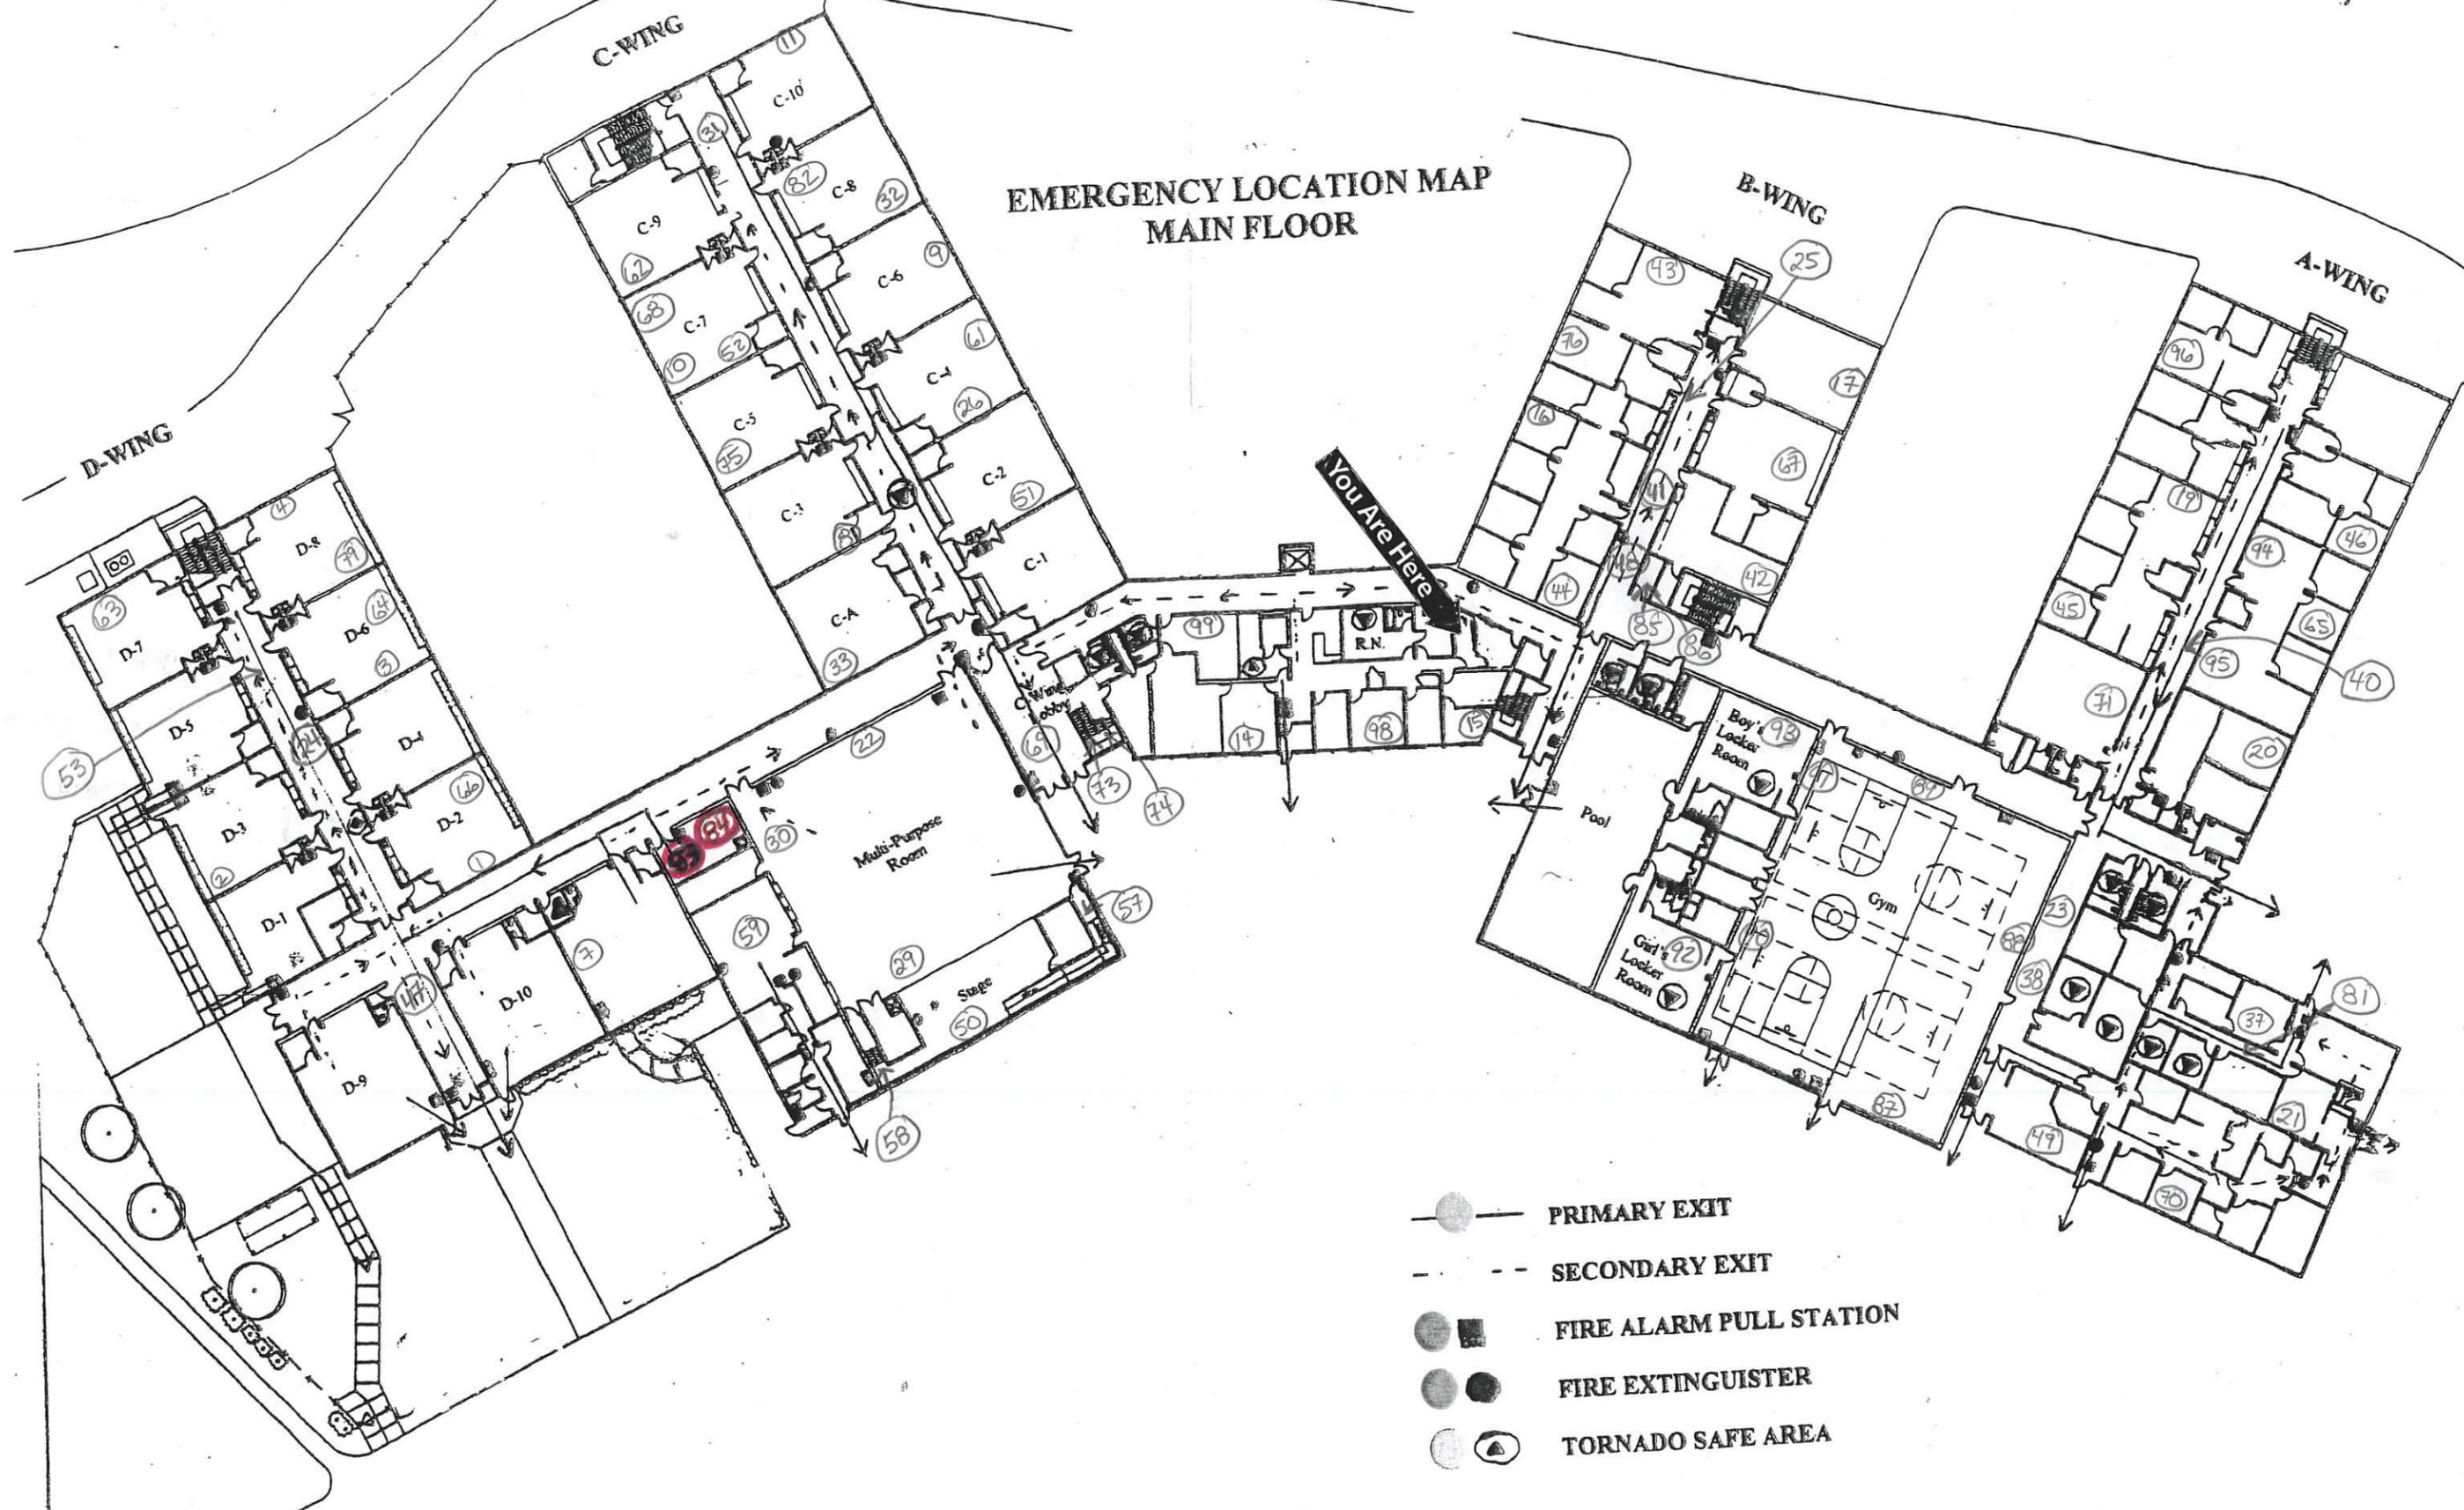
EMERGENCY LOCATION MAP MAIN FLOOR

Sample Locations

HZW's Asbestos Bulk Sampling Information Log for the Property, which includes the bulk sampling locations, material descriptions, quantities, condition and asbestos content is provided in **Attachment 2**. In addition, **Attachment 2** contains a drawing/sketch depicting the bulk sampling locations and the locations of building materials identified as ACM. A copy of the laboratory analytical report from CA Labs for the bulk samples collected at the Property is included as **Attachment 3**.

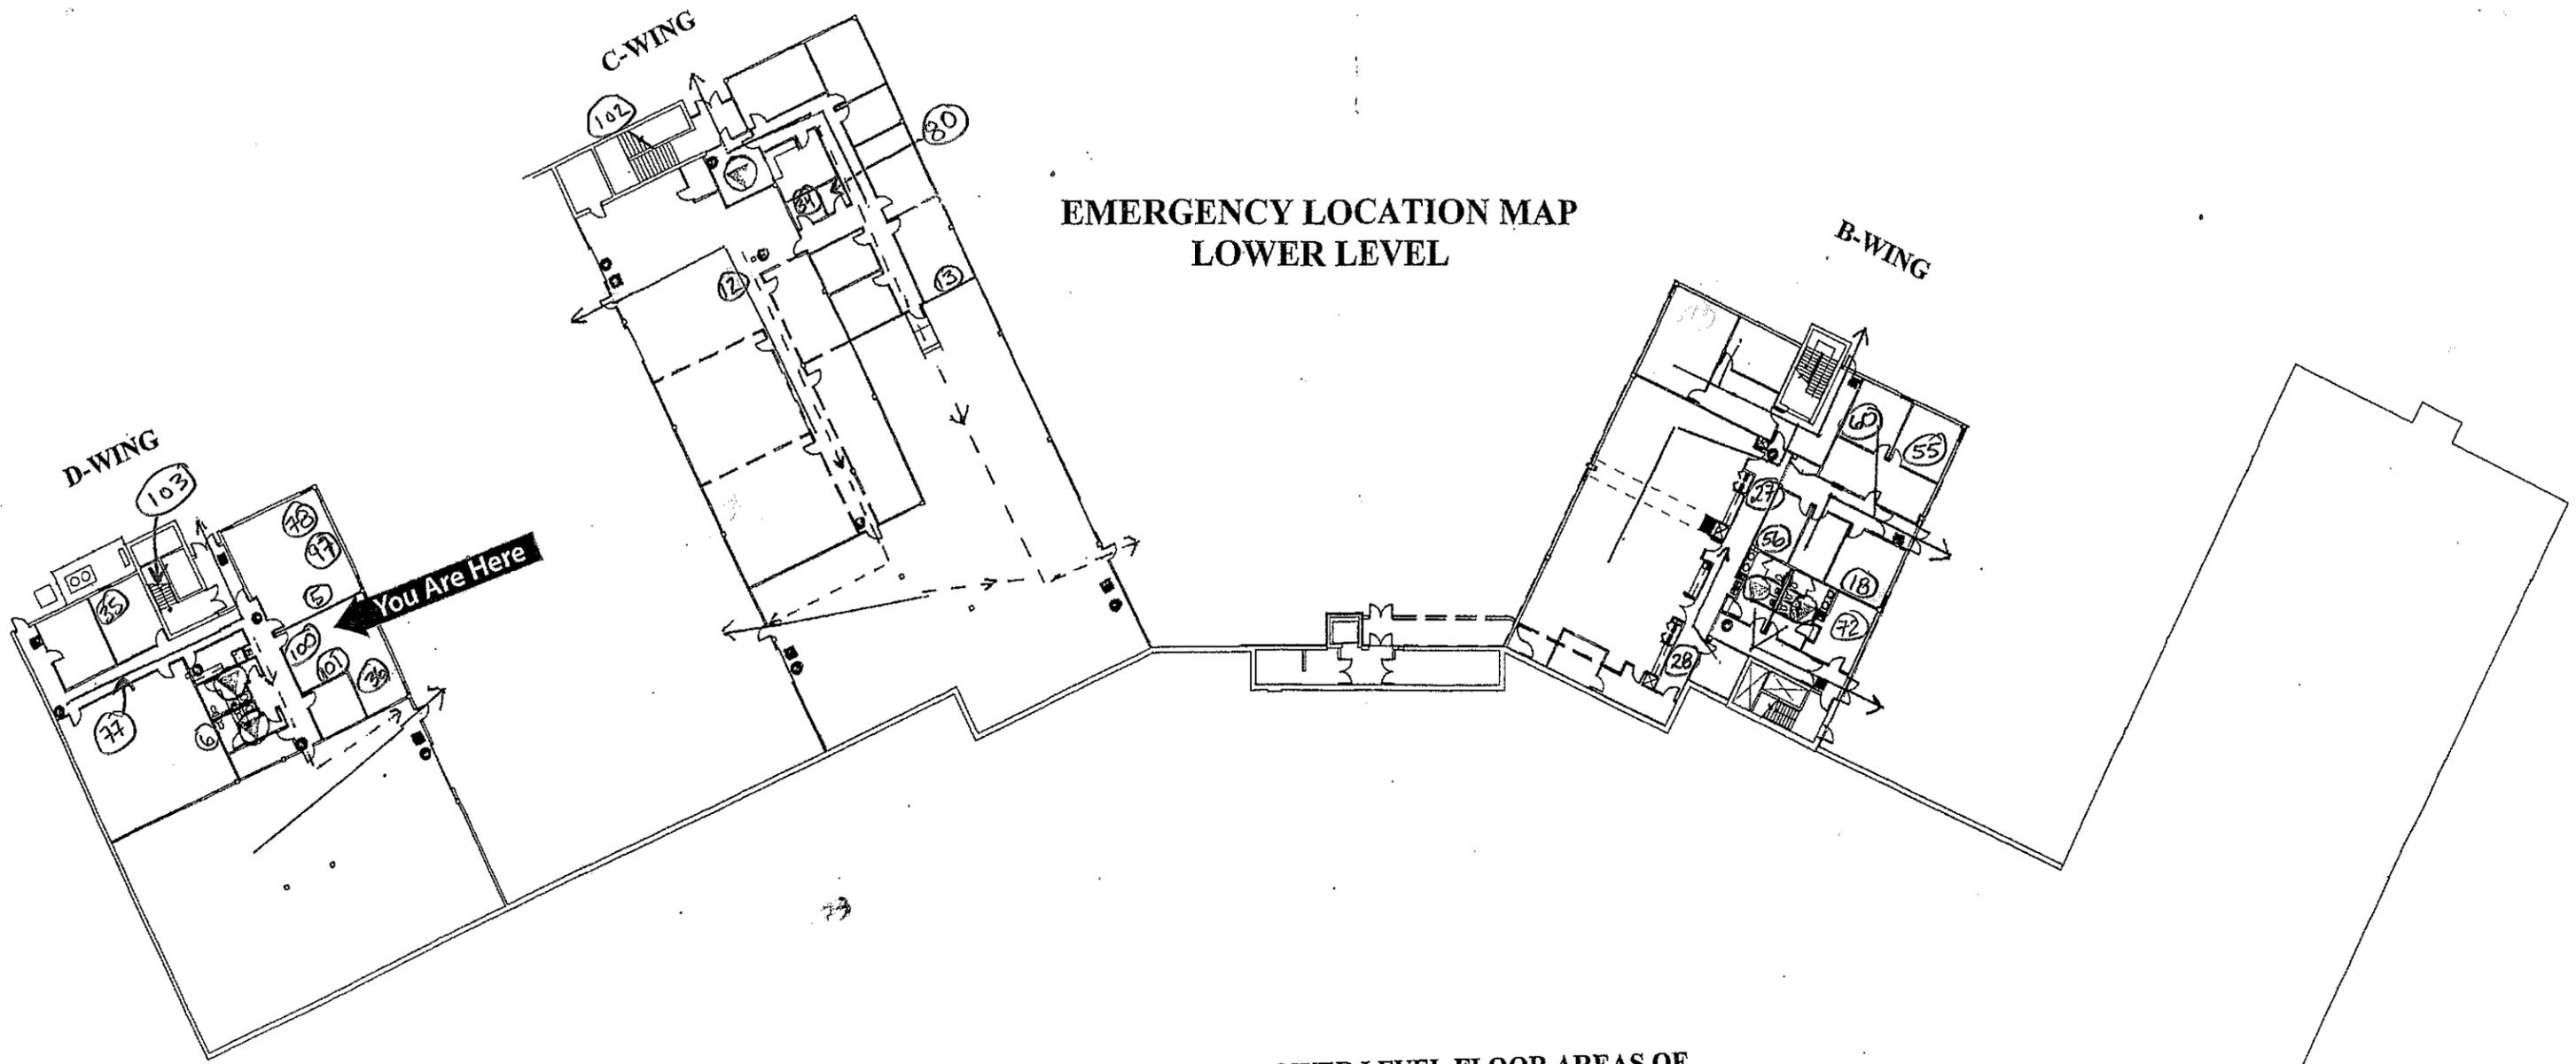
**EMERGENCY LOCATION MAP
LOWER LEVEL**

**TORNADO SAFE AREAS FOR LOWER LEVEL FLOOR AREAS OF
WEAVER LEARNING CENTER**
