GEOTECHNICAL ENGINEERING REPORT

Sparrow Pond Restoration Arlington, Virginia

**Arlington County
Department of Environmental Services**

**18 May 2022
270060009**

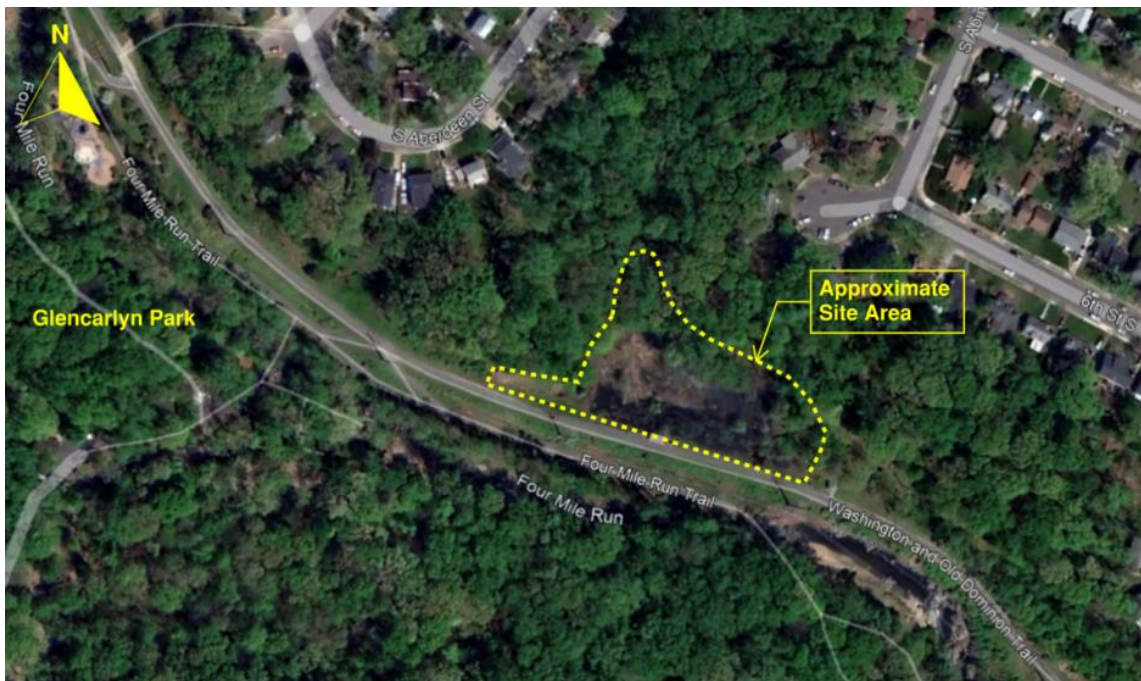
Inset 1

The project is focused on Sparrow Pond which is located in Glencarlyn Park in Arlington, Virginia. The project site area included in our assessment is about 62,000 square feet in size and is bordered by wooded areas to the east, north, and west and the Washington and Old Dominion Trail (W&OD Trail) to the south; see Inset 1. The pond generally consists of low grass vegetation, sediment, and areas of standing water.

Existing grades at the bottom of the pond typically range from el 149 to 151 except for isolated sediment mounds that are 1 to 5 feet above the basin bottom. The inlet area, northwest of the general pond area, has grades grading from el 151 to 155 increasing to the northwest. Site grades slope up in all directions outward from the pond bottom. The paved W&OD Trail, located south of the pond, is on an embankment with surface grades ranging from el 156 to 160.

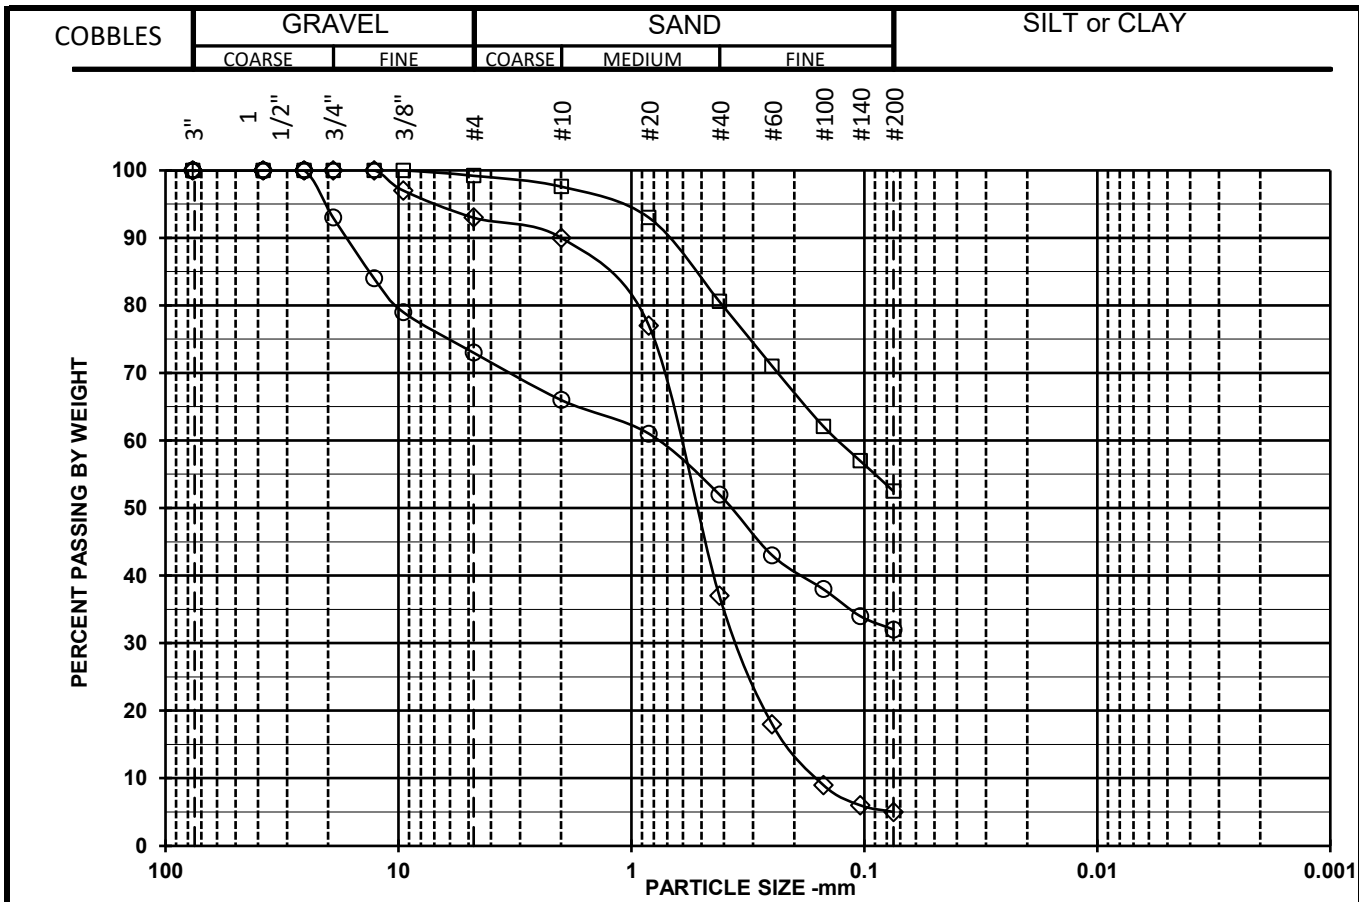
Open Symbols: Sieve analysis by ASTM D6913
 Filled symbols: Hydrometer analysis by ASTM D7928 corrected for complete sample

Symbol	□	◇	○
Boring	DCP-4	DCP-7	DCP-8
Sample	S-2	S-2	S-2
Depth	5-5.5	2.5-3	3-3.5
% +3"	0	0	0
% Gravel	0.8	7	27
% SAND	46.7	88	41
%C SAND	1.6	3	7
%M SAND	17	53	14
%F SAND	28.1	32	20
% FINES	52.5	5	32
D ₁₀₀ (mm)	9.53	12.7	25.4
D ₆₀ (mm)	0.129	0.625	0.778
D ₃₀ (mm)		0.35	
D ₁₀ (mm)		0.16	
Cc		1.2	
Cu		3.9
