Lead-Based Paint Inspection Report

Isabella Towers

1515 Isabella Circle
Knoxville, Tennessee

Project #19-1304

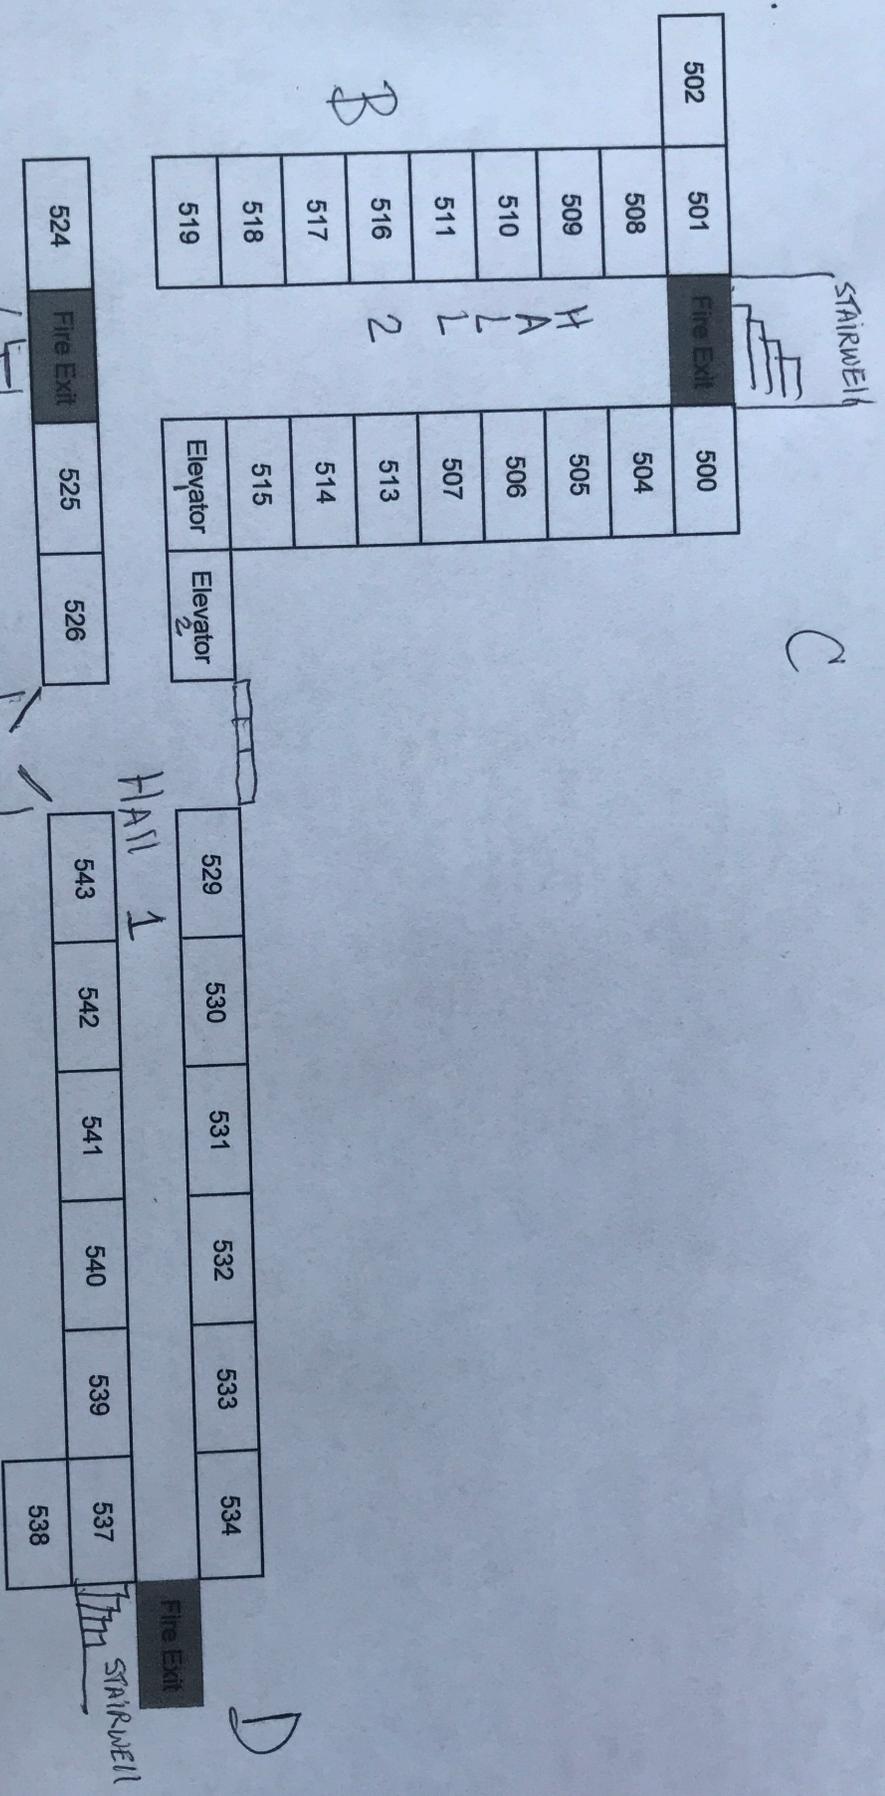
Isabella Towers Evacuation Plan

In case of an emergency requiring evacuation, elevators will not be available. Make your way to the nearest fire exit in a calm and orderly fashion. Once clear of the building assemble in the resident parking area in front of the building.
