# RFP 2021-102

## CARNEGIE LIBRARY ROOF REPAIR & RESTORATION

The Carnegie Library is a local historic site and a contributing structure in the City of Beaufort's National Historic Landmark District. The exterior scope of work for this project includes the repair of the existing terracotta roof, new dormer flashing, repair of the built-in-gutter liner, exterior wood repair, paint removal, painting, replacement of the addition roof on the east side of the building, and new underground drainage from the downspouts to the street. The interior scope of work is limited to interior repairs associated with water damage from previous and current roof leaks. Water damage has resulted in damage to historic plaster.

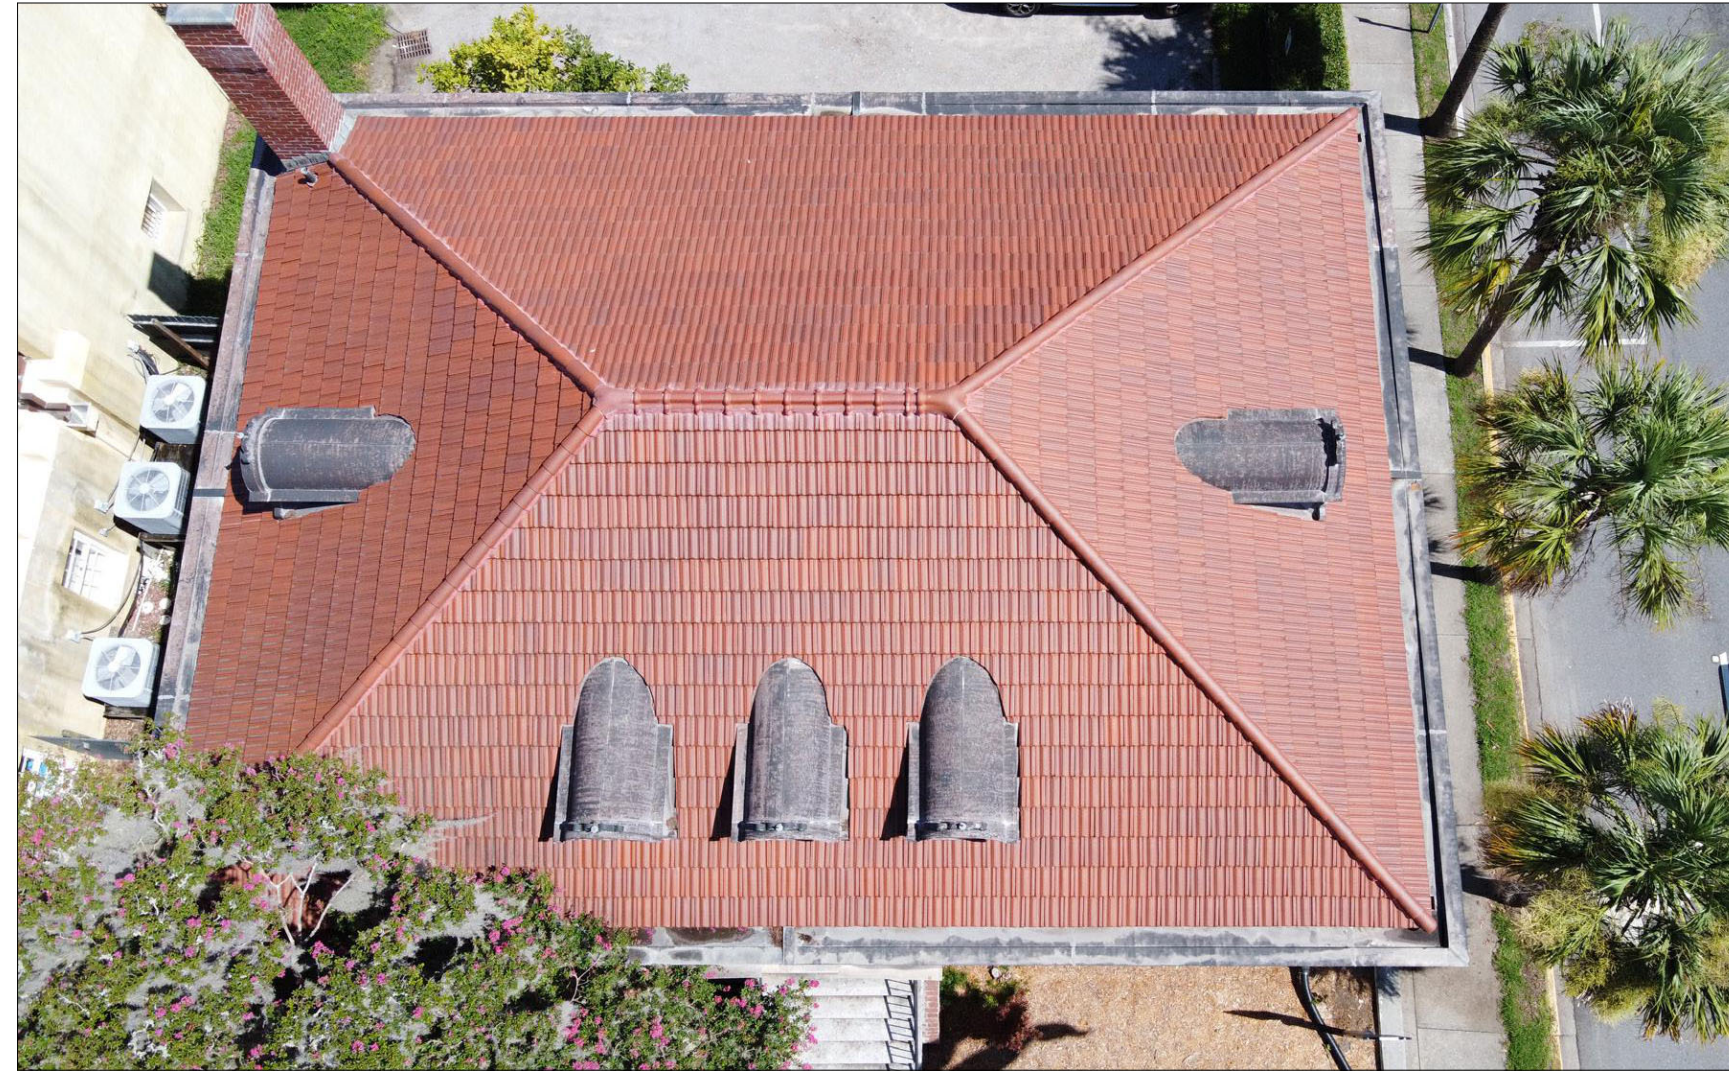
EXISTING CONDITIONS- OVERALL VIEW OF ROOF FROM ABOVE.

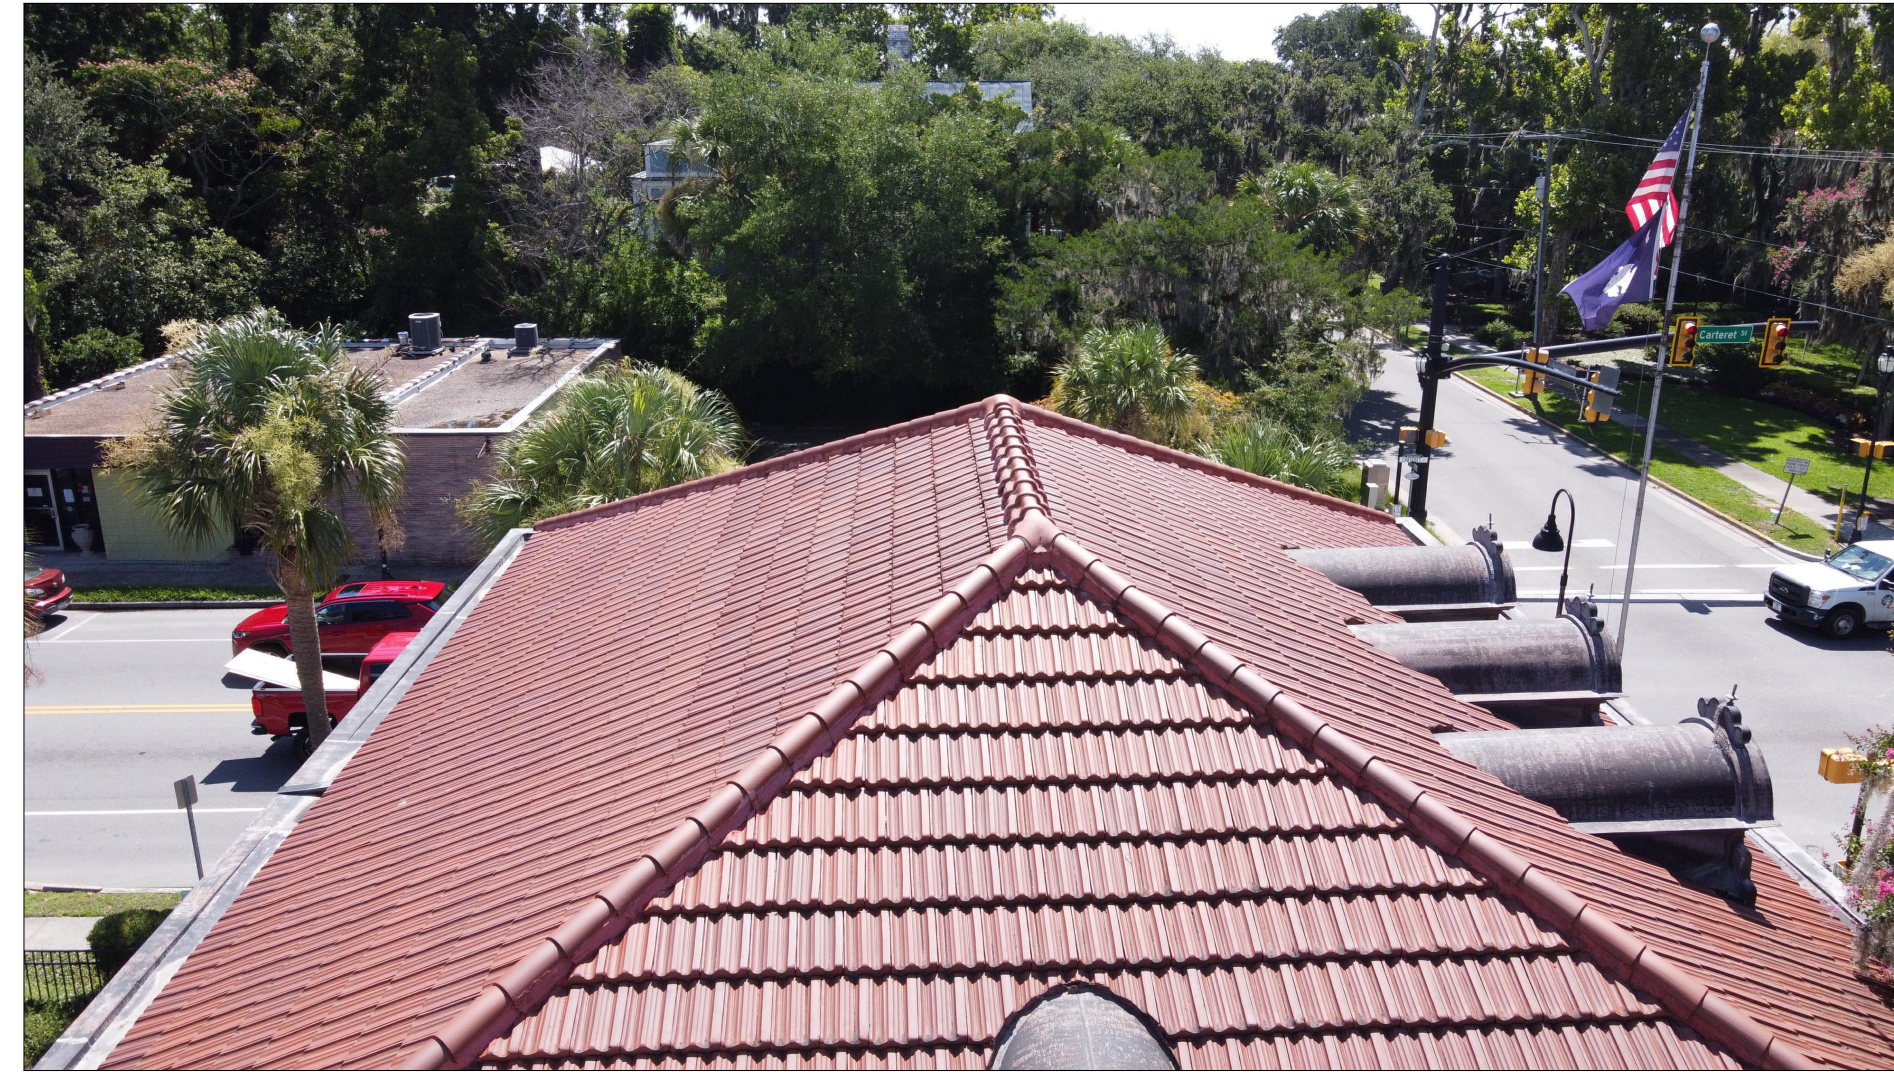
EXISTING CONDITIONS- VIEW OF ROOF LOOKING EAST.

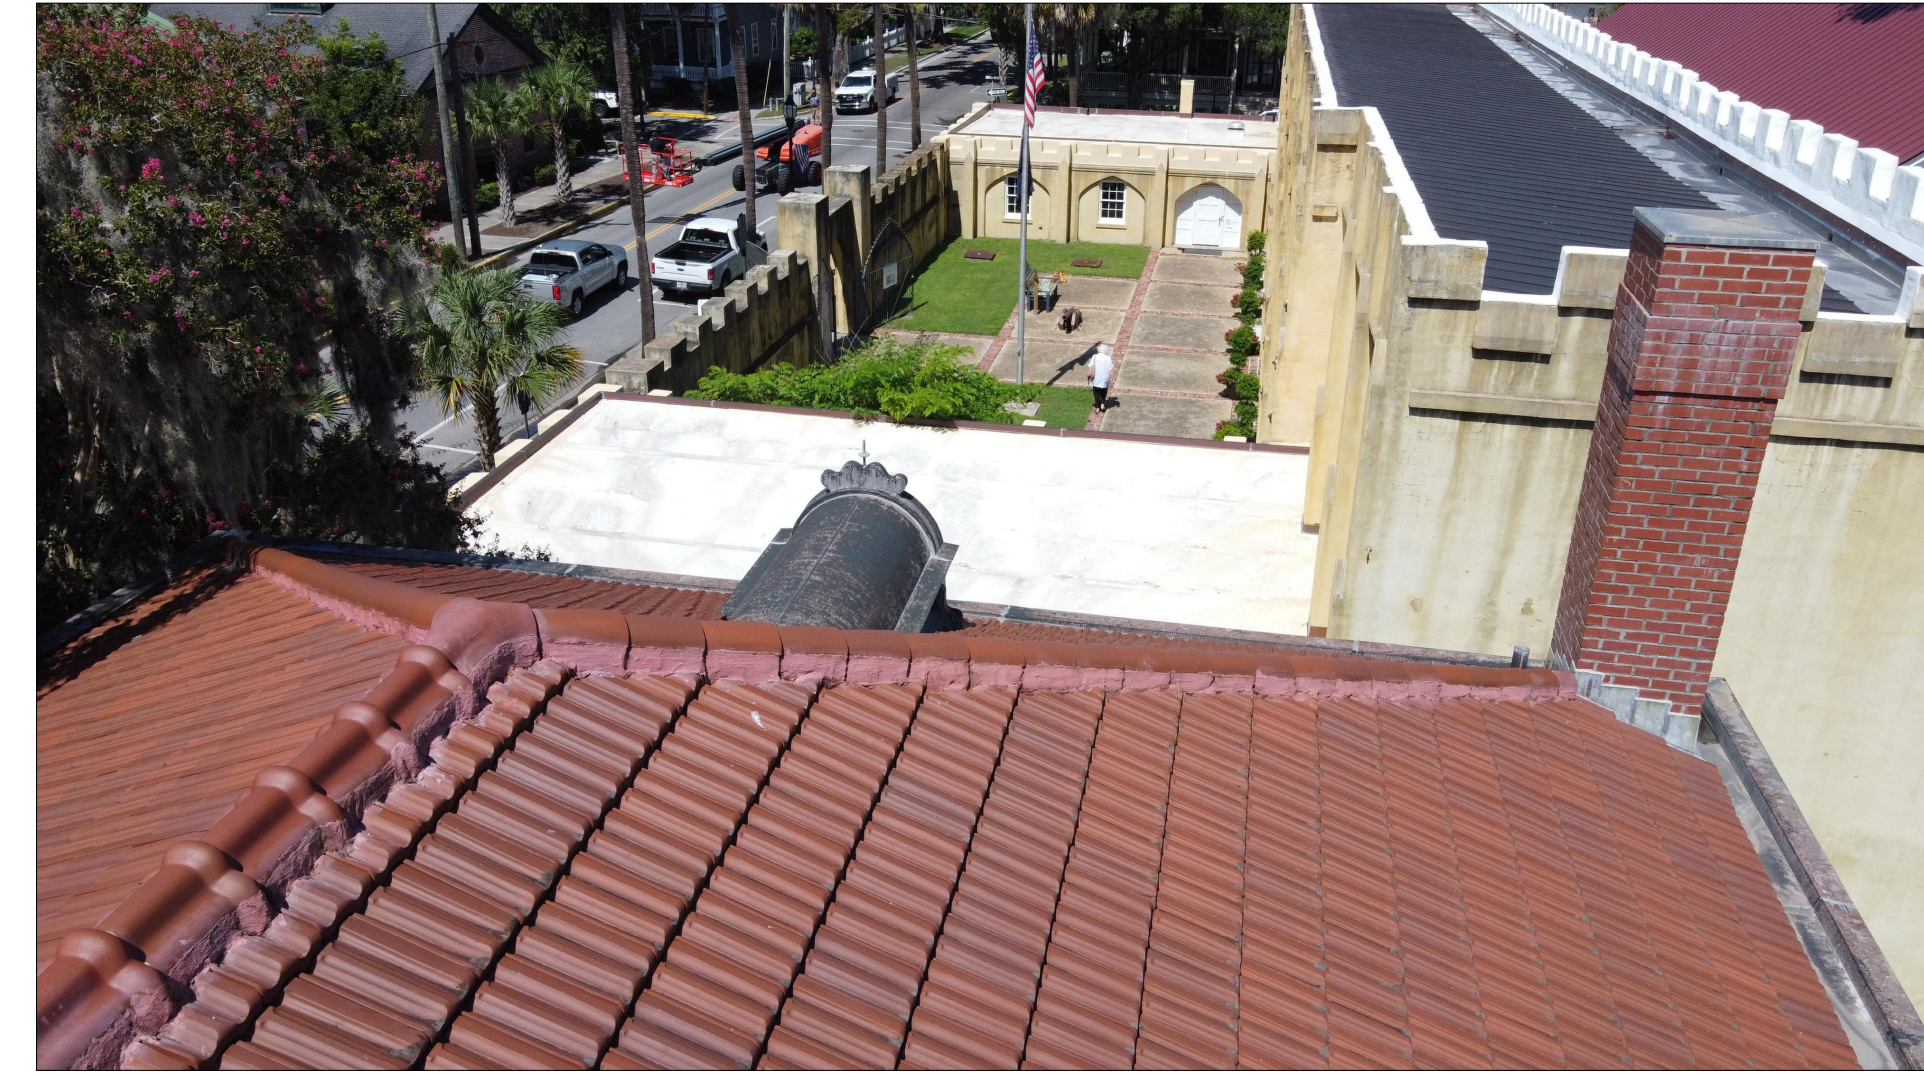
EXISTING CONDITIONS- DETAILED VIEW OF ROOF RIDGE AND HIP.

THE ROOF CURRENTLY LEAKS AROUND THE DORMERS AND AT THE RIDGE WHERE THE MORTAR IS RELEASING.

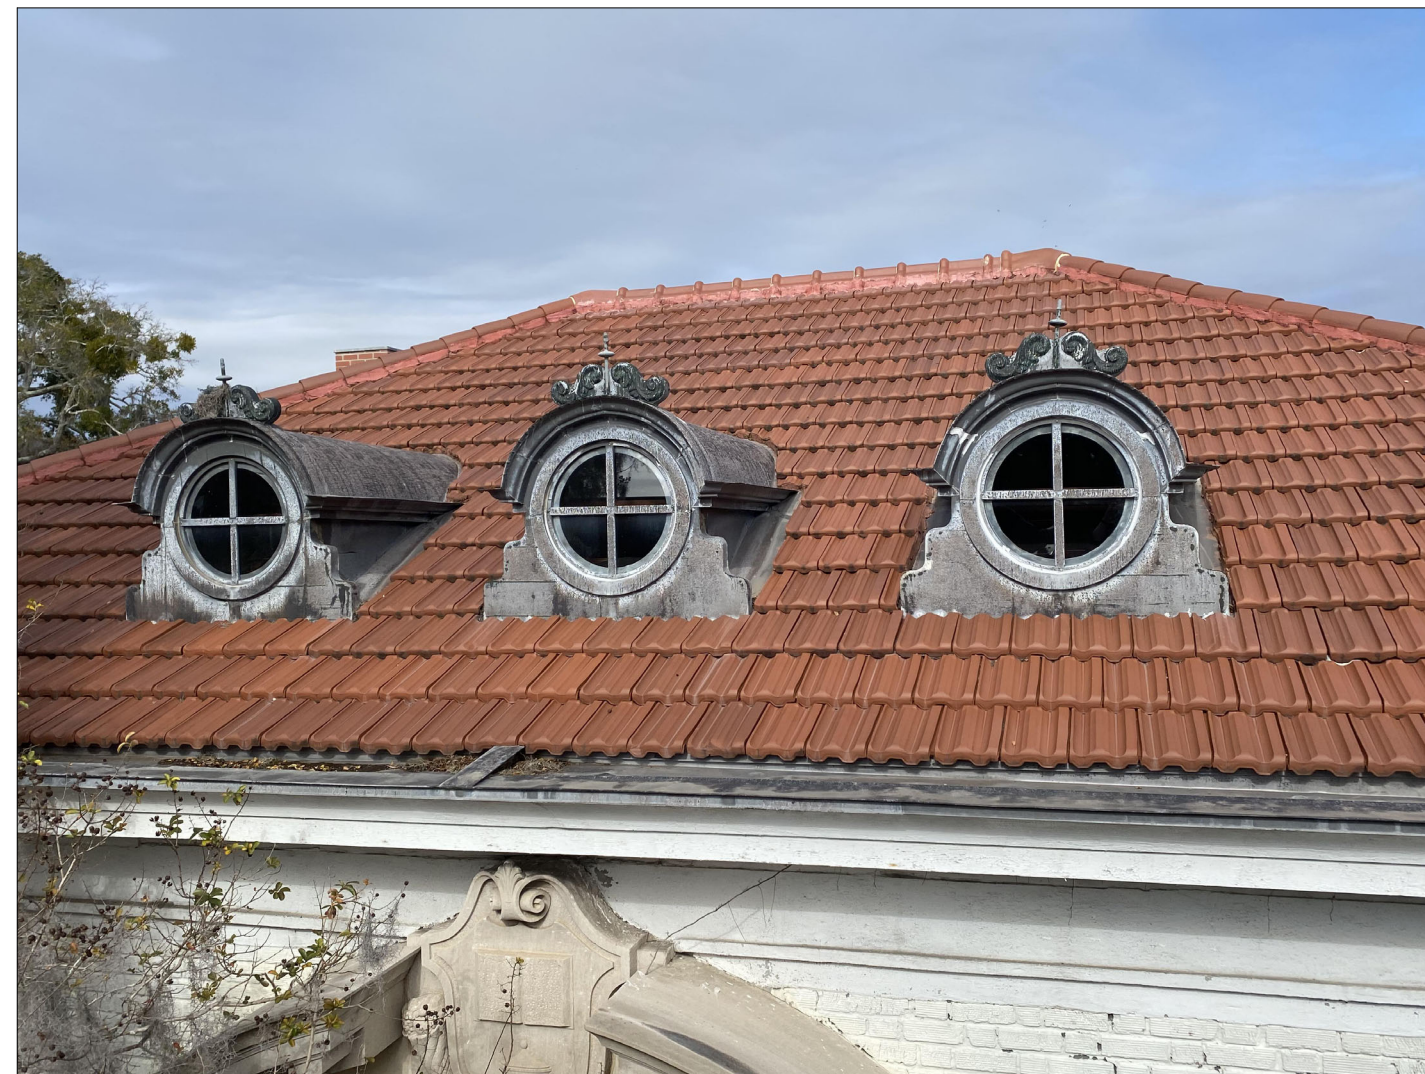
EXISTING CONDITIONS- VIEW OF SOUTH ELEVATION DORMERS.

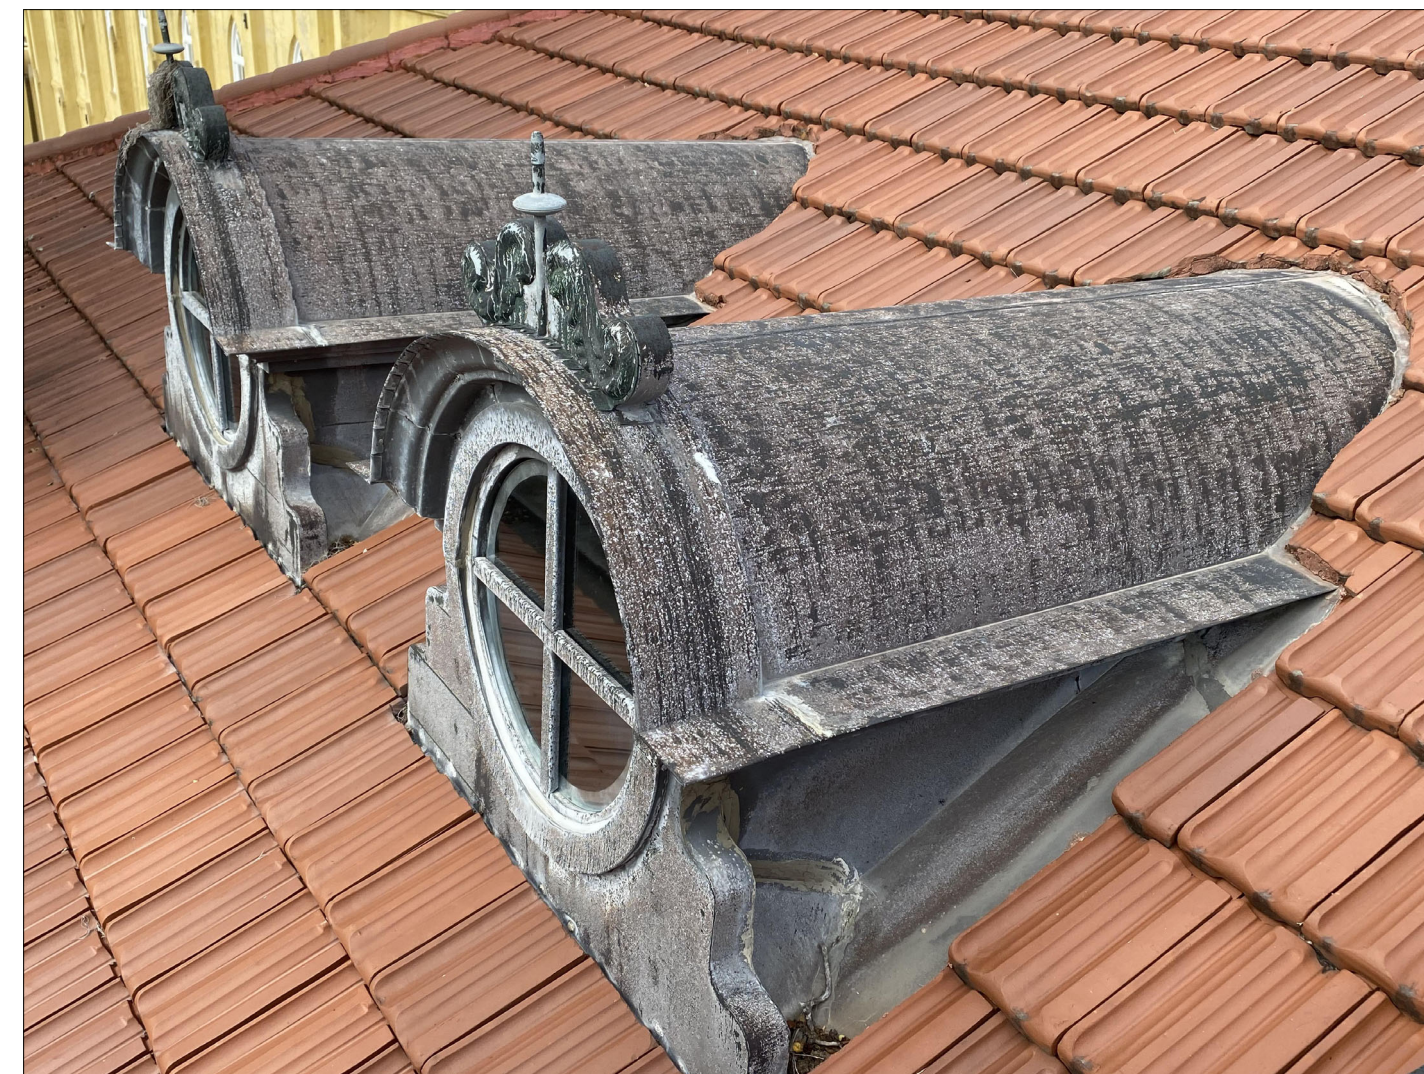
EXISTING CONDITIONS- DETAILED VIEW OF SOUTH ELEVATION DORMERS FROM THE SIDE.

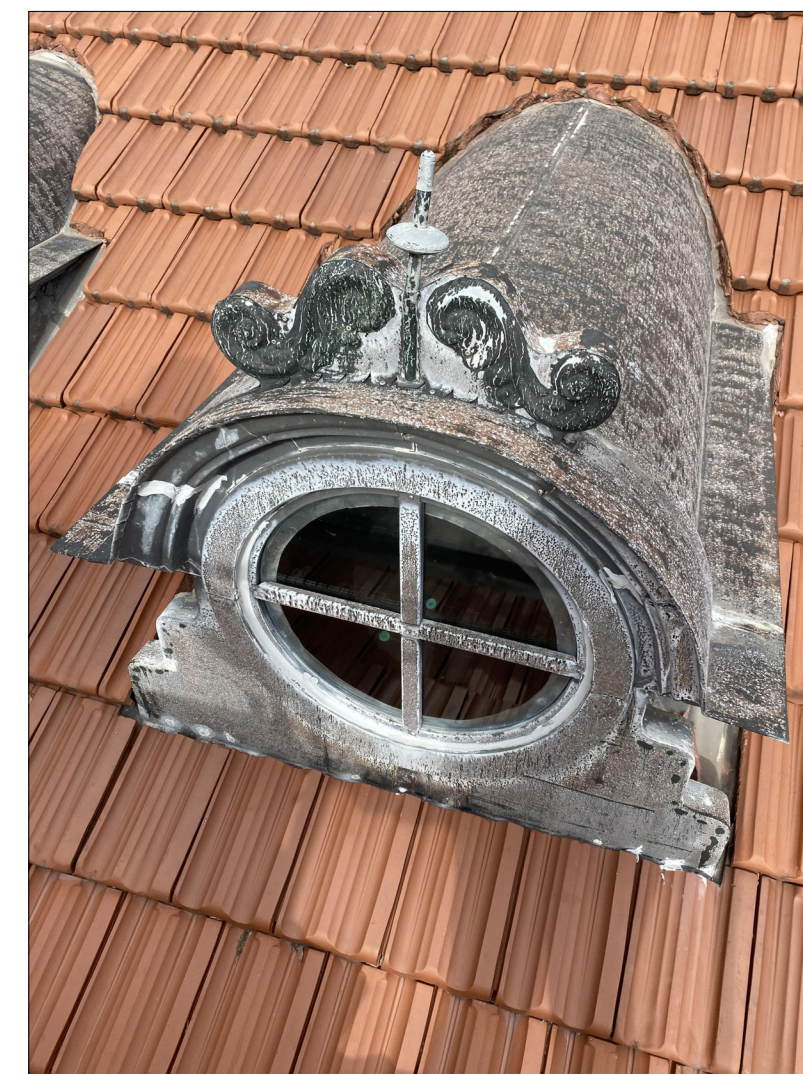
EXISTING CONDITIONS- DETAILED VIEW OF DORMER FRONT AT SOUTH ELEVATION.

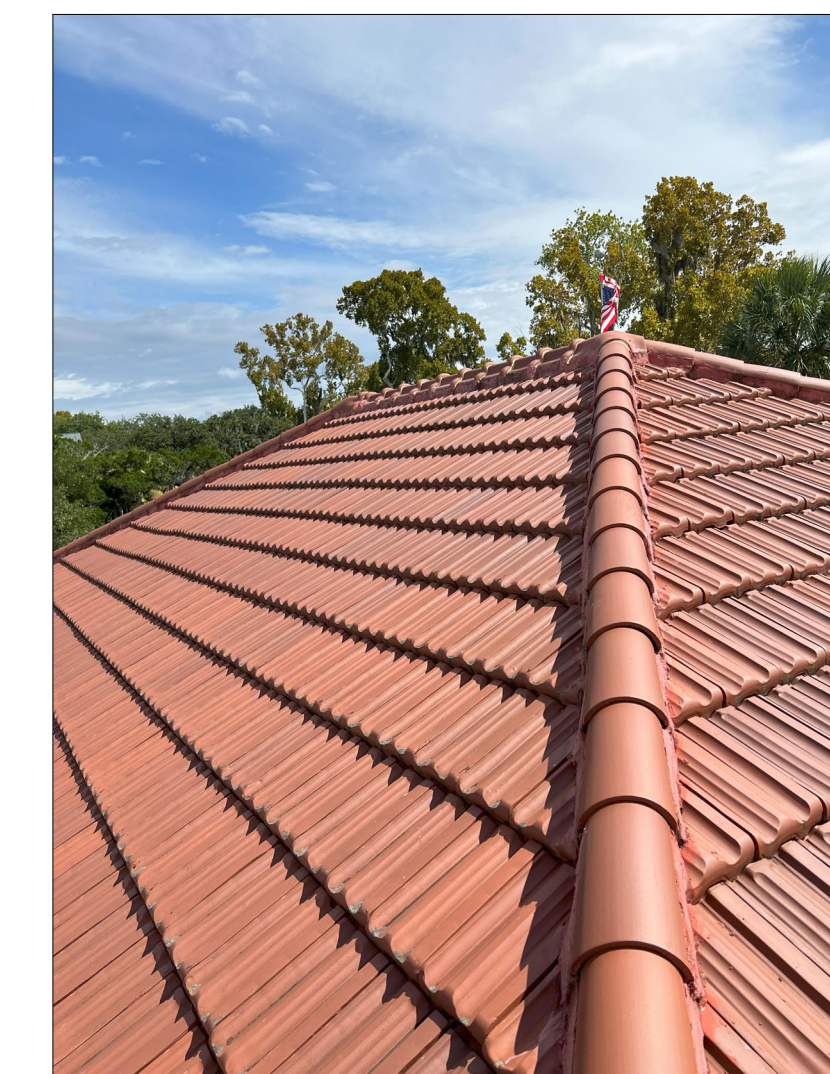
EXISTING CONDITIONS- DETAILED VIEW OF RIDGE TILES.

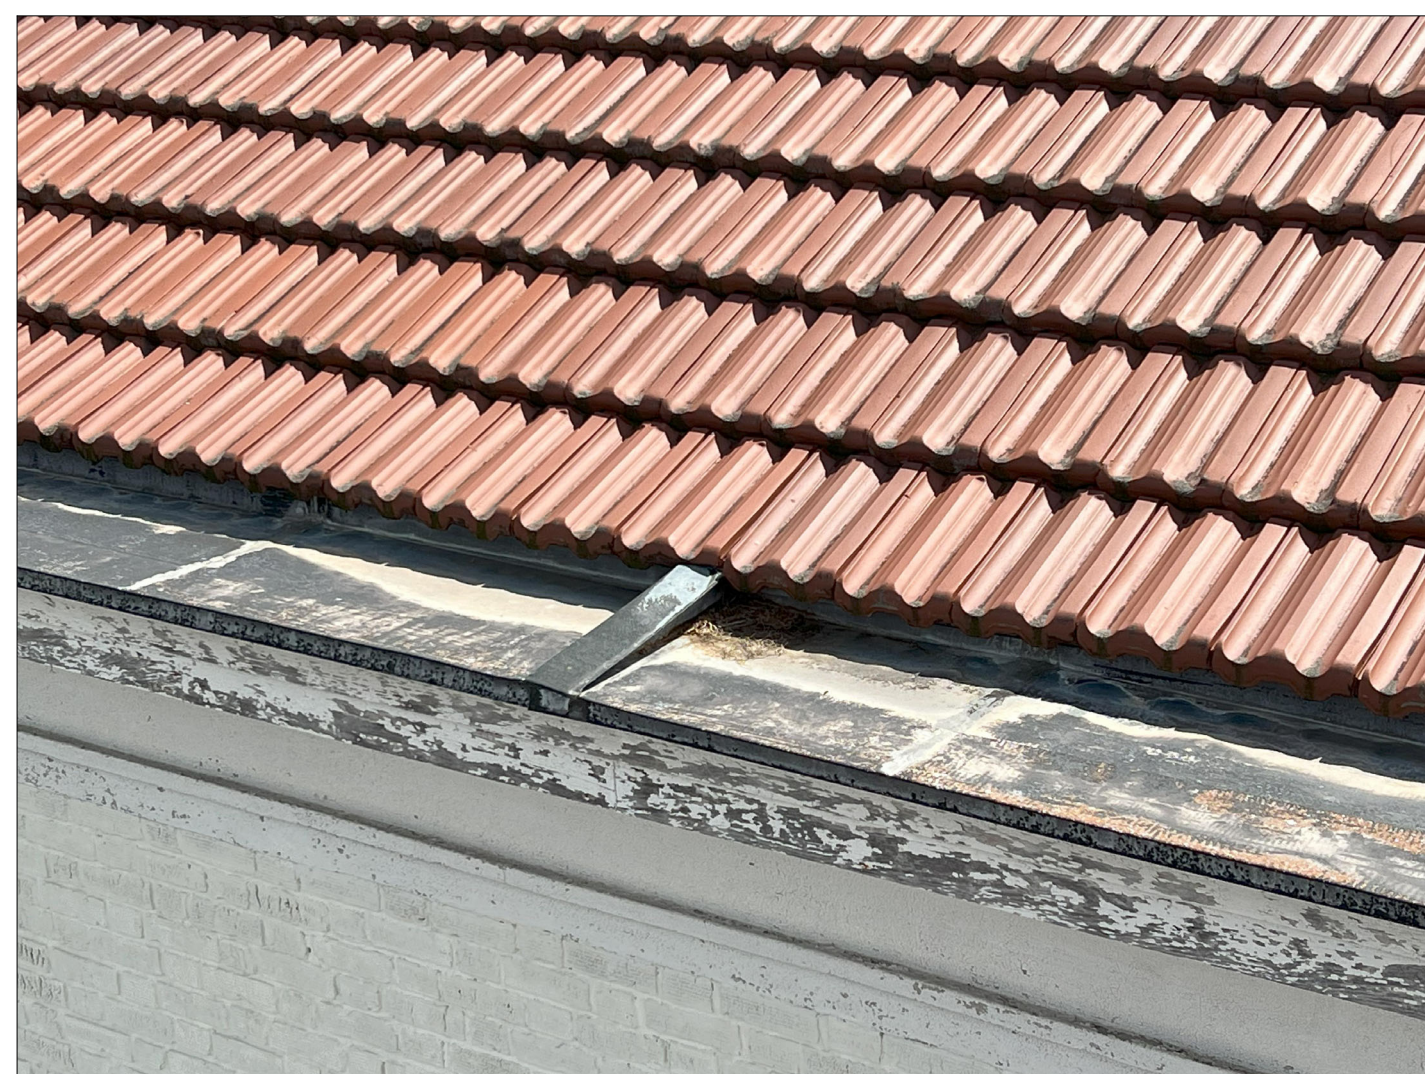
EXISTING CONDITIONS- VIEW LOOKING SOUTH, DETAILED VIEW OF BUILT IN GUTTER AND FRENCH TERRACOTTA TILES.

THE BUILT-IN-GUTTER LINER ALSO HAS DEFICIENCIES.

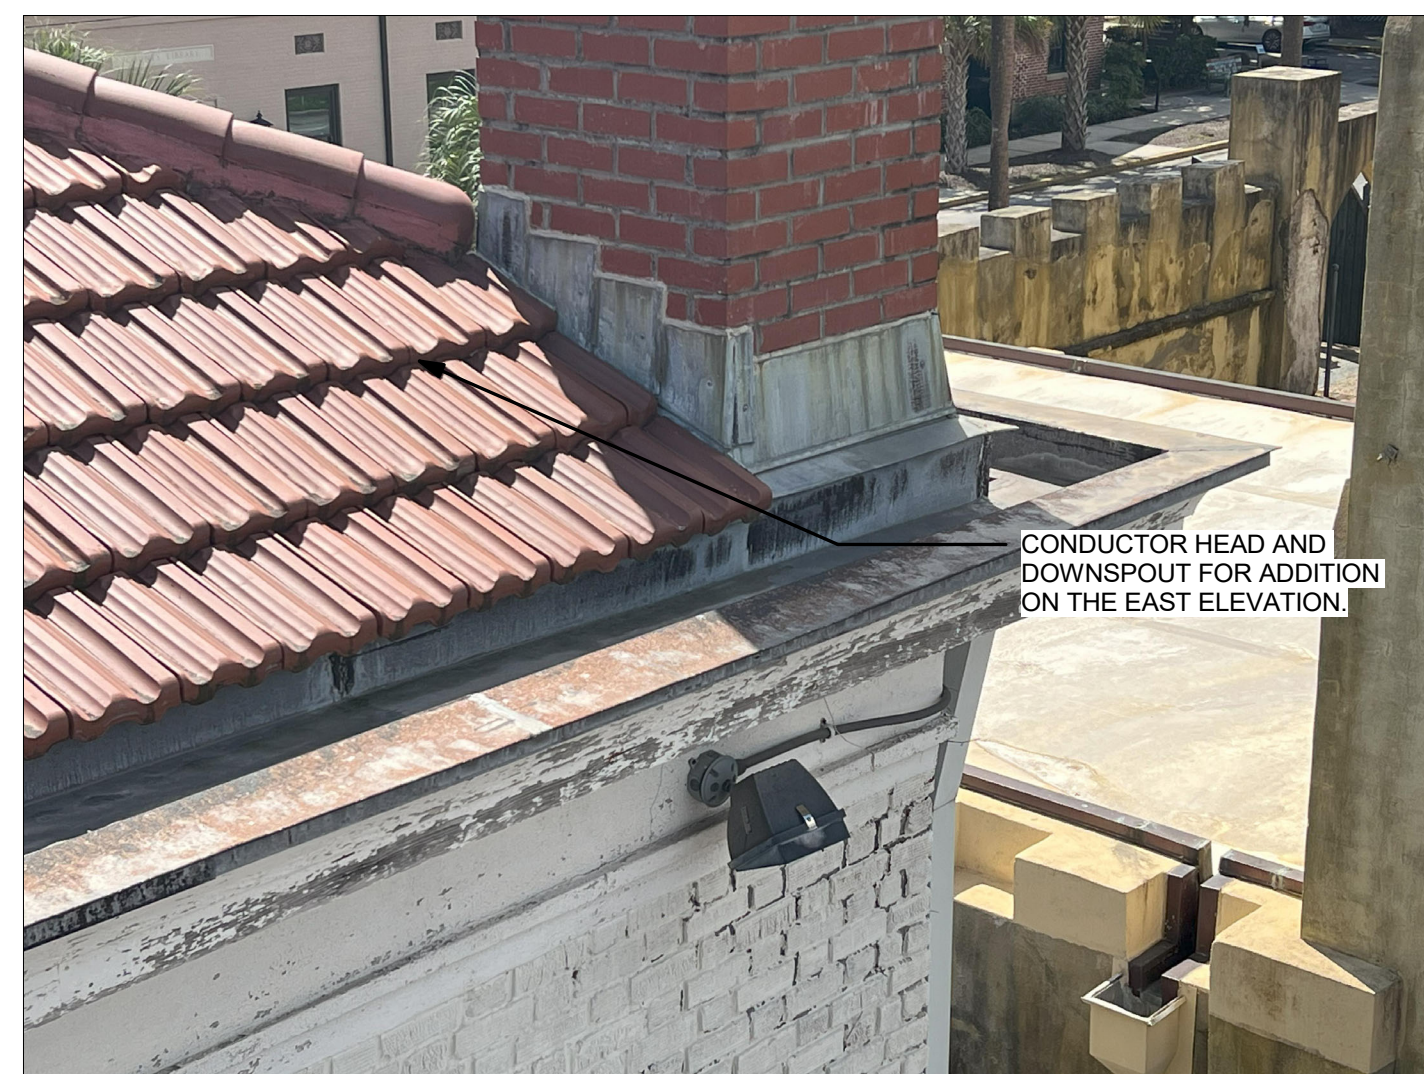
EXISTING CONDITIONS- VIEW AT NORTHWEST CORNER, DETAILED VIEW OF CHIMNEY PENETRATION AT ROOF.

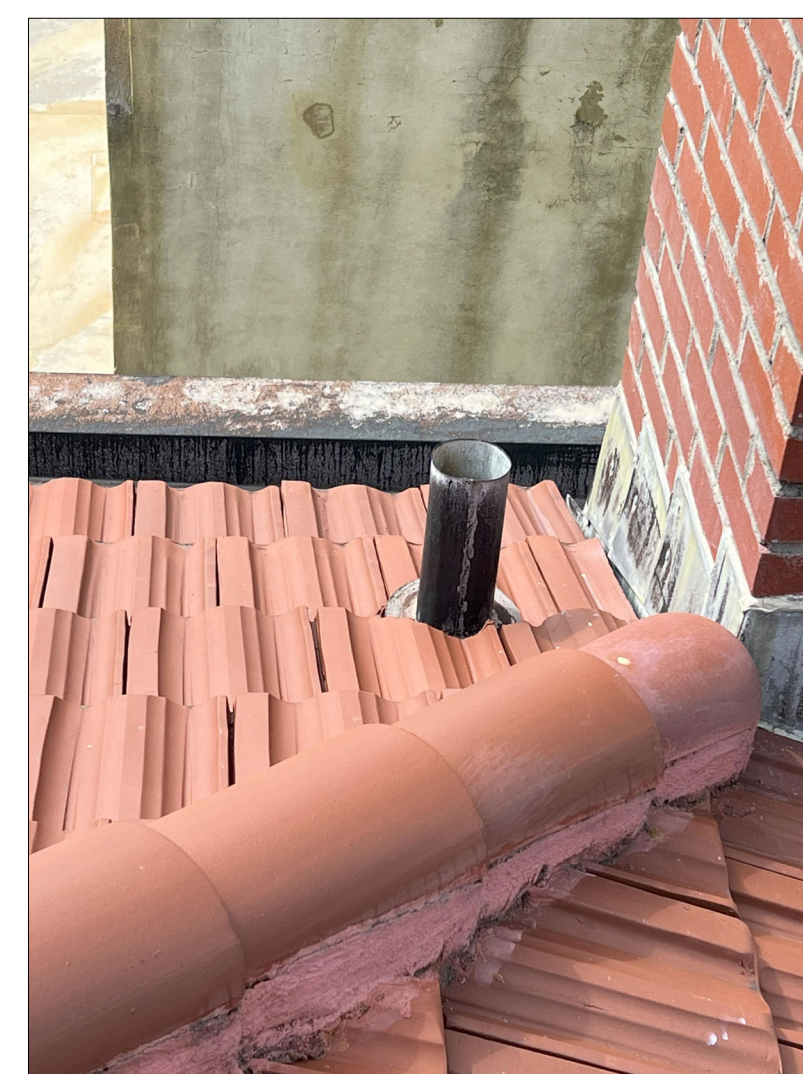
EXISTING CONDITIONS- VIEW AT NORTHWEST CORNER, DETAILED VIEW OF RIDGE AND VENT.

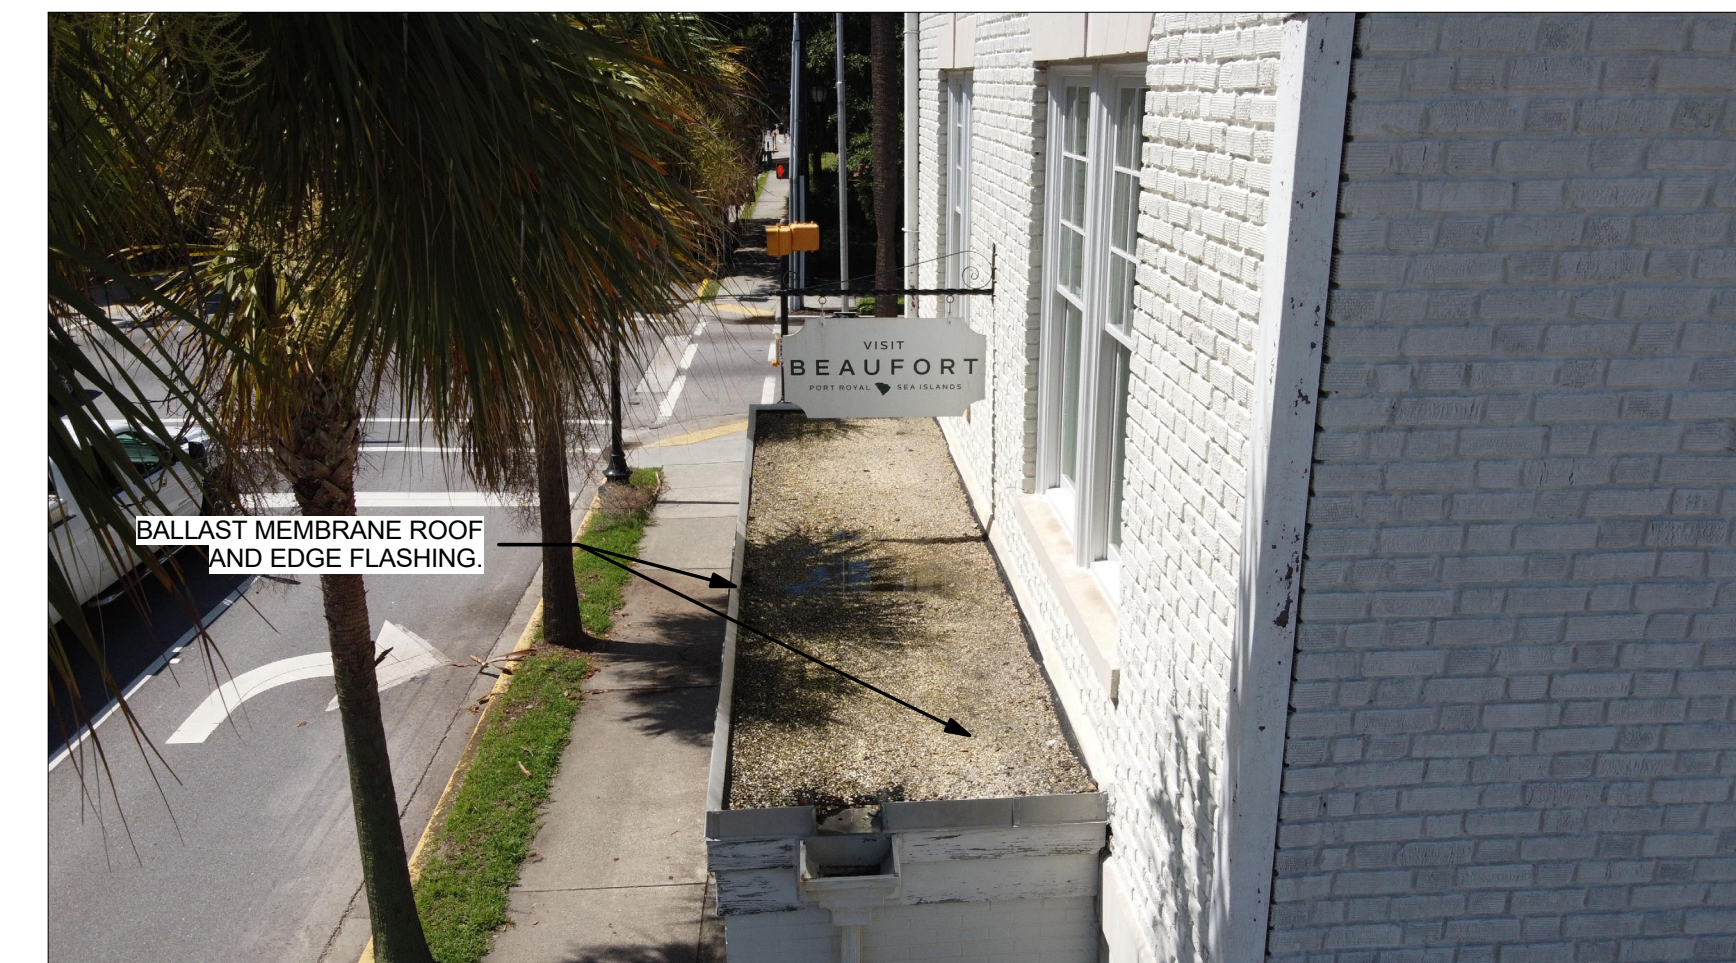
EXISTING CONDITIONS- EAST ELEVATION ADDITION ROOF.

EXISTING CONDITIONS- EAST ELEVATION ADDITION ROOF

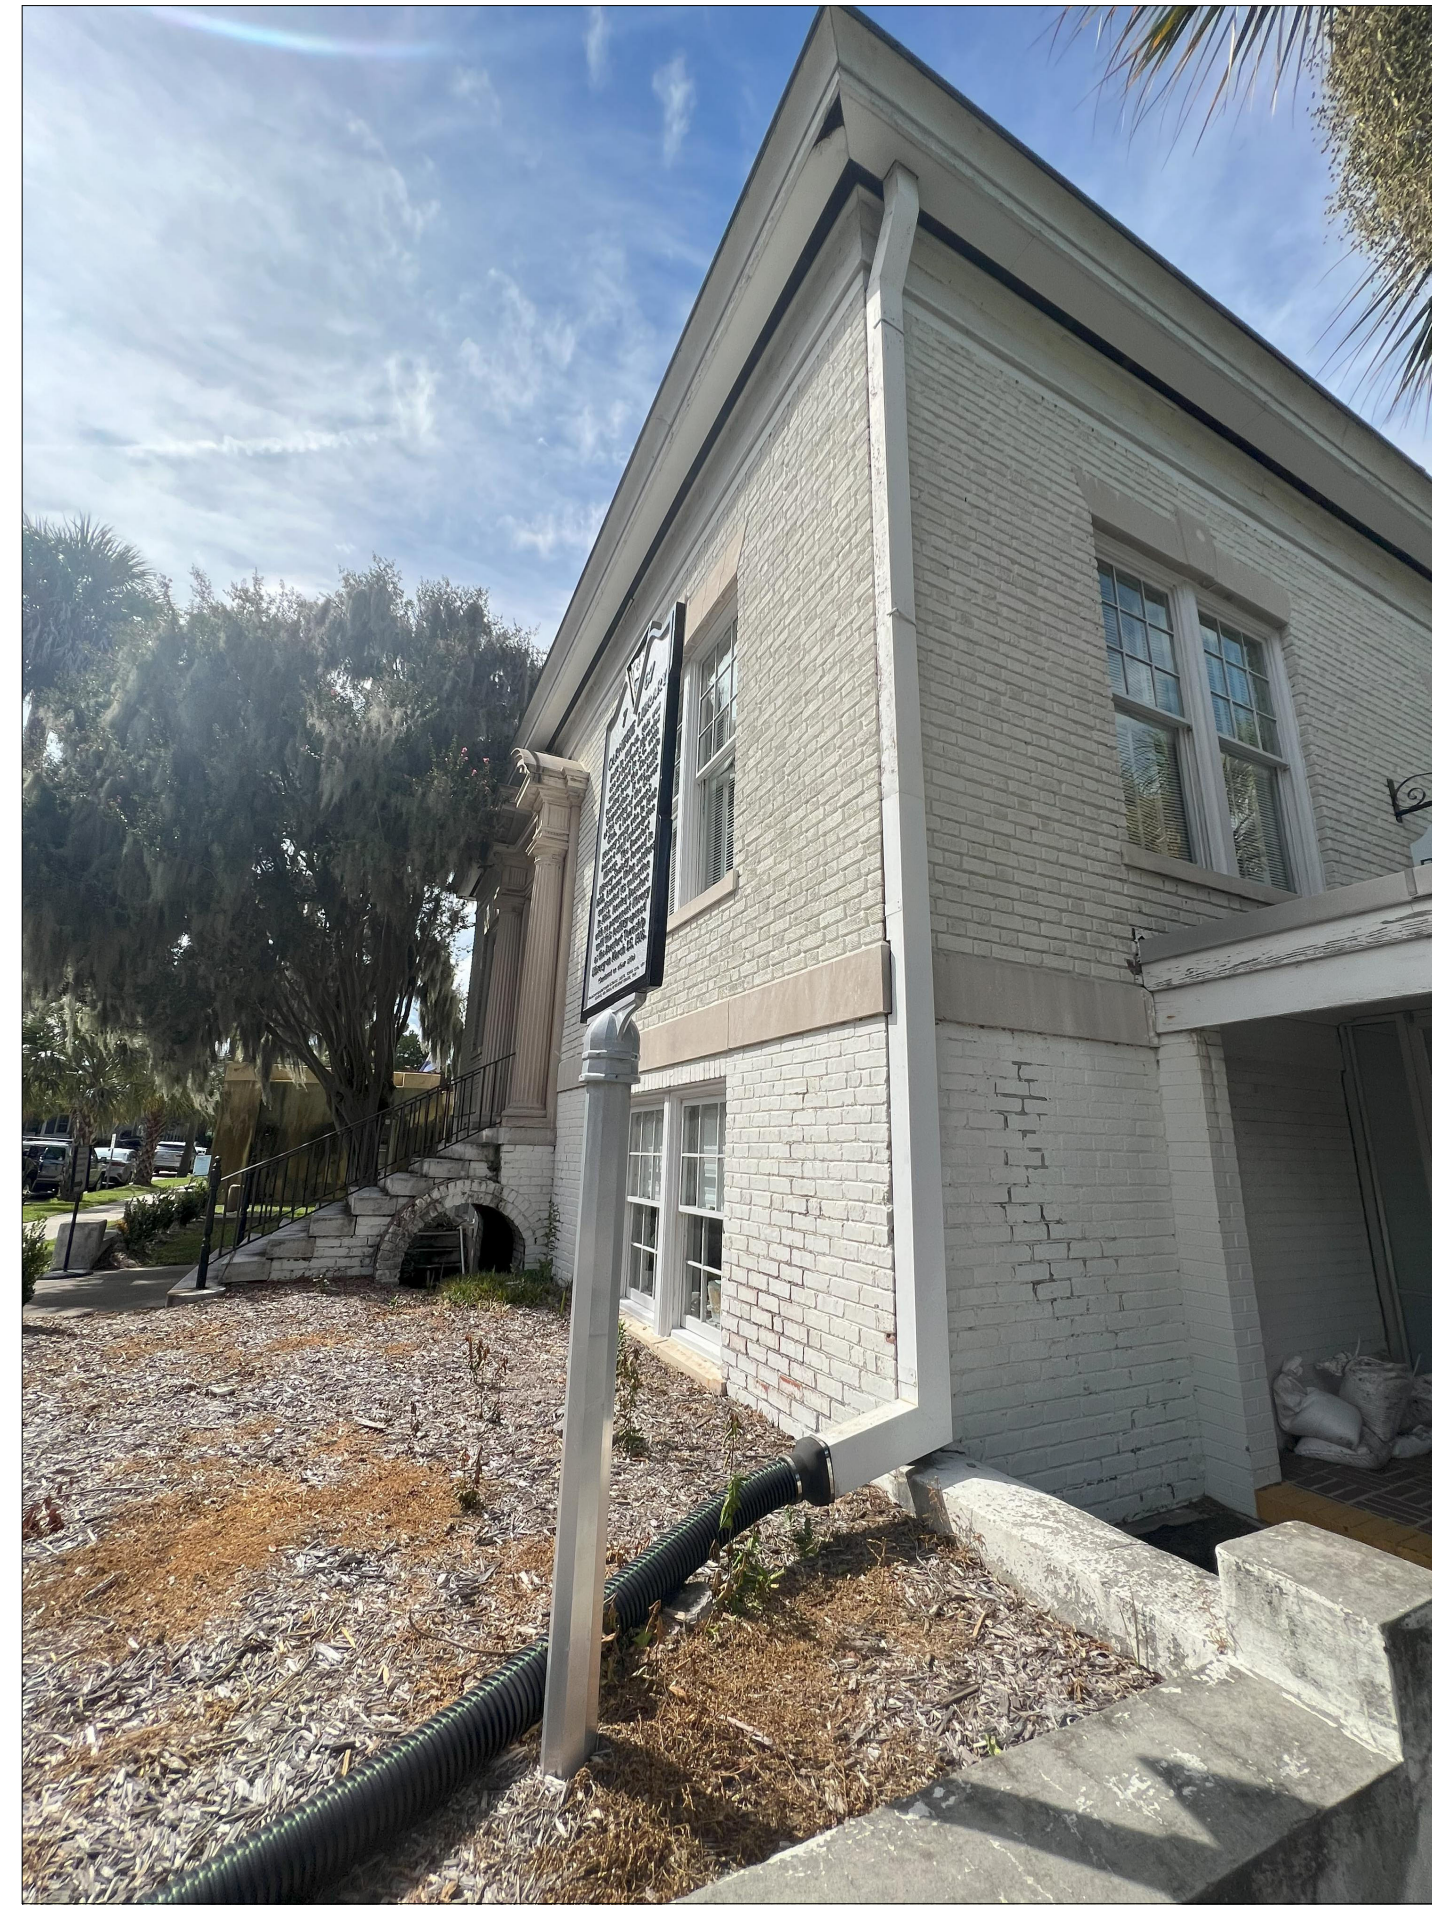
EXISTING CONDITIONS- SOUTHEAST CORNER DOWNSPOUT.

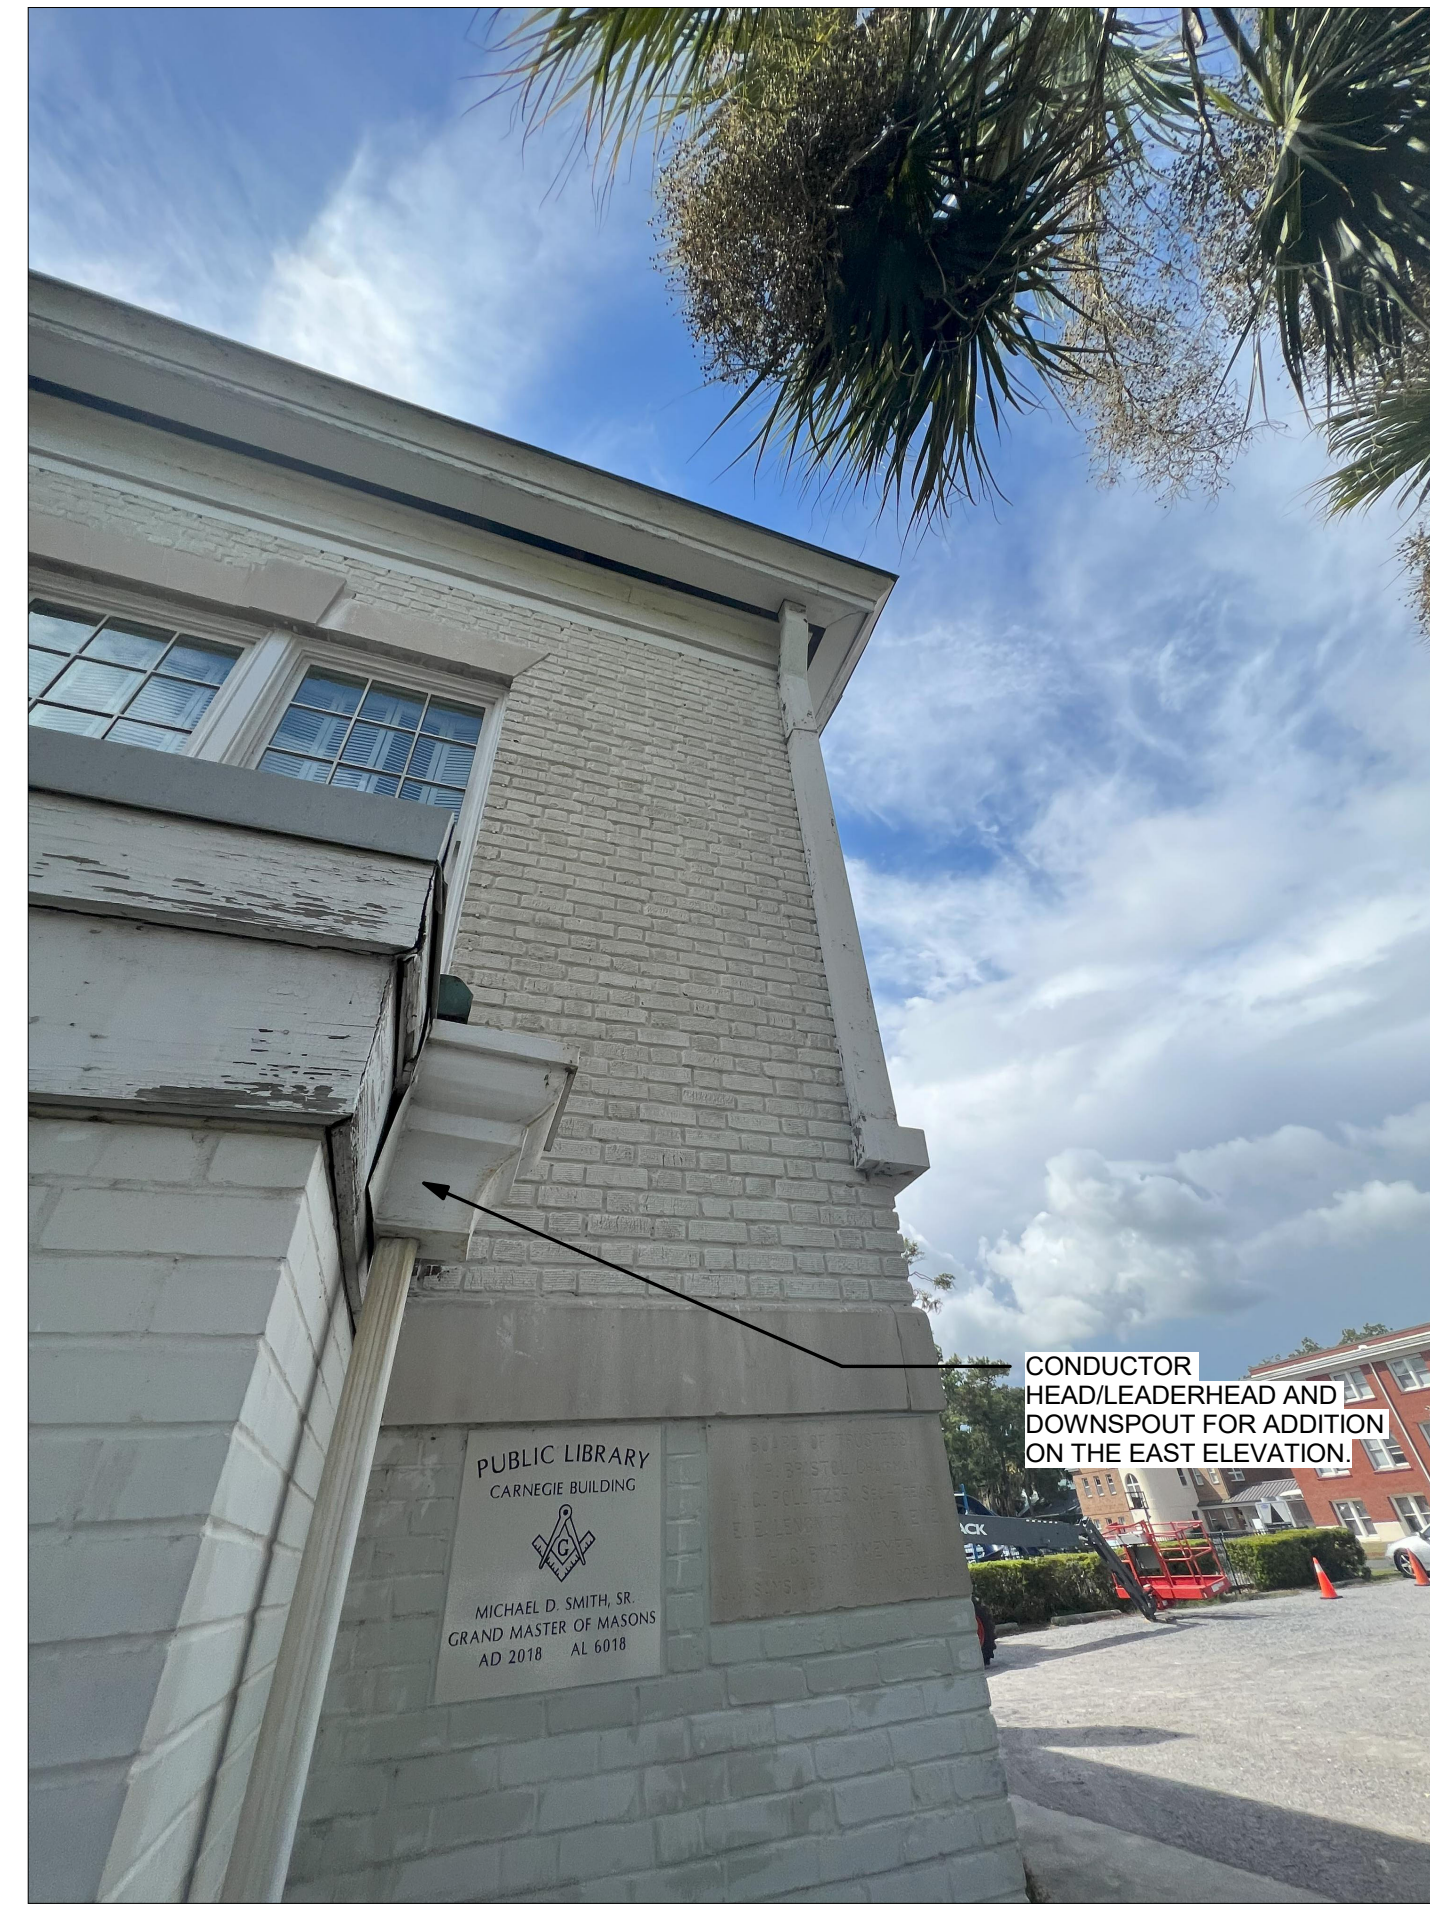
EXISTING CONDITIONS- DOWNSPOUTS ON NORTH SIDE OF THE EAST ELEVATION. CONDUCTOR HEAD/LEADERHEAD ON THE LEFT IS PART OF THE WATER DRAINAGE SYSTEM FOR THE ADDITION ROOF.
