# RFP 2021-102

## CARNEGIE LIBRARY ROOF REPAIR & RESTORATION

The Carnegie Library is a local historic site and a contributing structure in the City of Beaufort's National Historic Landmark District. The exterior scope of work for this project includes the repair of the existing terracotta roof, new dormer flashing, repair of the built-in-gutter liner, exterior wood repair, paint removal, painting, replacement of the addition roof on the east side of the building, and new underground drainage from the downspouts to the street. The interior scope of work is limited to interior repairs associated with water damage from previous and current roof leaks. Water damage has resulted in damage to historic plaster.

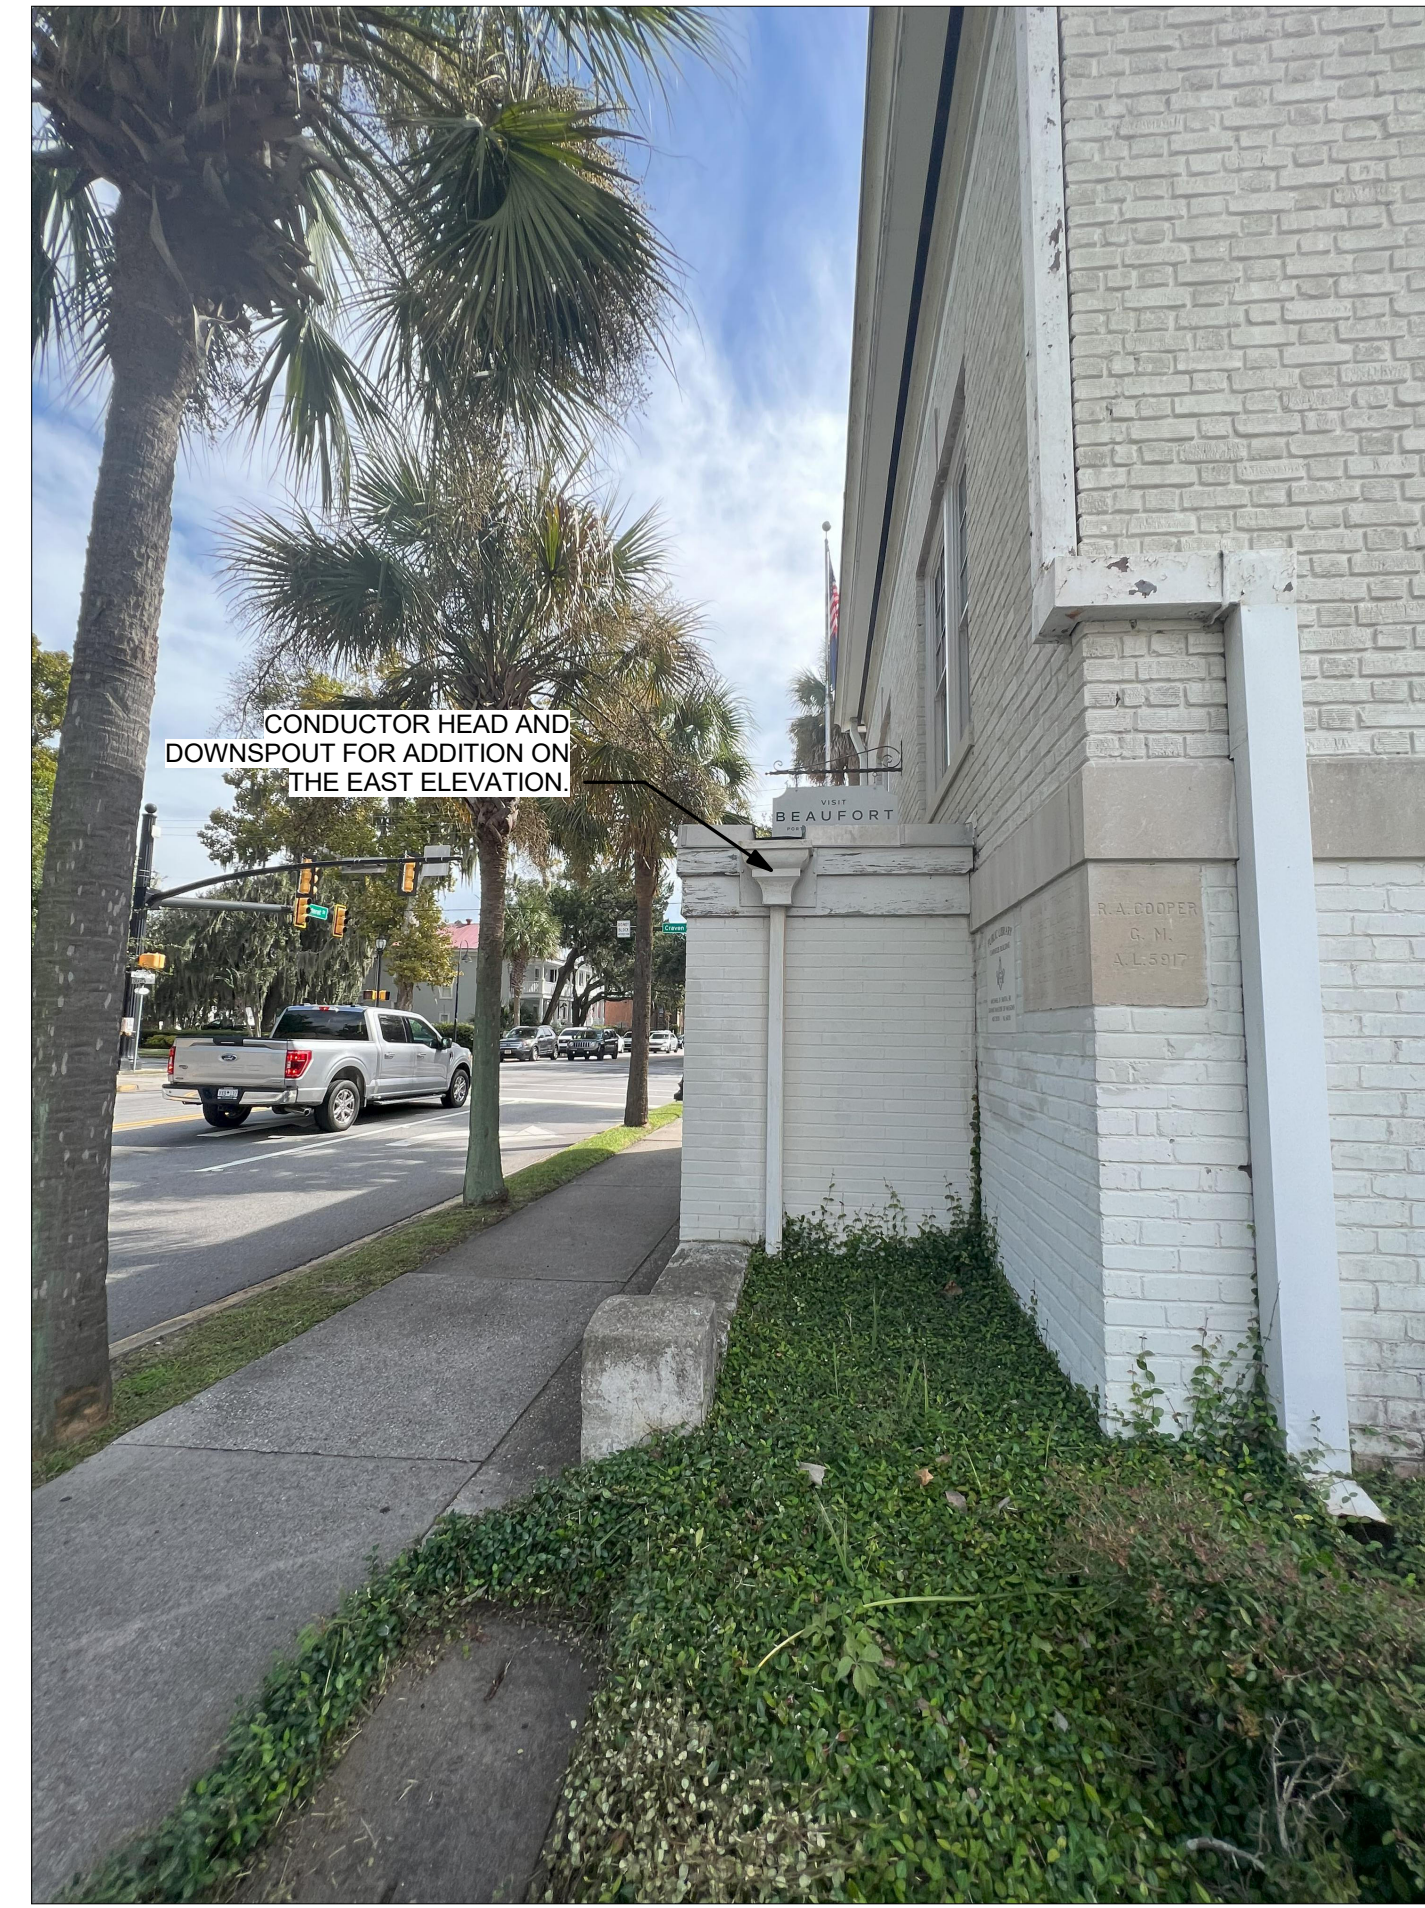
EXISTING CONDITIONS- NORTHEAST CORNER DOWNSPOUT. DOWNSPOUT AND CONDUCTOR/LEADER HEAD AT THE SIDE ADDITION CAN BE SEEN IN THE BACKGROUND.

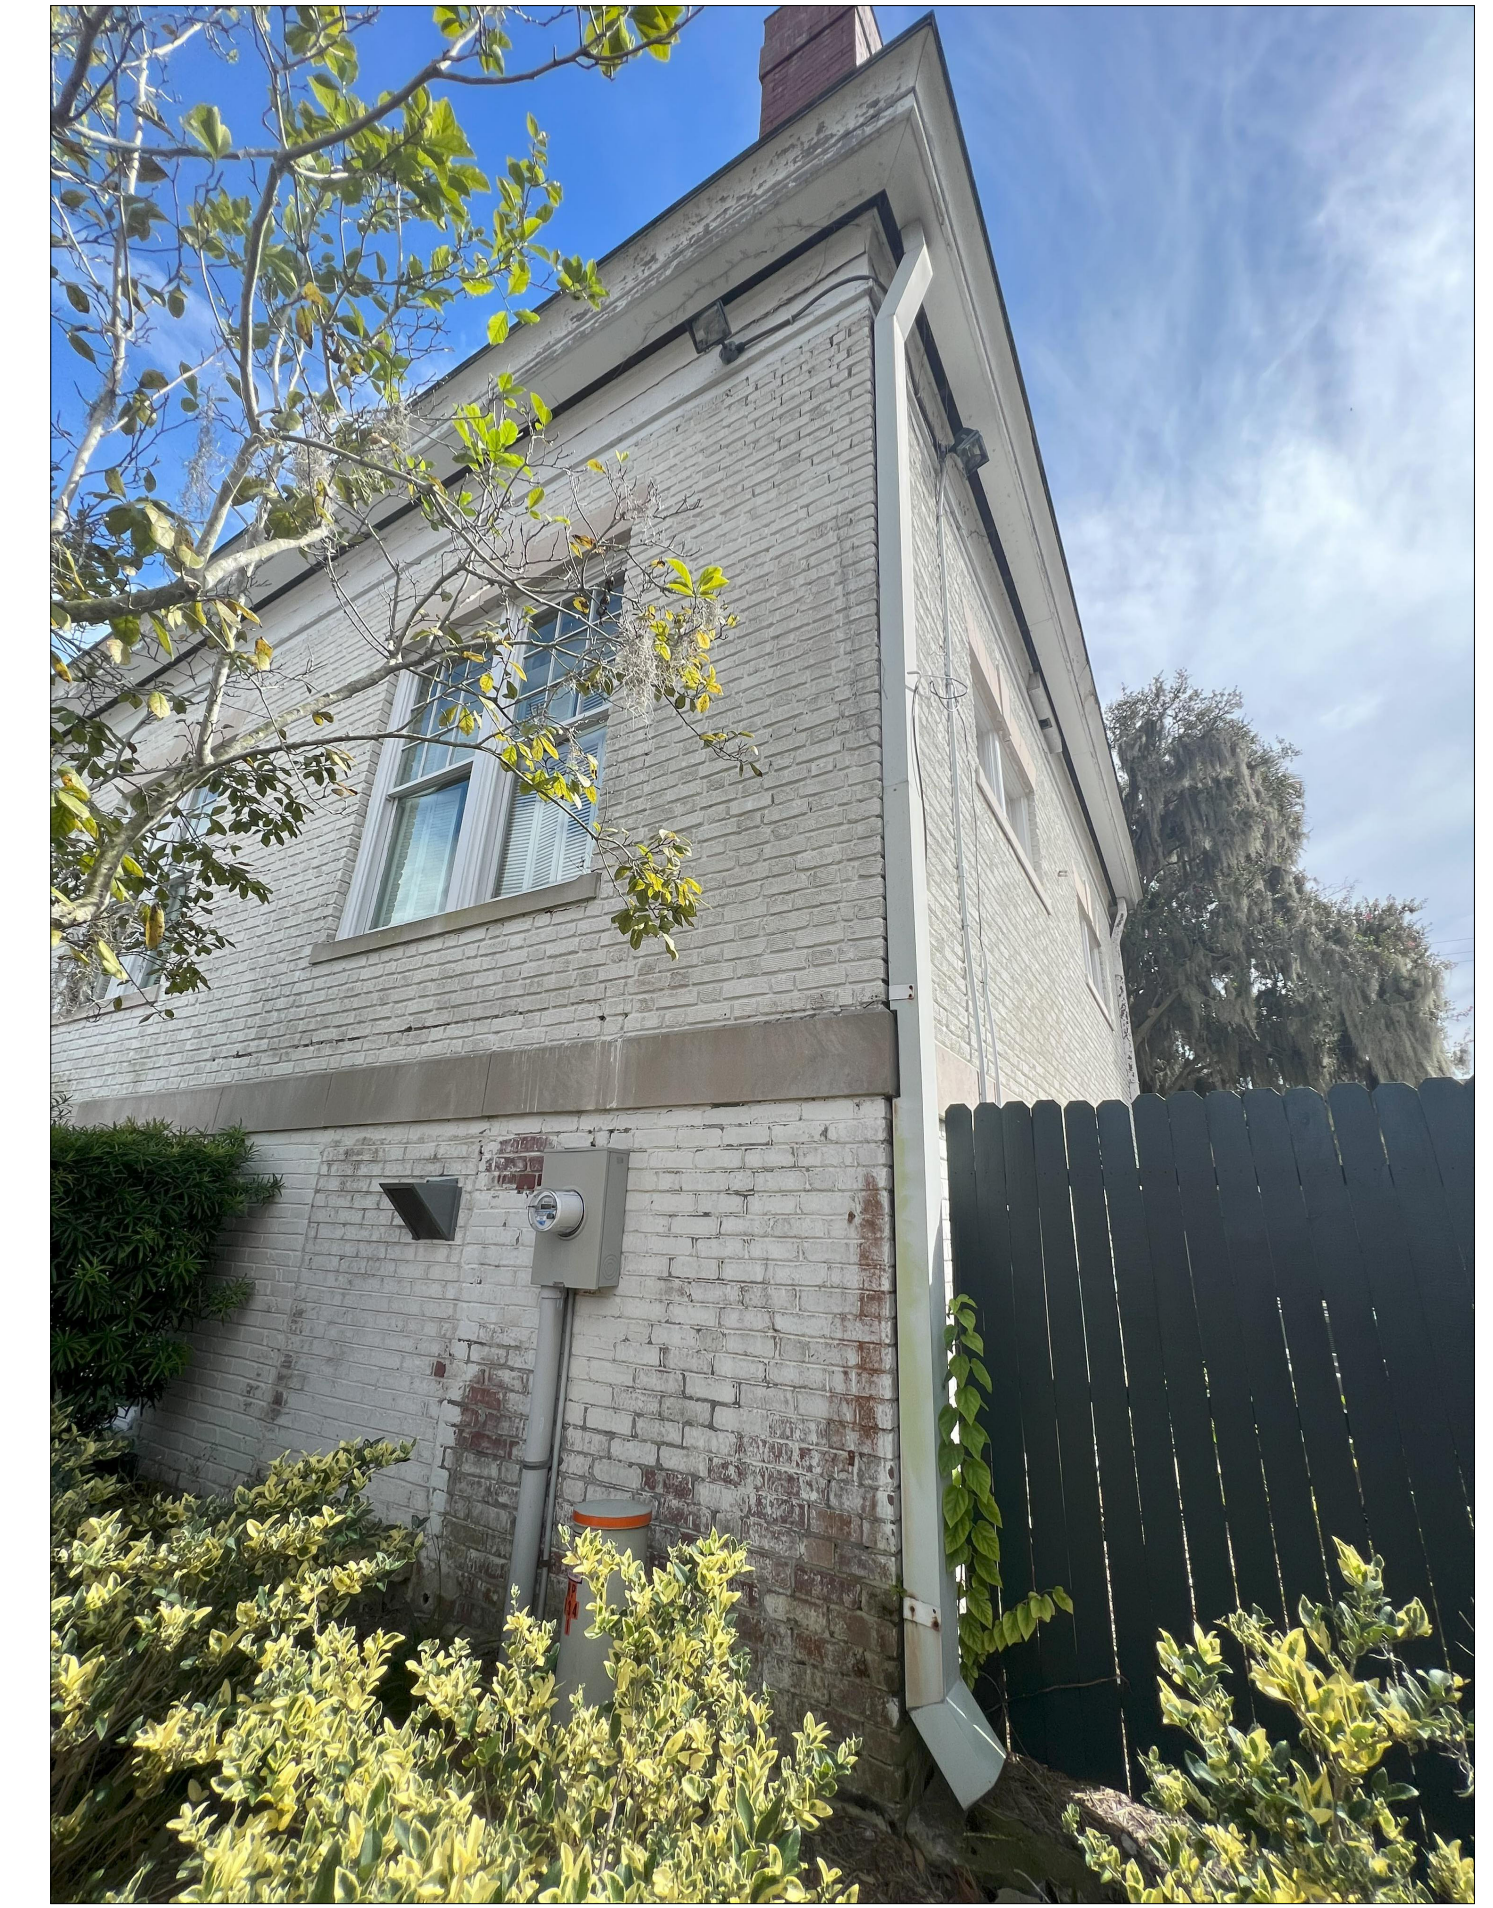
EXISTING CONDITIONS- NORTHWEST CORNER DOWNSPOUT.

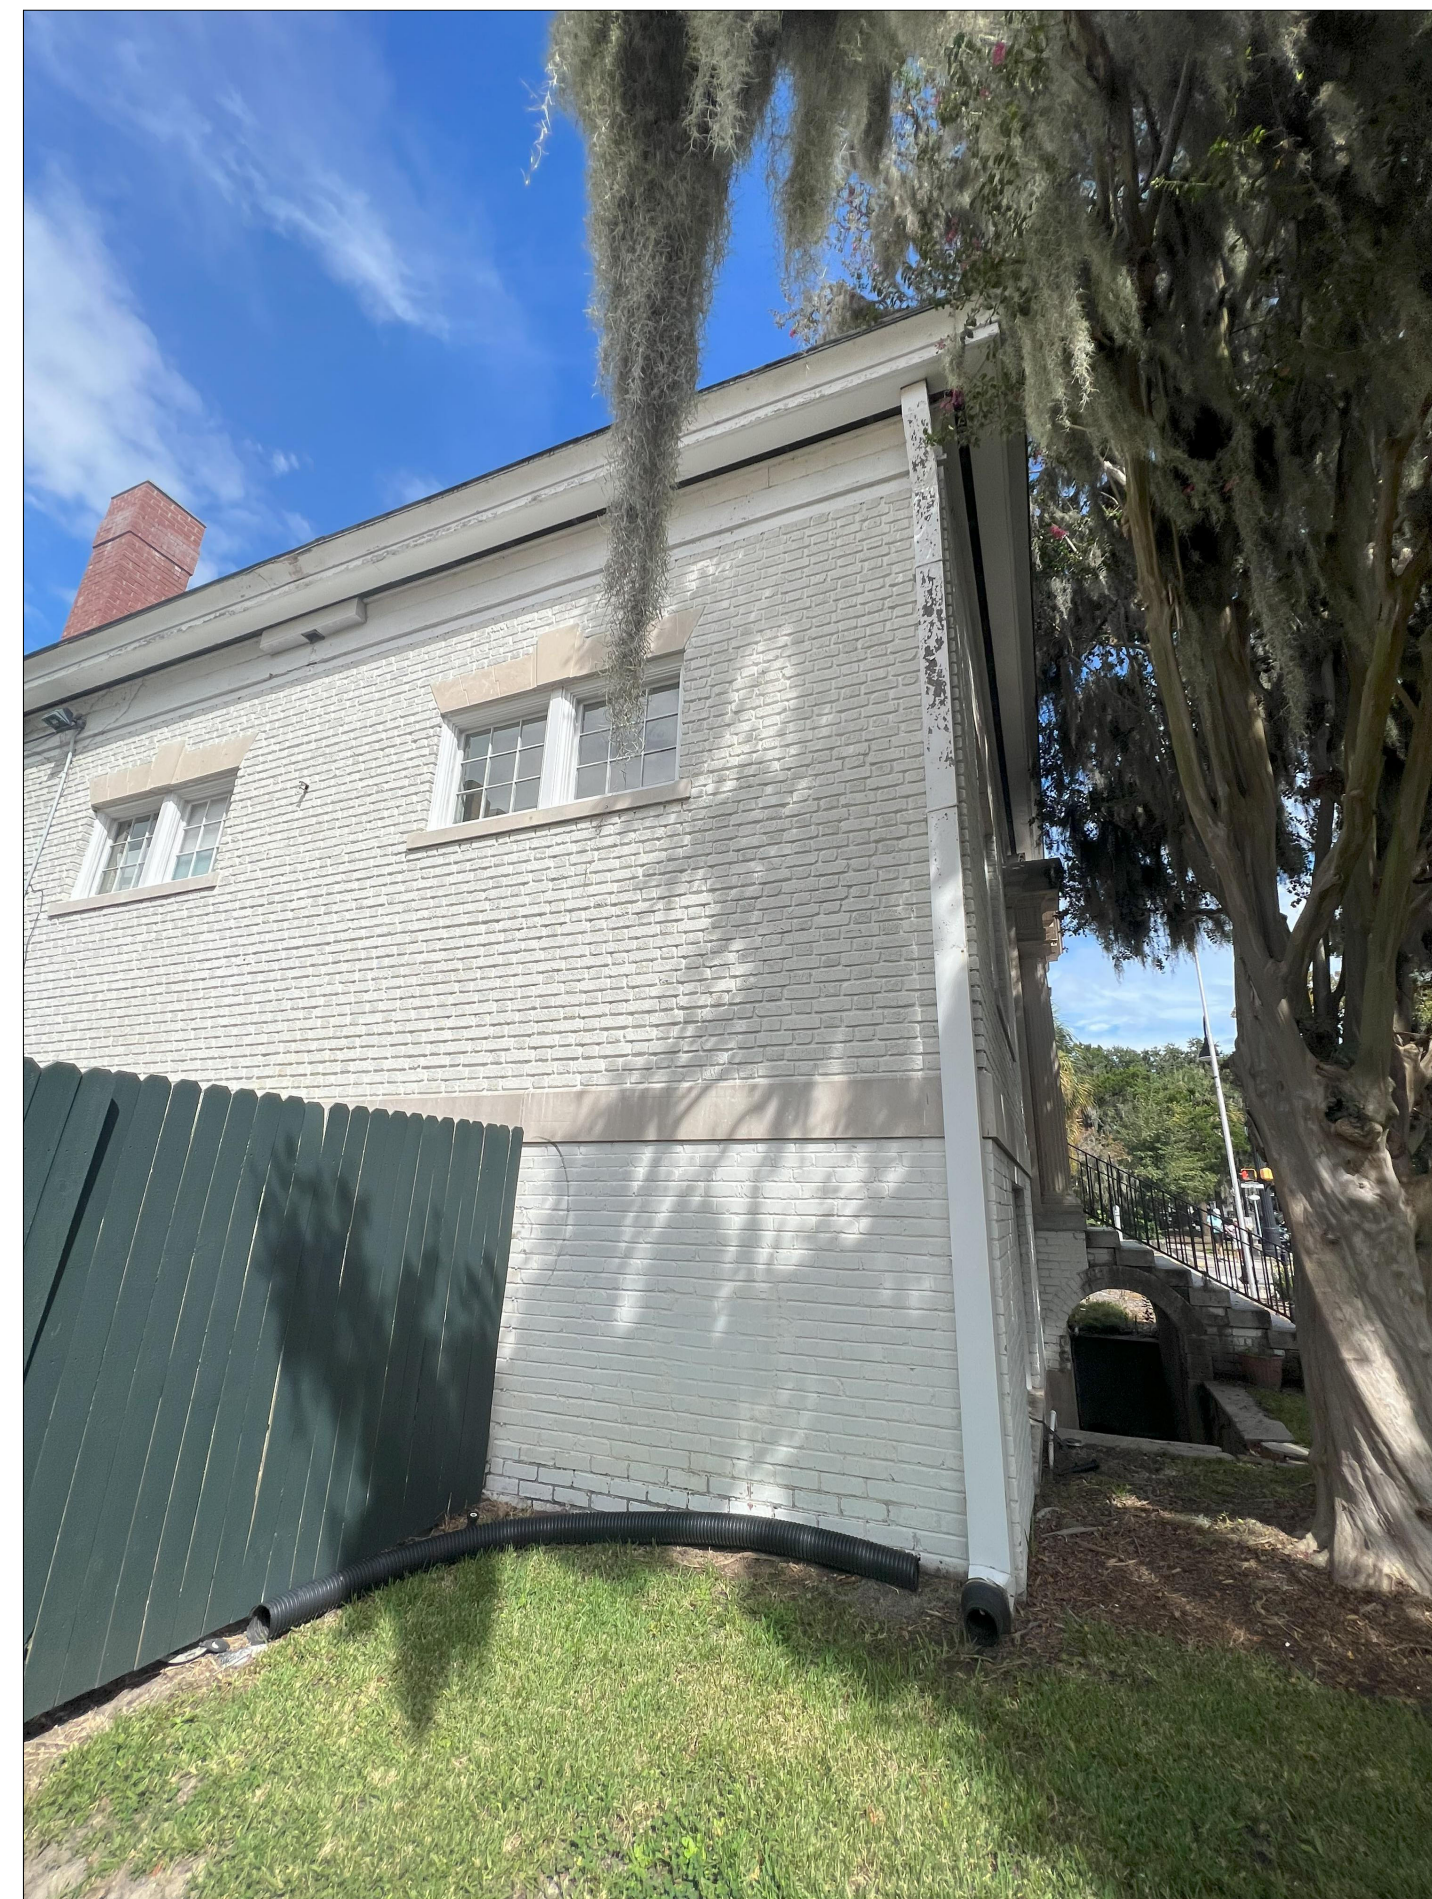
EXISTING CONDITIONS- SOUTHWEST CORNER DOWNSPOUT.

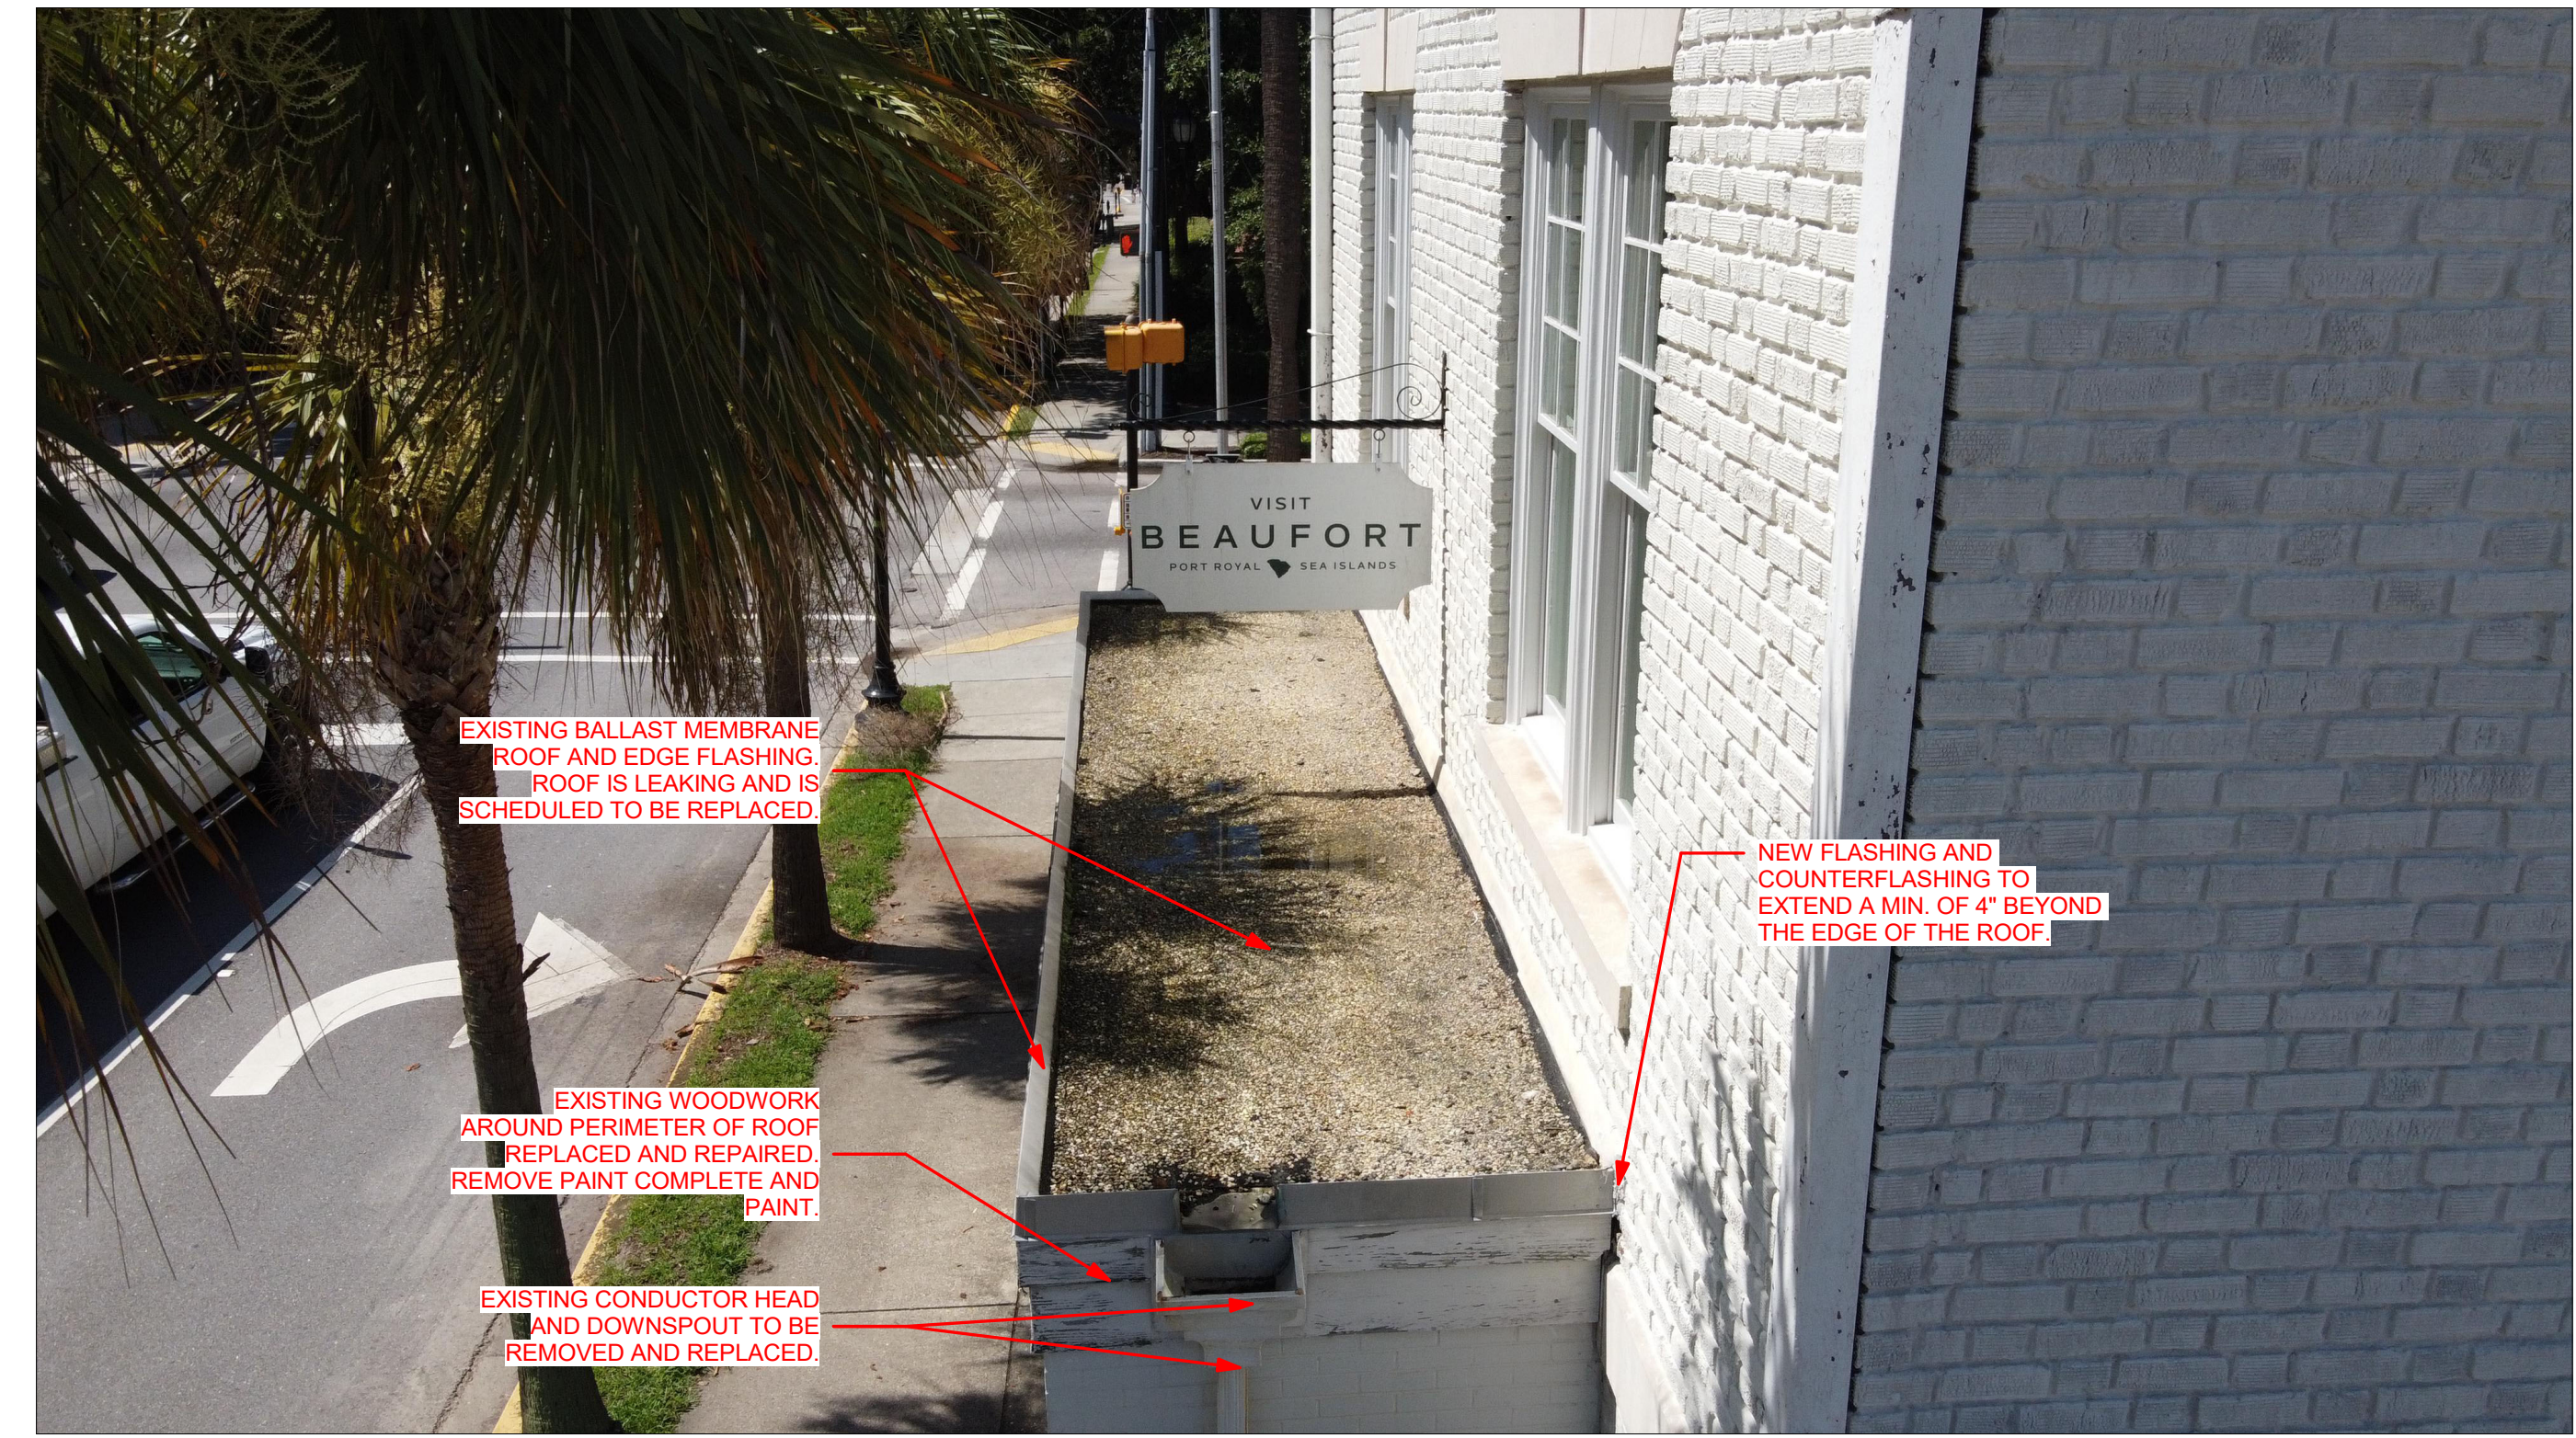
EXISTING CONDITIONS- EAST ELEVATION ADDITION ROOF

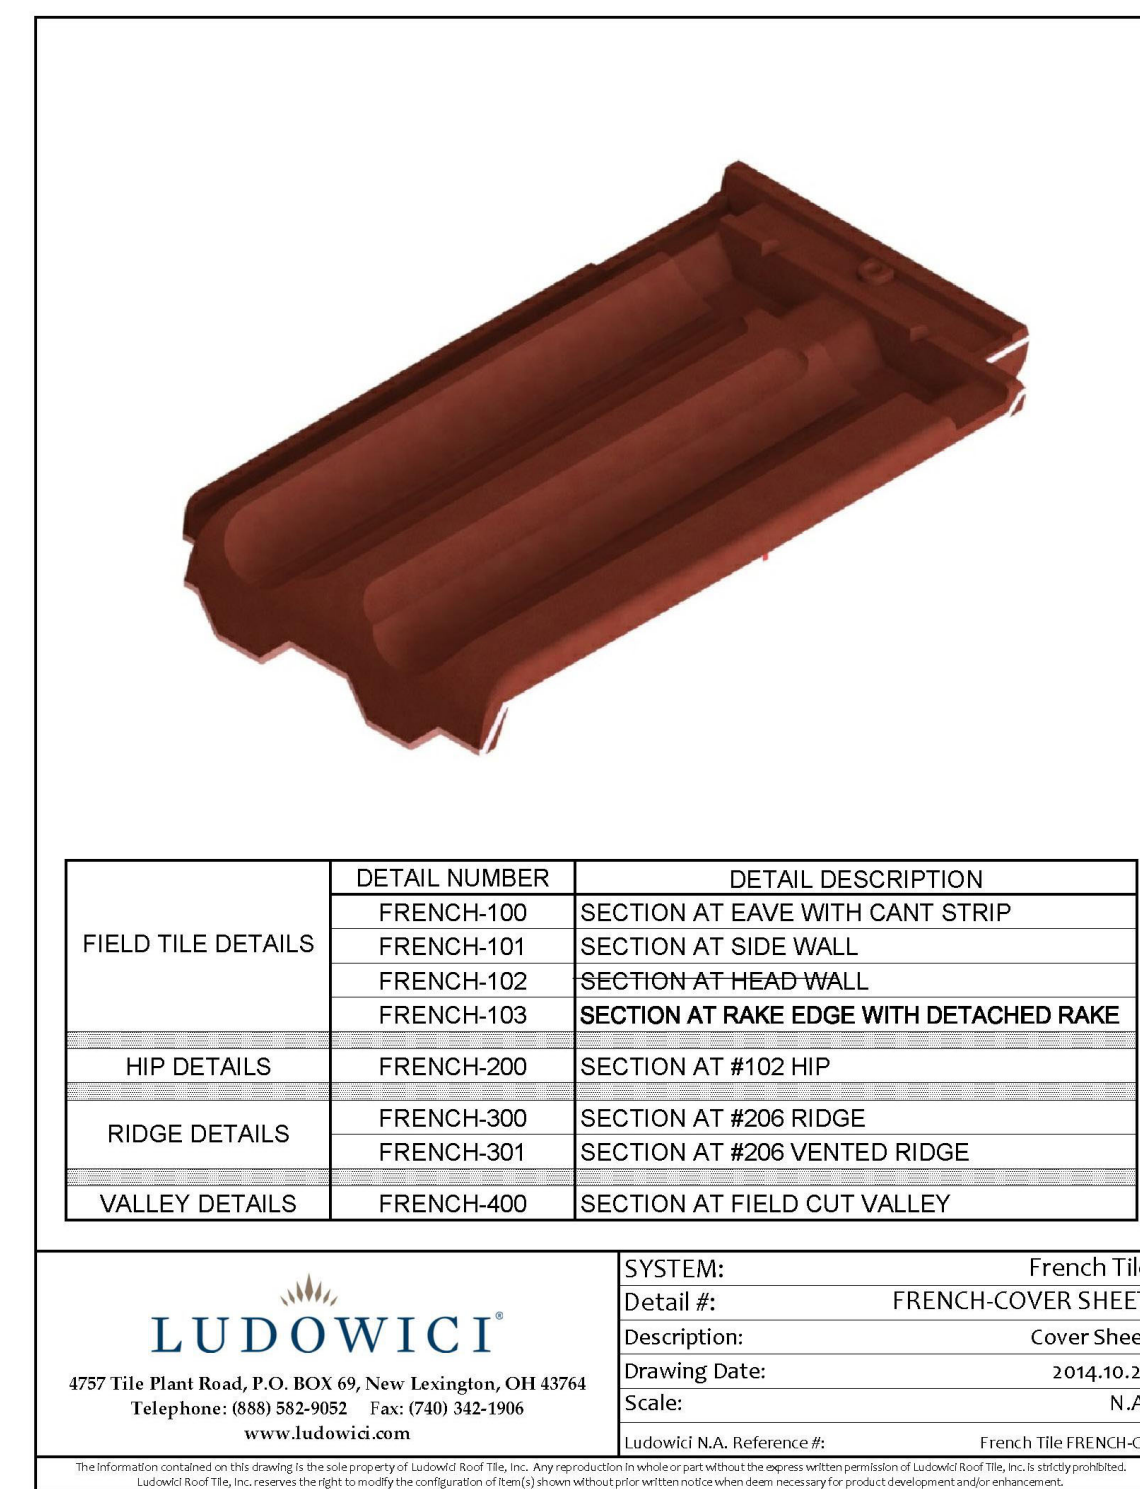
REFERENCE DETAIL, EXACT CONFIGURATION WILL VARY BASED ON EXISTING CONDITIONS

6 TERRACOTTA FRENCH INTERCONNECTING TILE  
NTS

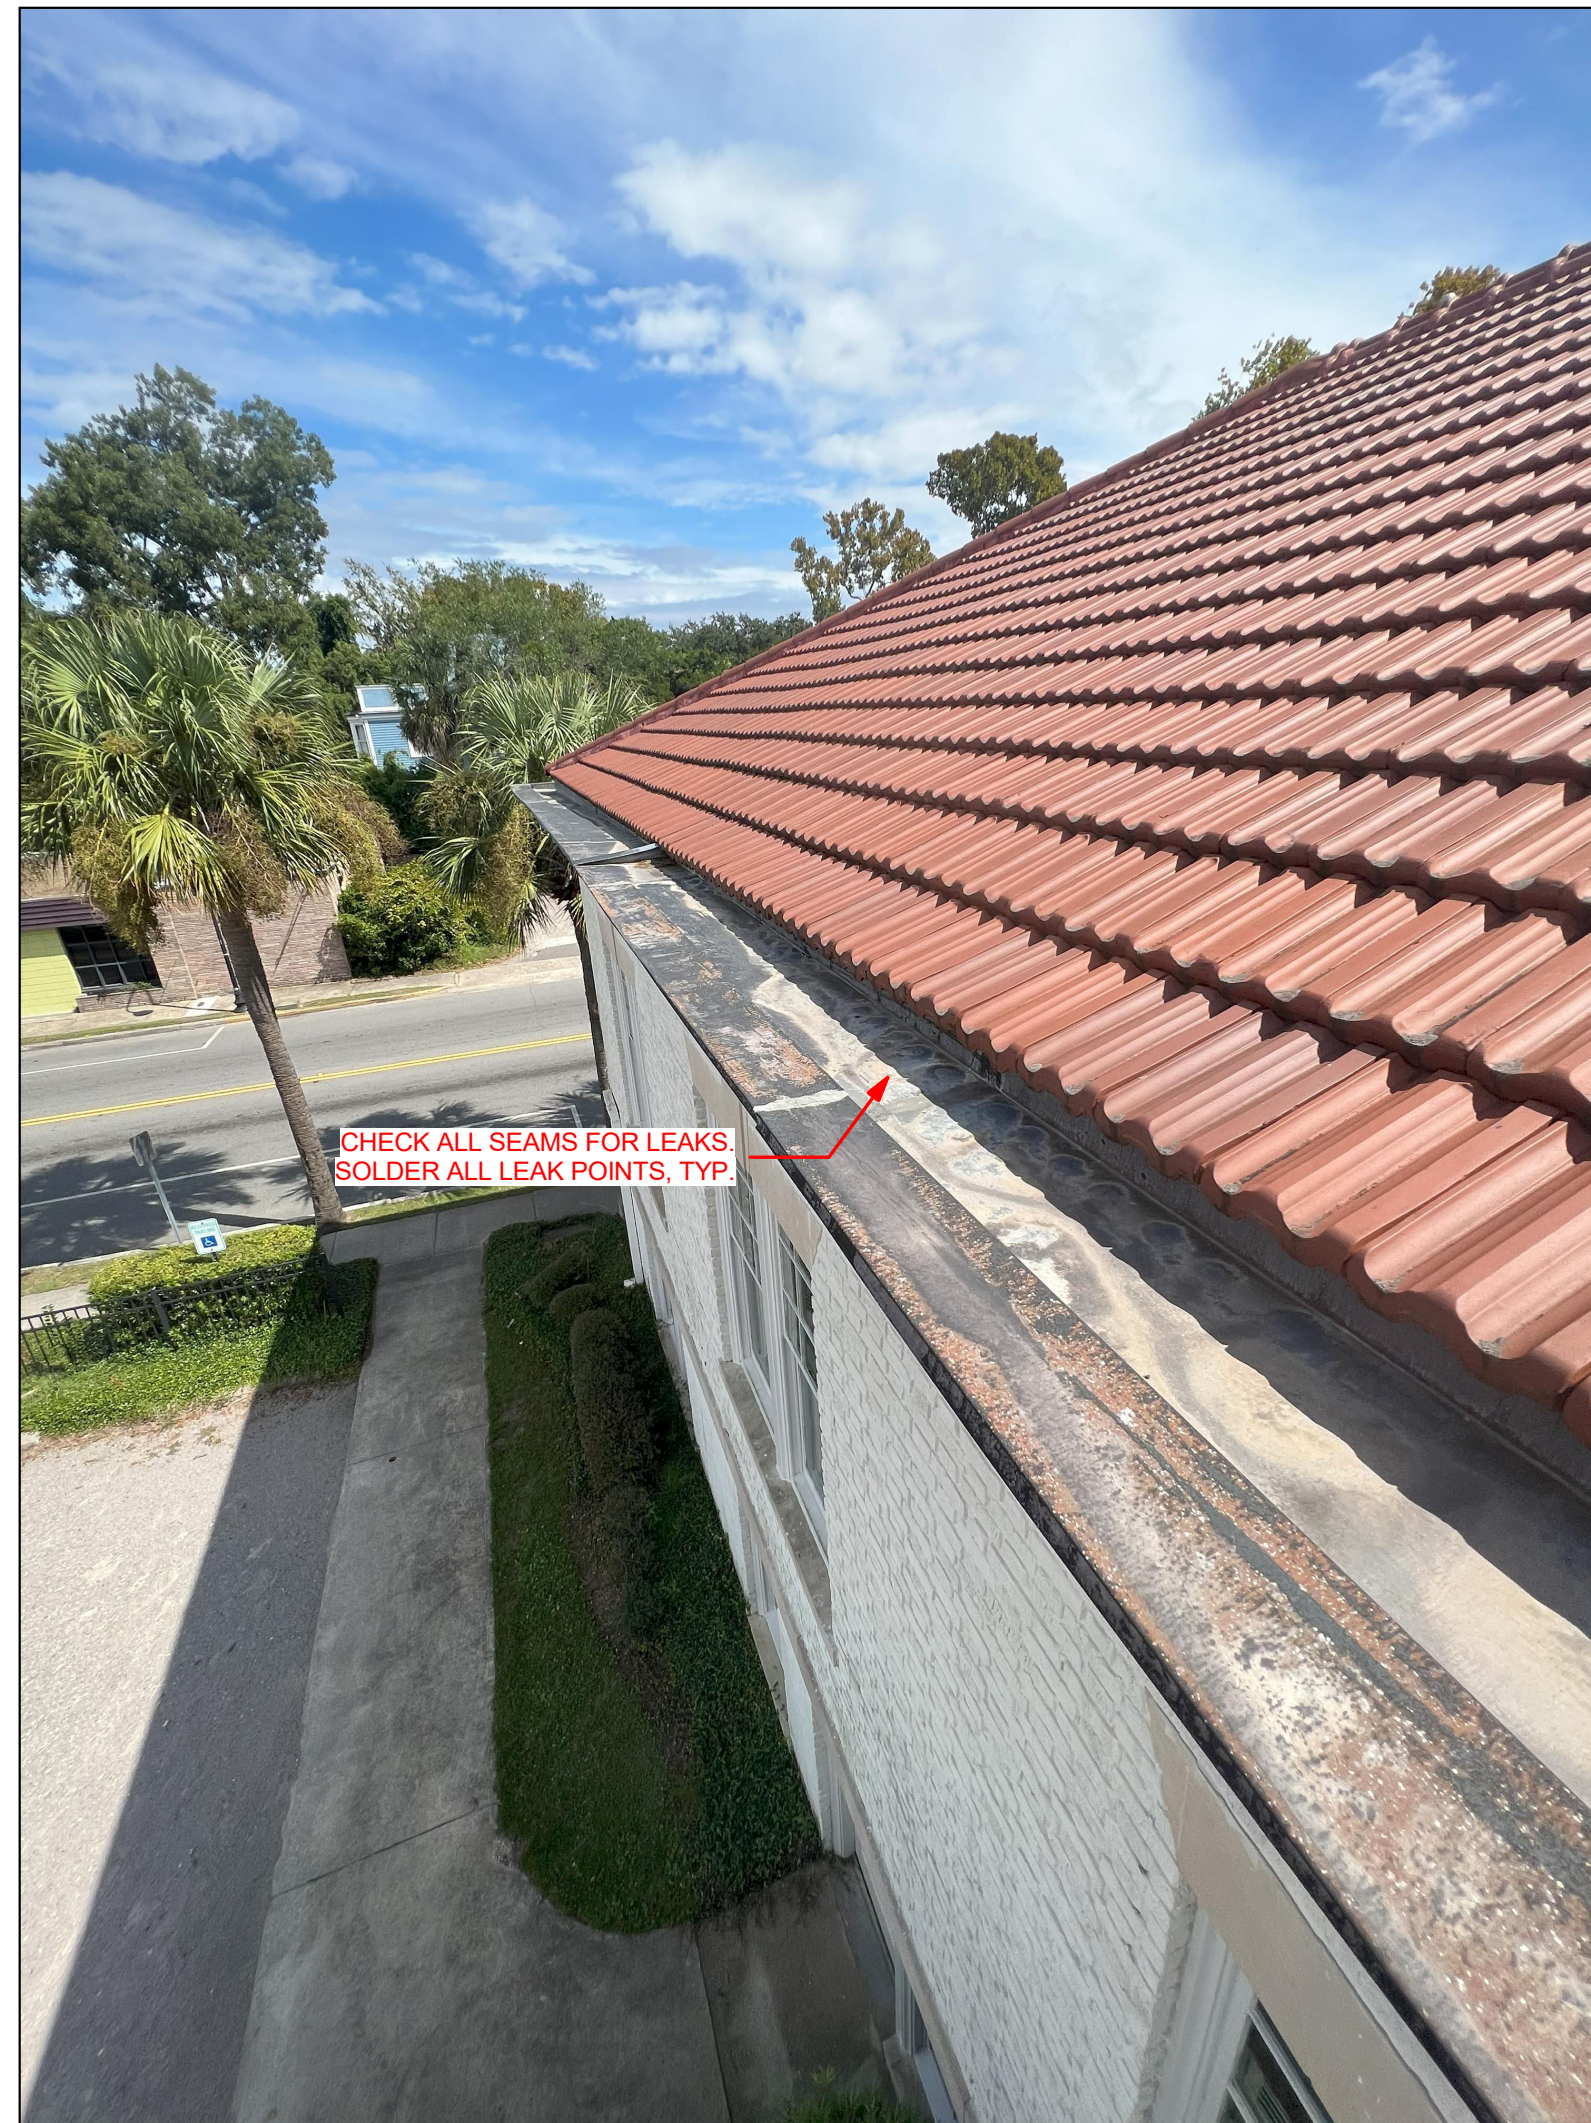
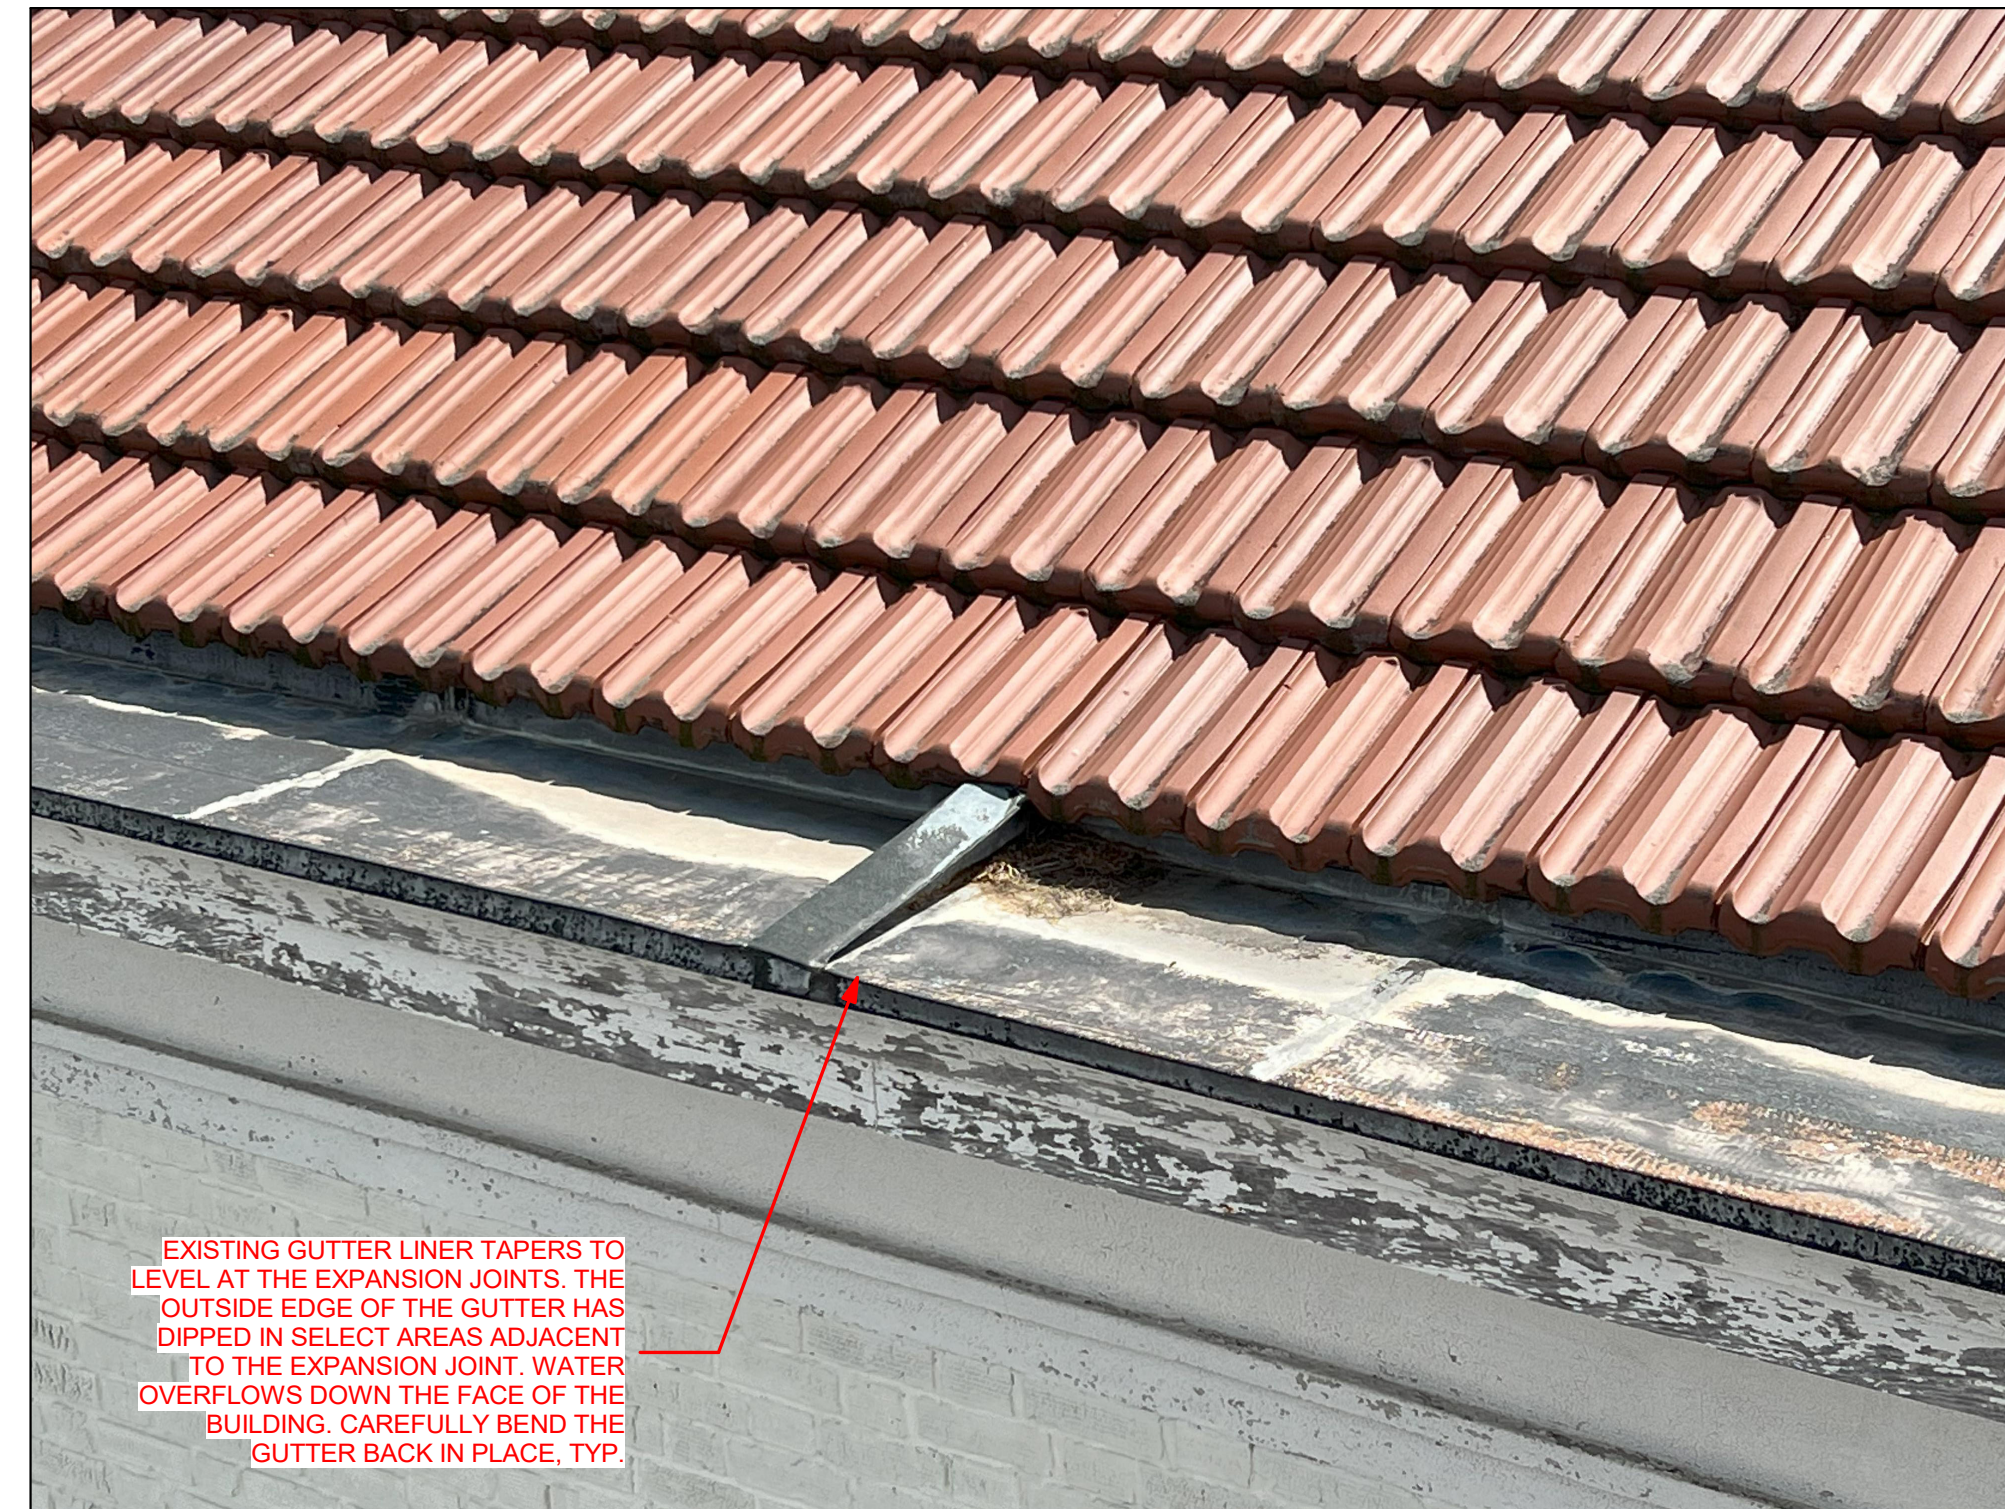
DETAIL VIEWS OF LEAD COATED COPPER LINER AT BUILT-IN-GUTTER

CONTRACTOR TO MODIFY GUTTER TO REMOVE LOW SPOTS WHERE WATER PONDS IN THE BASE OF THE METAL LINER. GUTTER TAPERS TO LEVEL AT EXPANSION JOINTS. ENSURE GUTTER PITCHES SO THAT WATER IS DIRECTED TO THE DOWNSPOUTS. THE OUTSIDE EDGE OF THE GUTTER HAS DIPPED IN SELECT AREAS ADJACENT TO THE EXPANSION JOISTS RESULTING IN WATER OVERFLOWING DOWN THE FACE OF THE BUILDING. CONTRACTOR TO CAREFULLY BEND THE GUTTER BACK IN PLACE. REPLACE ALL LOOSE OR MISSING FASTENERS WITH NON-FERROUS FASTENERS OR RIVETS (COPPER WITH BRASS MANDRELS), CAP WITH SOLDER. REPAIR ALL LEAKS AND OPEN SEAMS WITH SOLDER. SEE ADDITIONAL INFORMATION ON SHEET A102, PLAN 2.

CAULK CANNOT BE USED TO REPAIR THE LEAD COATED COPPER GUTTER LINER.

CONTRACTOR TO WATER TEST GUTTER TO IDENTIFY LEAKS AND ENSURE REPAIRS ARE WATERPROOF.

GUTTER LINER TO BE WATERTIGHT AT THE COMPLETION OF THE PROJECT.

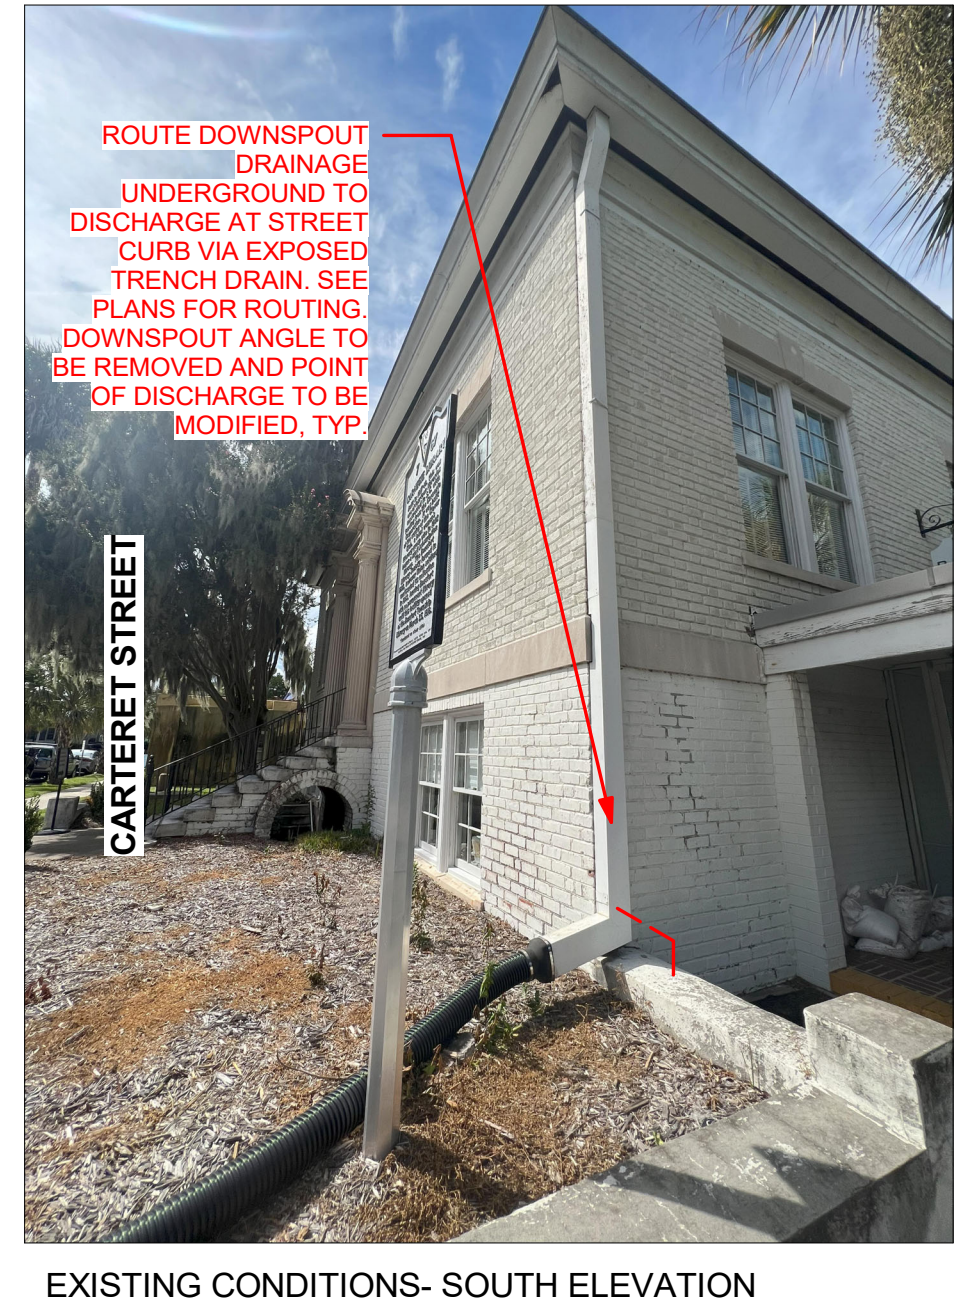
**NOTE: DO NOT USE SEALANT TO SEAL JOINT BETWEEN DOWNSPOUT PIPE AND BOOT. FILL ANY VOIDS WITH LEAD WOOL.**

**SIZE OF DOWNSPOUT BOOT TO FIT EXISTING DOWNSPOUTS. COORDINATE BASE OF BOOT ANGLE WITH DRAINAGE CONFIGURATION.**

**CAST IRON BOOT DETAIL**  
NTS

- DOWNSPOUTS TO BE CONNECTED TO NEW STORM DRAINAGE THAT WILL BE ROUTED TO THE STREET CURB. MODIFY DOWNSPOUTS AS REQUIRED TO TIE INTO NEW BOOTS.
- DOWNSPOUTS TO CONNECT TO NEW CAST IRON BOOT WITH CLEANOUT MADE BY JR HOE. CAST IRON BOOTS TO BE PAINTED TO MATCH THE BUILDING. MODIFY DOWNSPOUTS AS NECESSARY TO TIE INTO DOWNSPOUT BOOT. SIZE OF BOOT TO FIT EXISTING DOWNSPOUTS. COORDINATE BASE OF BOOT ANGLE WITH TRENCH CONFIGURATION. SEE MANUFACTURER DETAILS FOR INSTALLATION INSTRUCTIONS. ALL FASTENERS ATTACHING BOOT TO MASONRY TO BE STAINLESS STEEL MACHINE BOLTS WITH LEAD SHIELDS.
- REMOVE ALL SPLASH BLOCKS AND DISPOSE OF MATERIALS.

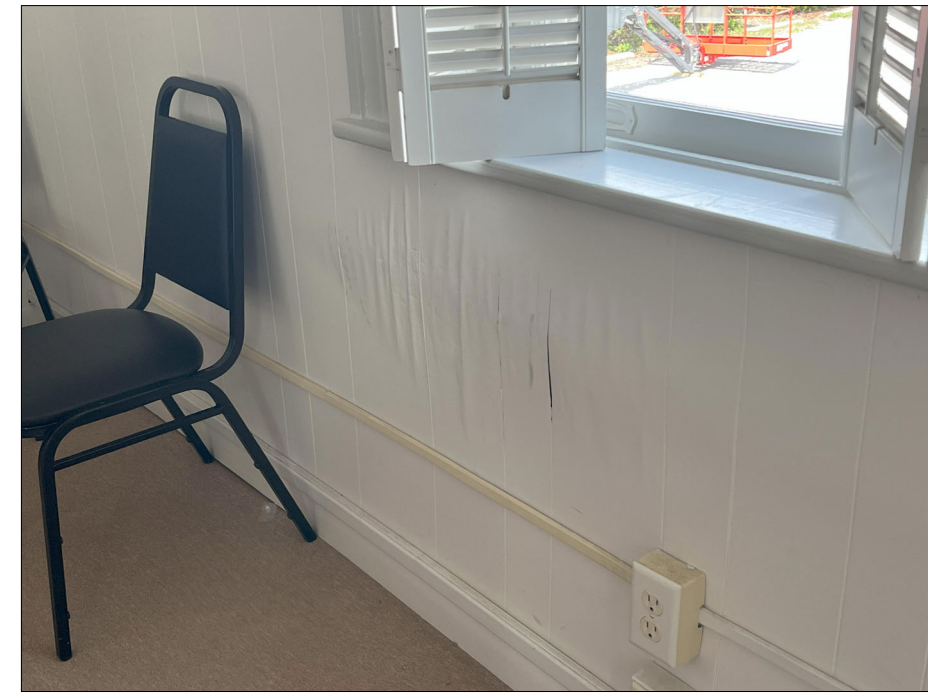
DETAIL PHOTO OF WATER DAMAGE BELOW WINDOWS 20 & 21.

INVESTIGATE CAUSE OF LEAK BELOW WINDOWS AND REPAIR AS REQUIRED. APPEARS TO BE CAUSED BY MORTAR AND SEALANT LOSS AT THE HEAD OF THE WINDOW AND/OR BELT COURSE AND EXCESSIVE OVERFLOW OF WATER FROM THE BUILT-IN-GUTTER ABOVE. THE GUTTER WILL BE ADDRESSED AS PART OF THE ROOF SCOPE OF WORK.
