# RFP 2021-102

## CARNEGIE LIBRARY ROOF REPAIR & RESTORATION

The Carnegie Library is a local historic site and a contributing structure in the City of Beaufort's National Historic Landmark District. The exterior scope of work for this project includes the repair of the existing terracotta roof, new dormer flashing, repair of the built-in-gutter liner, exterior wood repair, paint removal, painting, replacement of the addition roof on the east side of the building, and new underground drainage from the downspouts to the street. The interior scope of work is limited to interior repairs associated with water damage from previous and current roof leaks. Water damage has resulted in damage to historic plaster.

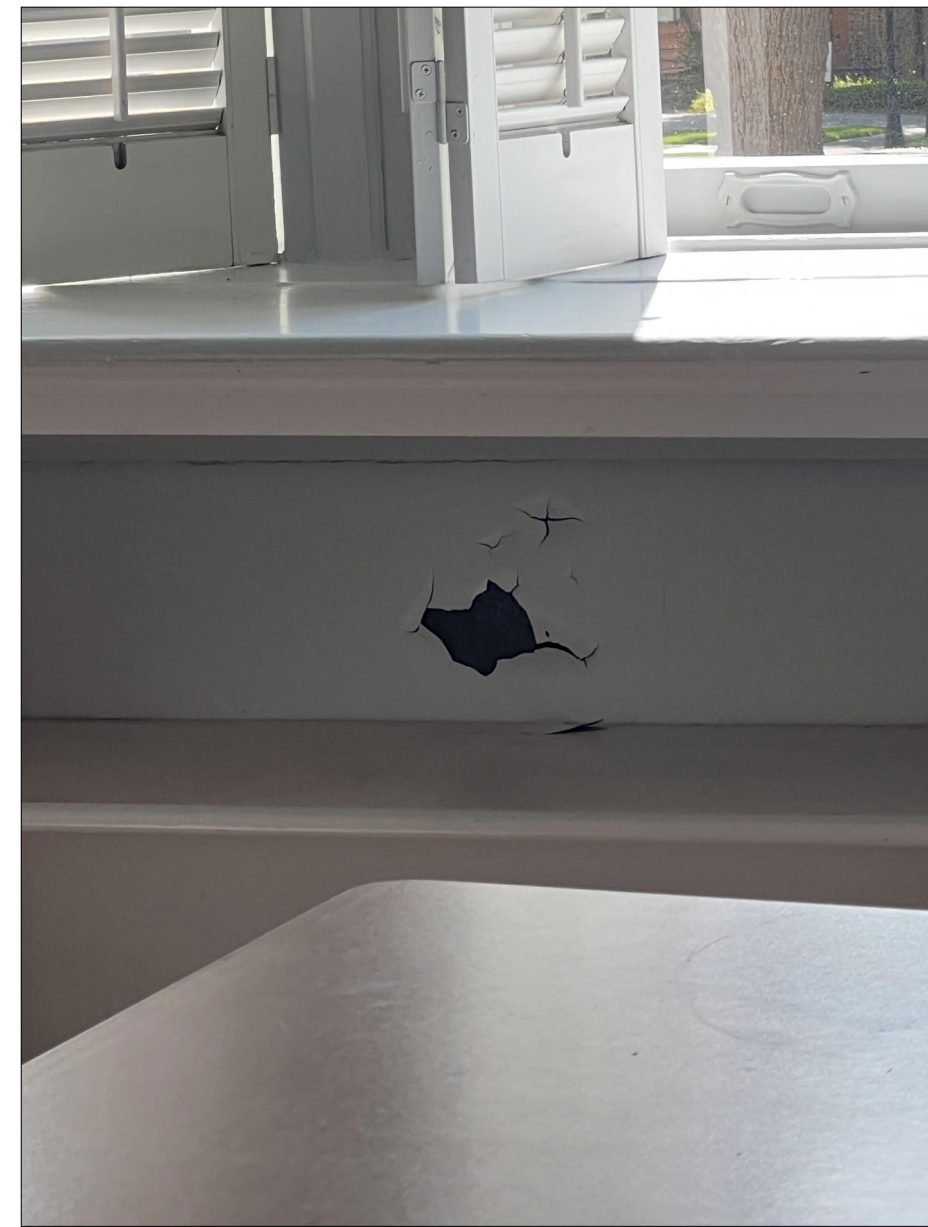
DETAIL PHOTO OF CRACKED PAINT BELOW WINDOWS 14 & 15, TYPICAL CONDITION BELOW WINDOWS.

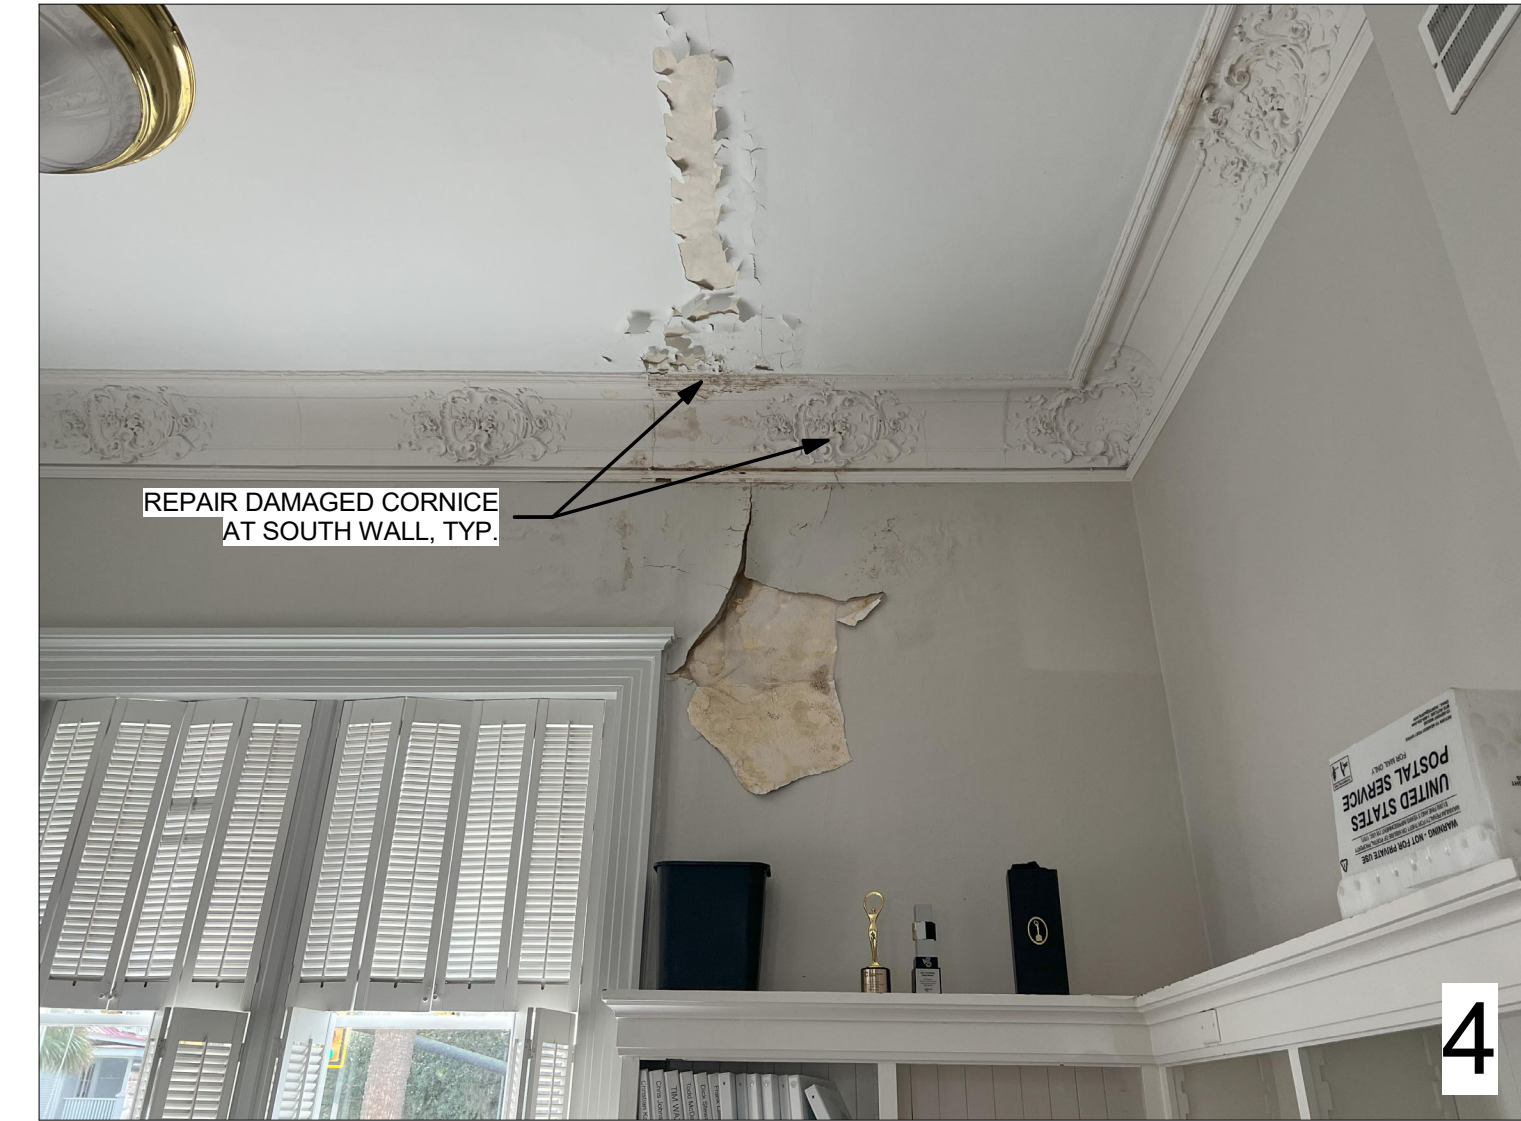
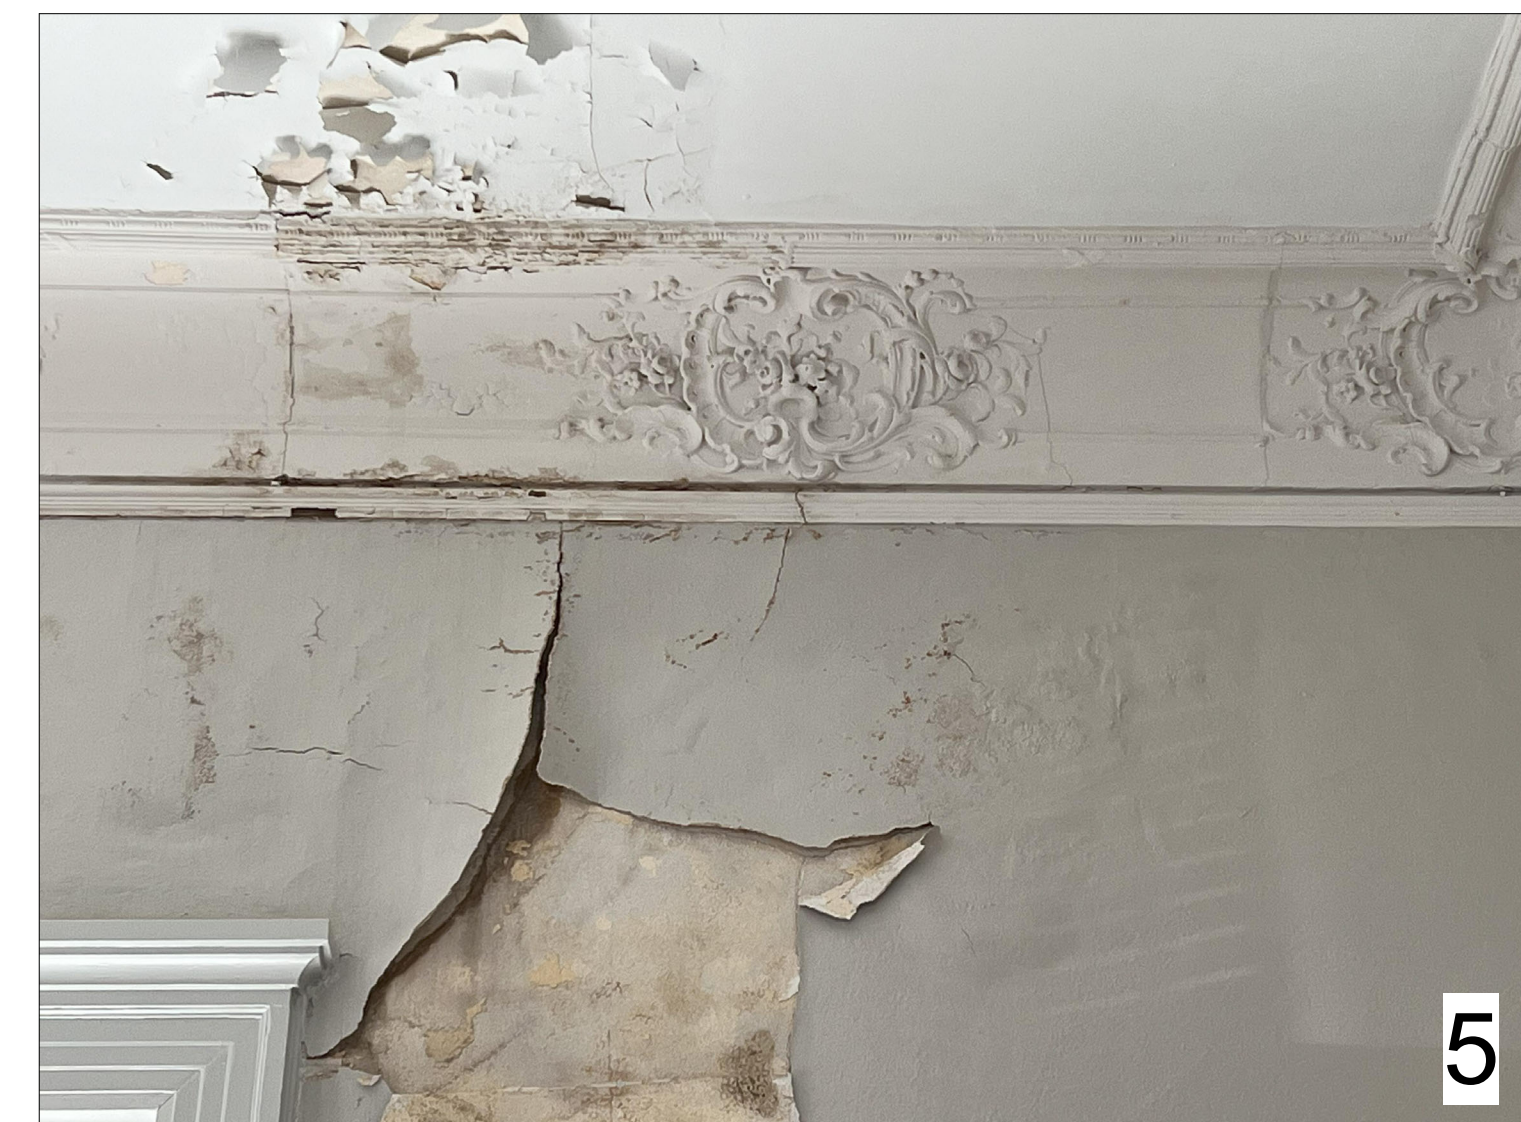
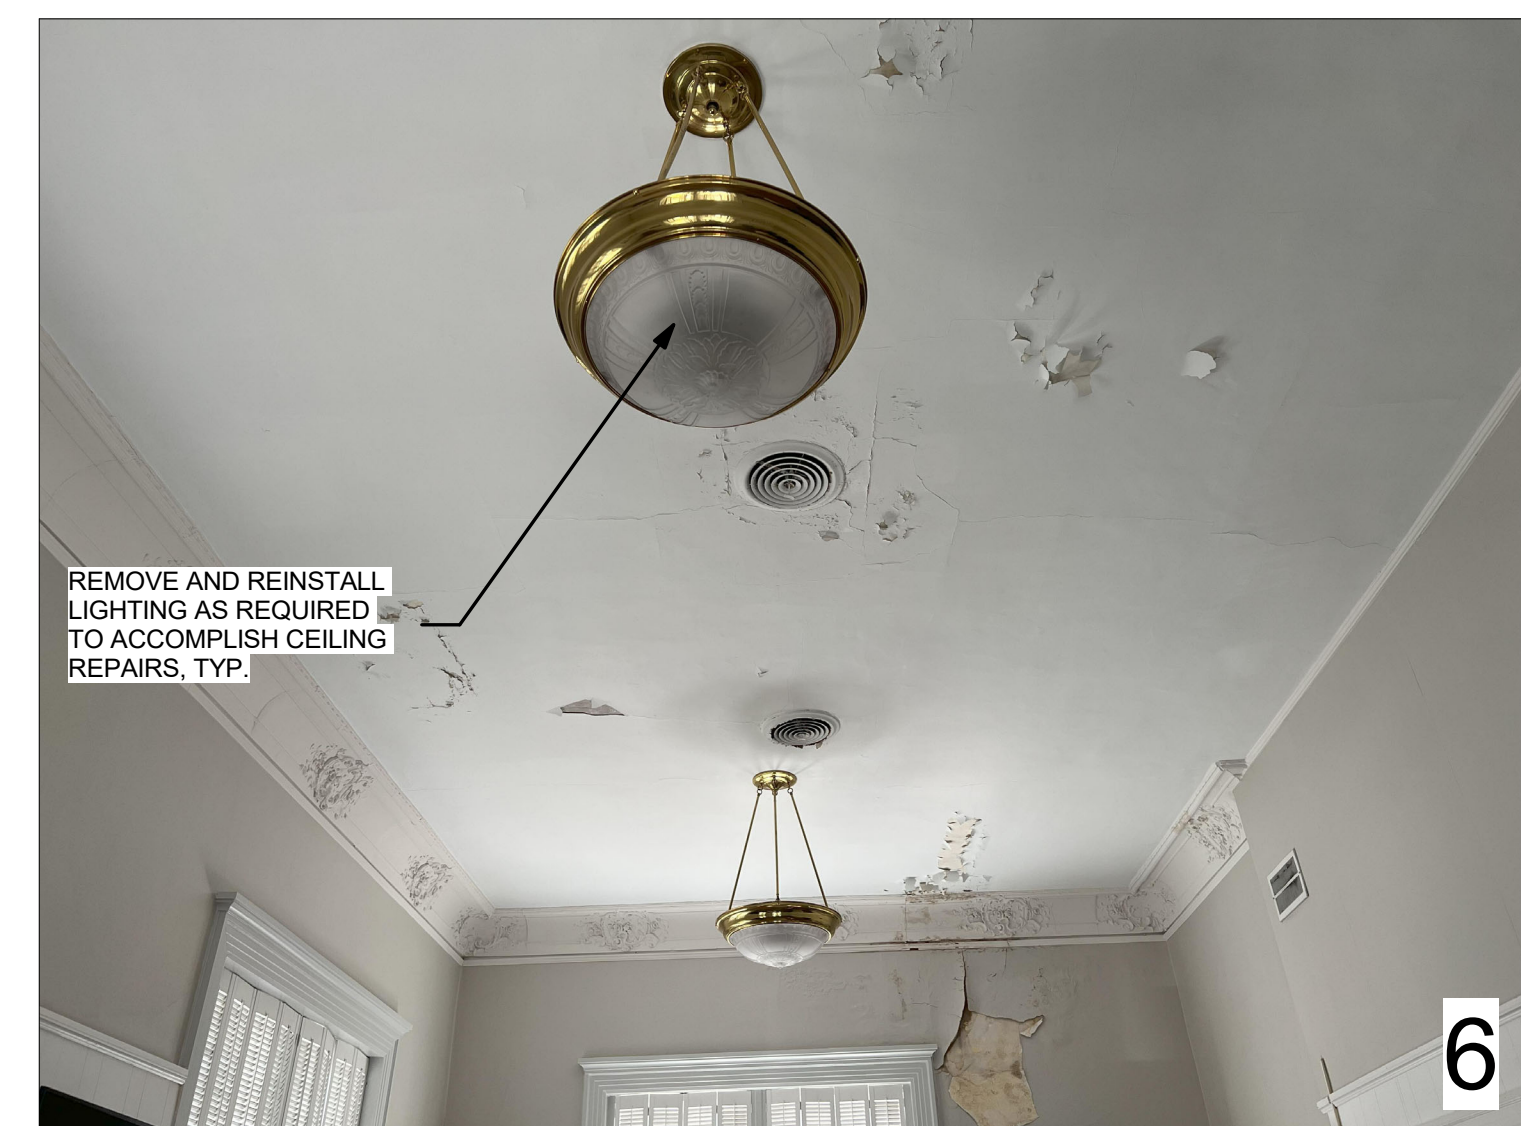
EXISTING CONDITIONS- CONFERENCE ROOM CEILING
