PARTIAL FLOOR PLAN

SHEET:	PARTIAL FLOOR PLAN
PROJECT:	SHULER THEATER 131 NORTH 2ND STREET RATON, NEW MEXICO 87740
DATE:	4/22/2015
SCALE:	AS SHOWN
DRAWN:	MGH
SHEET:	A1

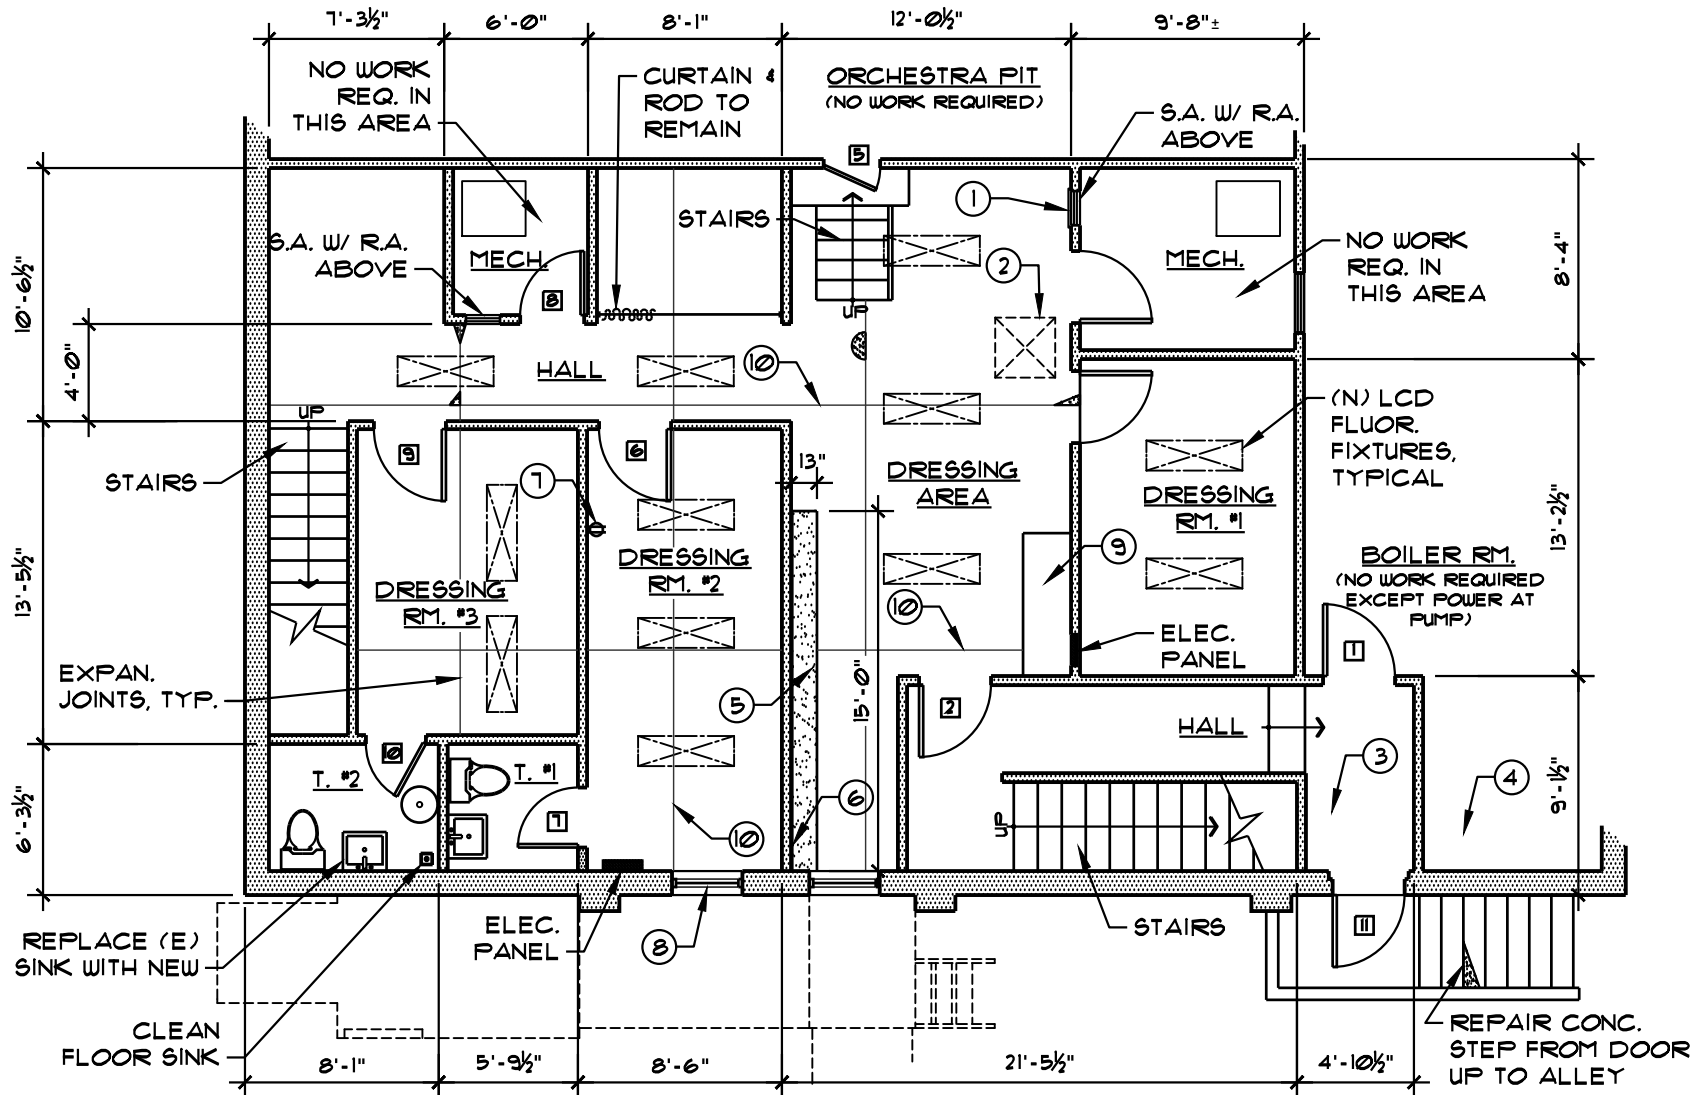
1. INSTALL BLANK PLYWD. PANEL OVER OBSOLETE REGISTER.
2. REPLACE DAMAGED 2x2 PINE END AT OVERHEAD TRAP DOOR TRACK.
3. ADD NEW 1x6 WOOD BASEBOARD AT THIS LANDING, EXCEPT AT EXTERIOR WALL.

4. NEW POWER RECEPTACLE AT EXISTING SUMP PUMP IN THIS LOCATION.
5. REPLACE LAMINATE AT 15' LONG COUNTERTOP & LAMINATE BACKSPLASH, AND 4-1/2" VERTICAL EDGE, OR REPLACE WITH NEW COUNTERTOP TO MATCH EXISTING DIMENSIONS. NEW LAMINATE TO BE IDENTIFIED BY ARCHITECT FROM MANUFACTURER'S BASE LINE.

6. REPLACE ONE BROKEN MIRROR 15"x 24" OVER MAKE-UP COUNTER. MOUNT WITH COMMON PLASTIC CLIPS TO MATCH REMAINING 5 MIRRORS.
7. REPAIR WALL OUTLET.
8. REPLACE BROKEN WIRE GLASS AT OPERABLE SASH OF ALUMINUM SLIDING WINDOW. SASH SIZE APPROXIMATELY 16" x 26". SECURITY BARS AT OUTSIDE OF WINDOW TO REMAIN.

9. EXISTING CABINET, NO WORK REQUIRED.
10. CONCRETE EXPANSION JOINT, TYPICAL.
11. SEE PROJECT MANUAL FOR ADDITIONAL WORK IN THIS PROJECT AREA AND OTHER AREAS OF THE BUILDING. SEE PROJECT MANUAL FOR ADDITIONAL DESCRIPTIONS.

SCALE: 1/8" = 1'-0"
