Santa Rosa County Property Appraiser

Parcel Number	03-1N-28-2530-00700-017B
Situs/Physical Address ★	6866 QUINN ST MILTON ★
Property Usage	MOBILE HOME (000200)
Section-Township-Range	03- 1N- 28
Tax District	MILTON
2018 Millage Rates	0
Acreage	0.26
Homestead	N
Brief Legal Description	TOWN OF MILTON COM NW COR OFLOT 17 BLK 7 TH E 438.7 FT TOPOB TH N 80 FT TO QUINN BAYOUTH S 20*48'W 176.6 FT TH S 72*39'E 70.02 FT TH N 20*48'E 154.12 FT TO BAYOU TH W ON BAYOUTO POB AS DES IN OR 3490PG 1335

The mobile home is a one-story, off-grade approximately 800-square-foot structure with a metal roof and exterior siding, wood panel and Masonite interior walls and ceilings, vinyl floor tiles and sheet flooring, and fiberglass insulation. The finished shed room is a one-story, slab-on-grade approximately 200-square-foot structure with a metal roof and Masonite exterior siding, drywall interior walls and ceiling, vinyl sheet flooring and fiberglass insulation. The entire structure is in poor condition and is planned to be demolished.

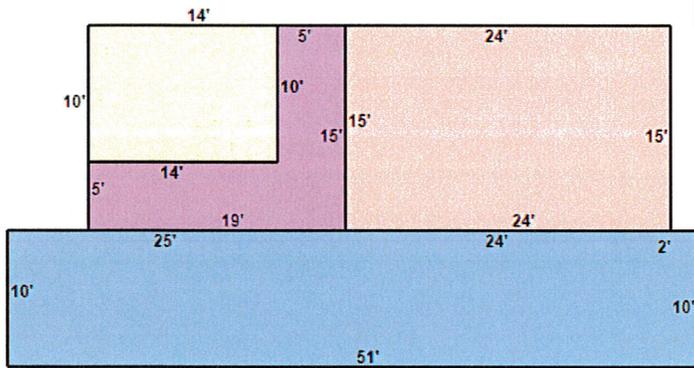
Use: MOBILE HOME (000200)

UST	UNF STORAGE	140	2004
OP1	PRCH OPUF1	145	2004
PTO	PATIO	360	1980
BAS	BASE AREA	510	1972
