Form A Pullout Test Report

(Refer to the ANSI/SPRI FX-1 Standard Field Test Procedure for Determining the Withdrawal Resistance of Roofing Fasteners for full documentation)									
Job name:		Highlands County Annex							
Location:		Sebring, FL							
Test date:		10-10-19			Ambient temperature:		90 F	°F	
Roof area:		sq. ft		sq. ft	Tester manufacturer:		ComTen Industries		
Max. capacit	y of tester:	2,000		Select one:		🛛 lbf	$\Box kN$		
Date of last calibration:		8/31/2019			Number of pulls recorded on Form B:		5		
Fastener tested:		#15 Dekfast screw			Fastener manufacturer:		SFS Group USA		
Fastener test	ted:	text		Fastener manufacturer:		text			
Fastener test	ted:	text			Fastener manuf	facturer:	text		
Test perform	ed by:	Harley Coleman - SFS Group USA							
Witnessed by:		Shawn Sulzener - Fibertite			Test cut areas repaired by:		Shawn Sulzener - Fibertite		
Project type	(select one):	New con	structio	n	⊠ Tear off		Retrofit

Form B Pullout Test Report

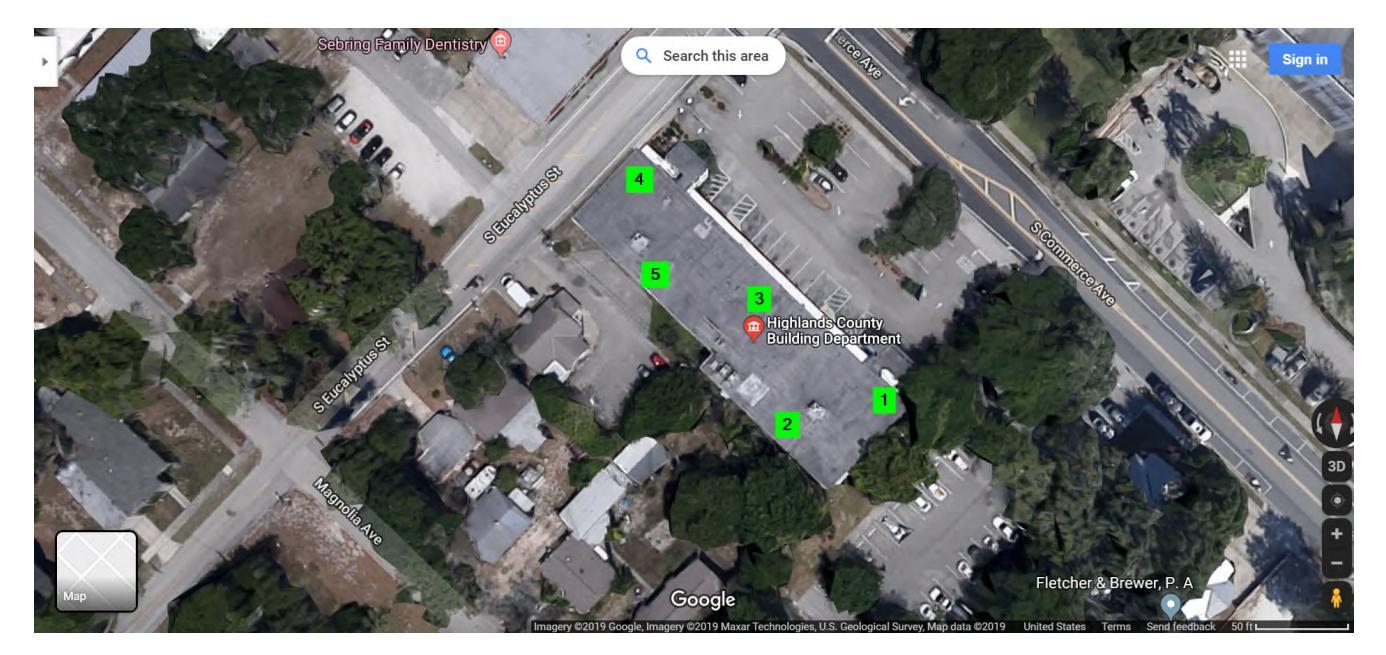
Record the test results and the reasons for the additional tests in the comment section (above) on Form B (this form). If there are anomalies in pull values, deck at the point of the anomaly should be inspected to determine cause. An anomaly is defined as one or more pullout values that fall exceedingly high or low from the population. Roof plan not to scale. Identify where the pullouts were performed with corresponding test number.

Existing roof makeup: Modified Bitumen over lightweight concrete over metal deck
