**EXTERIOR PAINT  
 ARTHUR JOHNSON MEMORIAL LIBRARY  
 RATON, NEW MEXICO**

SHEET NUMBER  
**2**

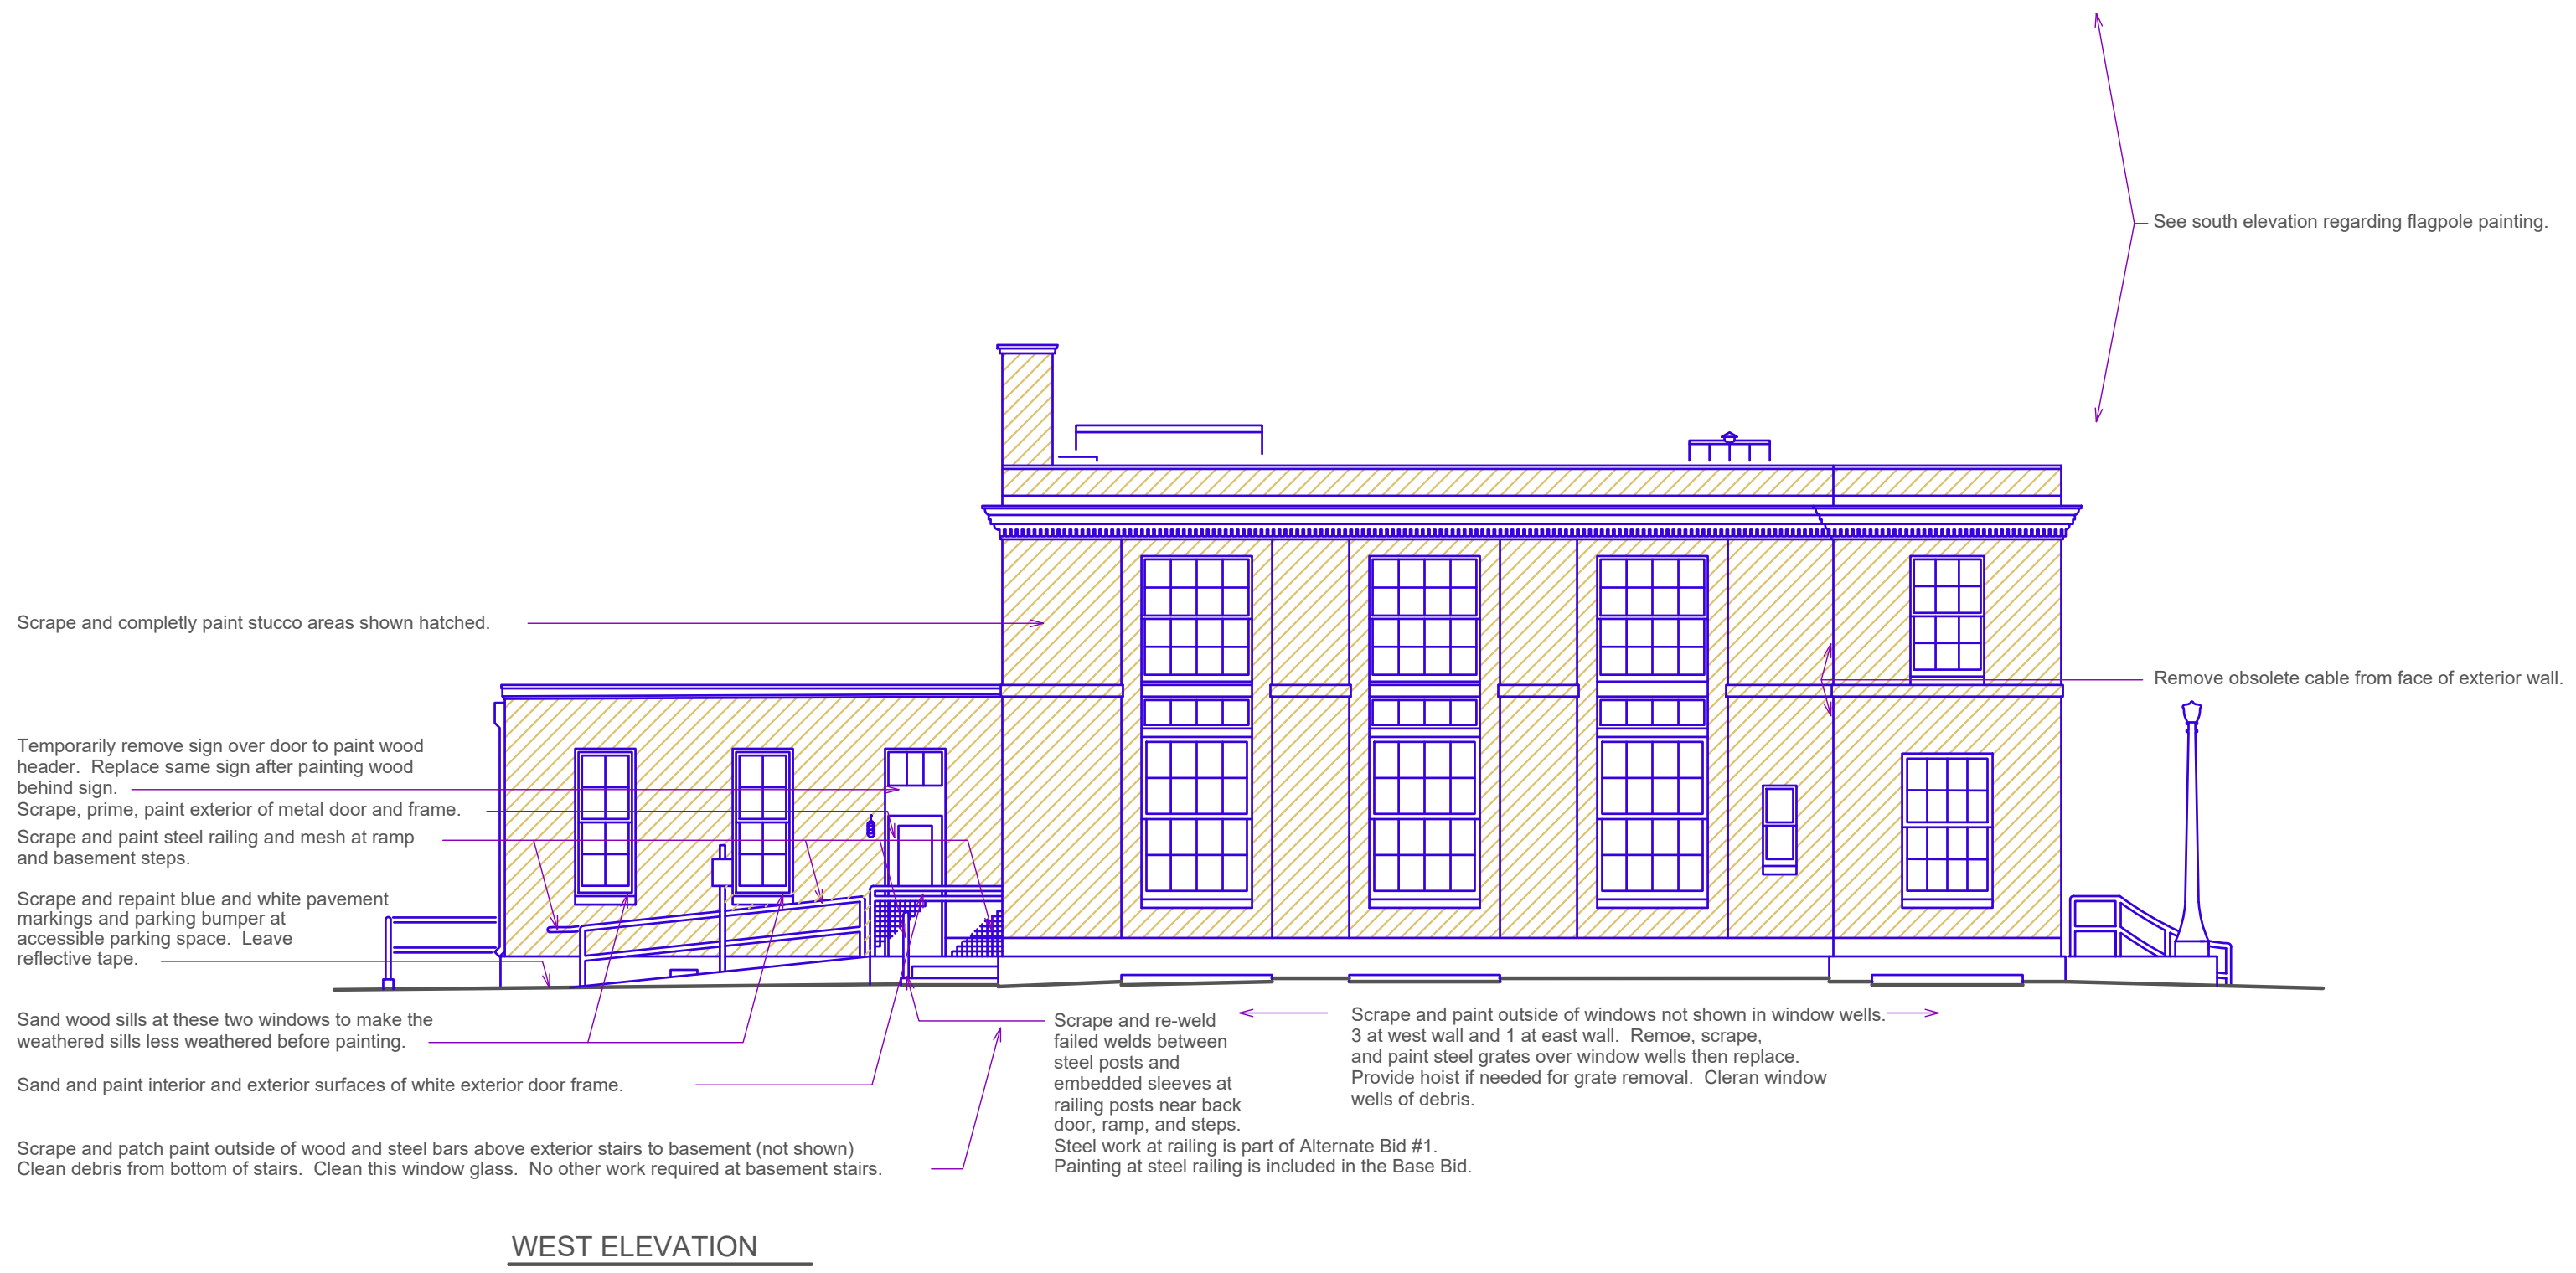
**WEST ELEVATION**

- Scrape and completely paint stucco areas shown hatched.
- Temporarily remove sign over door to paint wood header. Replace same sign after painting wood behind sign.

- Scrape, prime, paint exterior of metal door and frame.
- Scrape and paint steel railing and mesh at ramp and basement steps.
- Scrape and repaint blue and white pavement markings and parking bumper at accessible parking space. Leave reflective tape.

- Sand wood sills at these two windows to make the weathered sills less weathered before painting.
- Sand and paint interior and exterior surfaces of white exterior door frame.

- Scrape and patch paint outside of wood and steel bars above exterior stairs to basement (not shown). Clean debris from bottom of stairs. Clean this window glass. No other work required at basement stairs.

- Scrape and re-weld failed welds between steel posts and embedded sleeves at railing posts near back door, ramp, and steps. Steel work at railing is part of Alternate Bid #1. Painting at steel railing is included in the Base Bid.

- Scrape and paint outside of windows not shown in window wells. 3 at west wall and 1 at east wall. Remove, scrape, and paint steel grates over window wells then replace. Provide hoist if needed for grate removal. Clean window wells of debris.

- Remove obsolete cable from face of exterior wall.
- See south elevation regarding flagpole painting.
