Peralta Community Resource Center (Building 100 Replacement)

**ISSUE FOR BID**

DRAWN BY JA CHECKED BY DM
SHEET TITLE INSTALLATION DETAILS - SECURITY

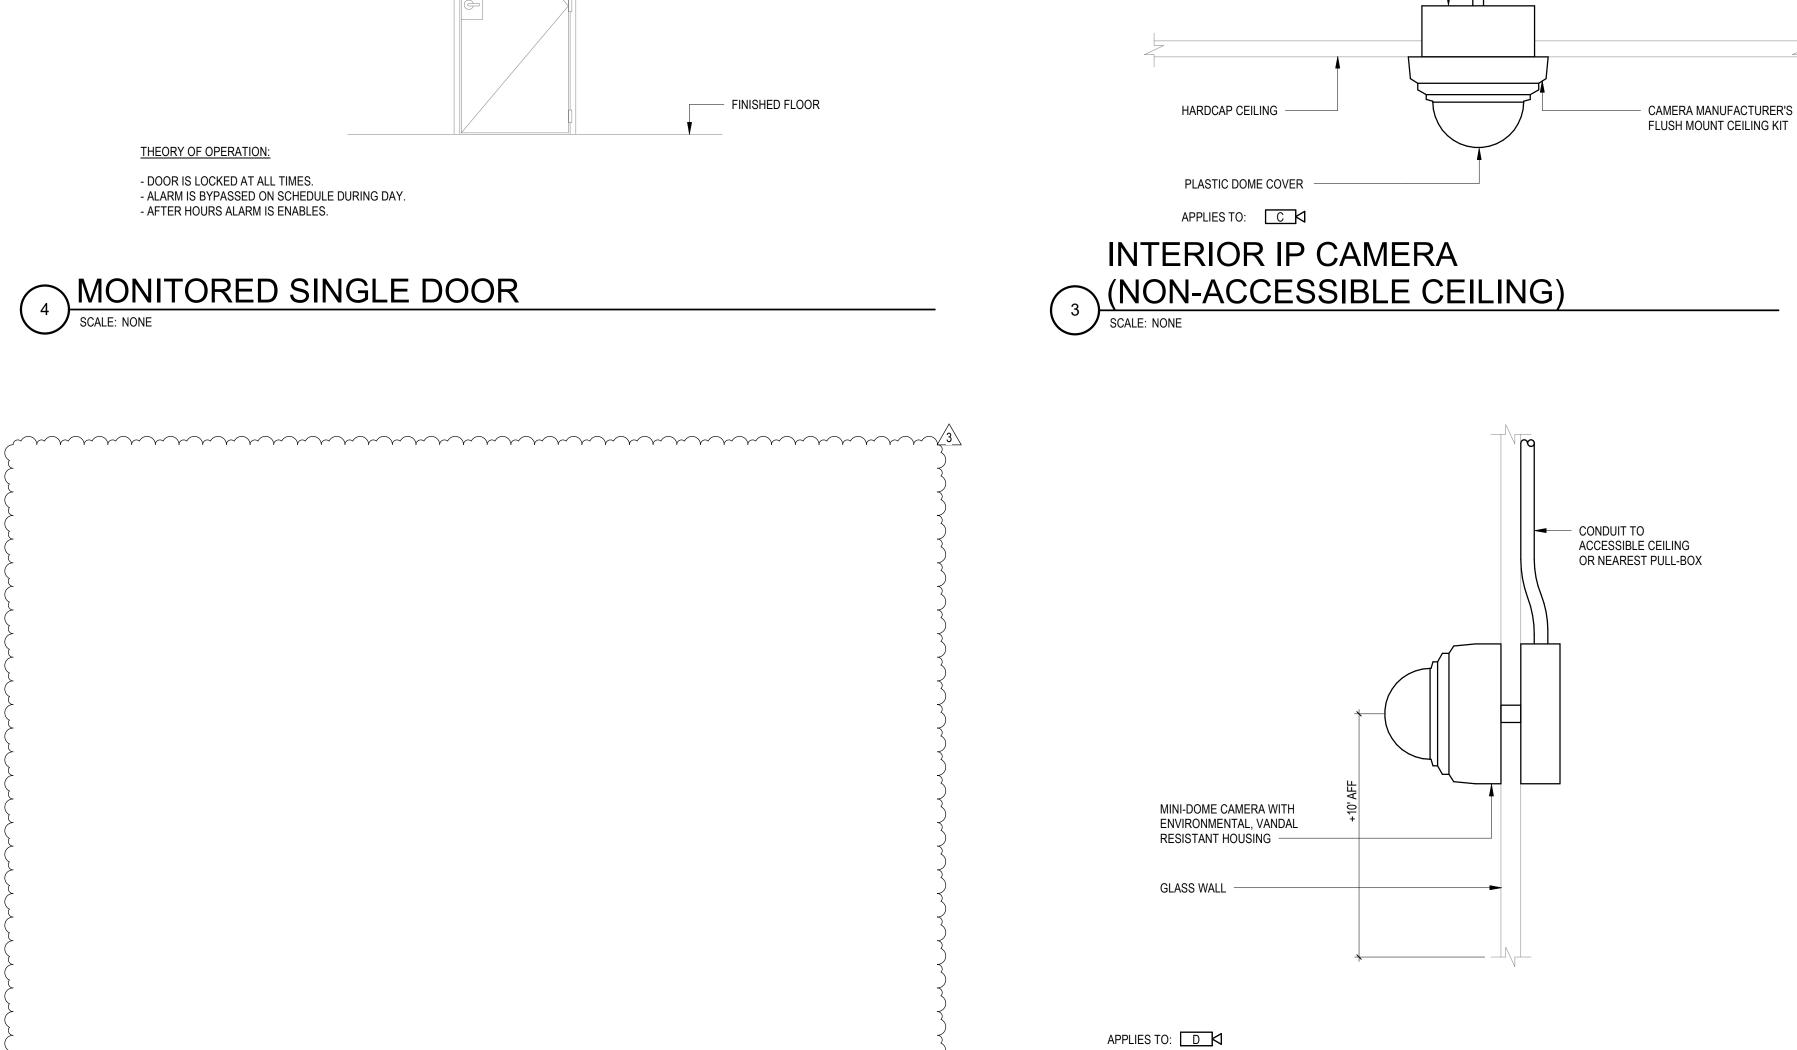
7 MOUNT
SCALE: NONE

PROVIDE 3/4" CONDUIT TO ACCESSIBLE CEILING OR

NEAREST PULL-BOX —

4 SQUARE DEEP

BRACKET AND

SINGLE GANG RING

JUNCTION BOX WITH

CAMERA EXTERIOR GLASS WALL

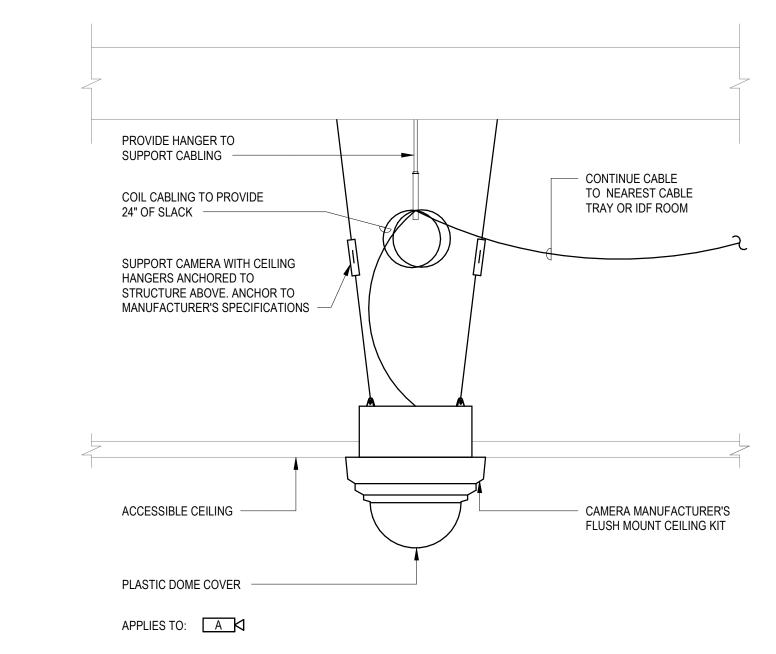
CAMERA INTERIOR FLUSH MOUNT

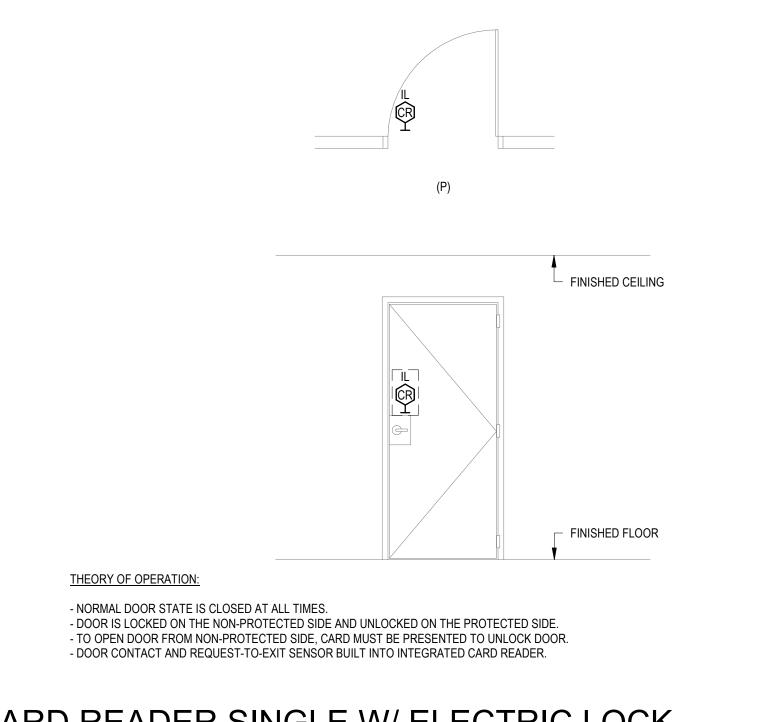
6 CARD READER SINGLE W/ ELECTRIC LOCK SCALE: NONE

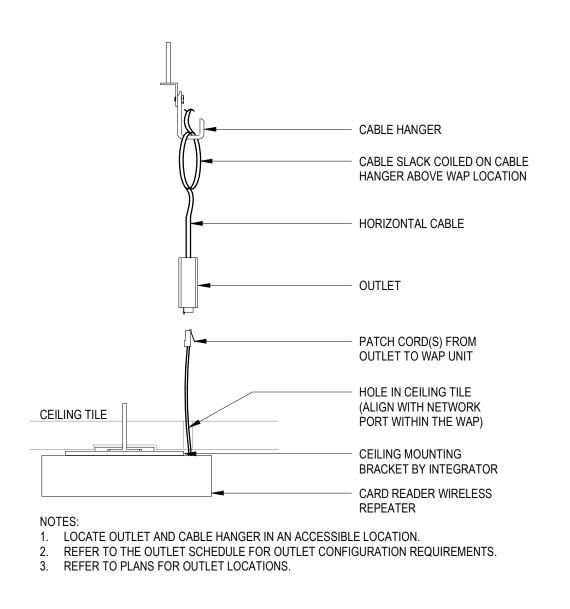
SCALE: NONE

CARD READER WIRELESS REPEATER- CLG GRID-MT

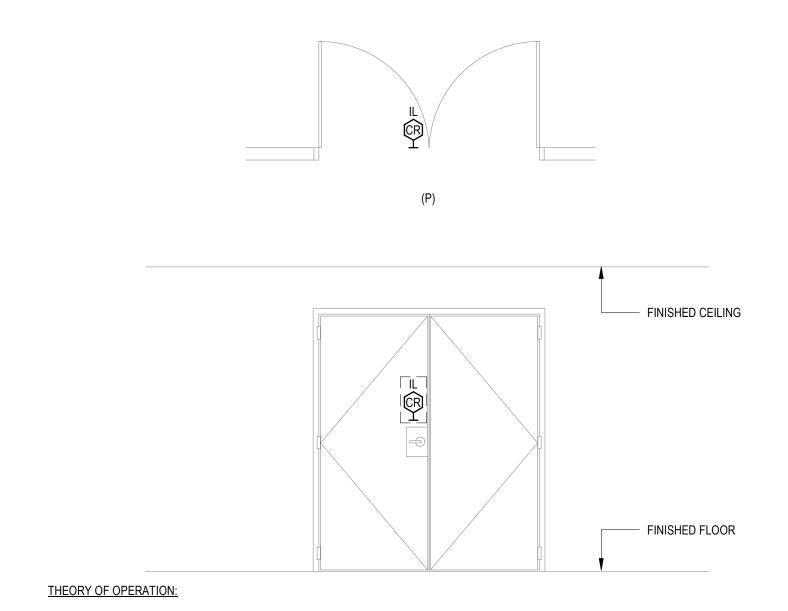
- NORMAL DOOR STATE IS CLOSED AND LOCKED AT ALL TIMES. - DOOR IS LOCKED ON THE NON-PROTECTED SIDE AND UNLOCKED ON THE PROTECTED SIDE. - TO OPEN DOOR FROM NON-PROTECTED SIDE, CARD MUST BE PRESENTED TO UNLOCK DOOR. - REQUEST TO EXIT MOTION DETECTOR BYPASSES ALARM ONLY ON EXIT. - DOOR CONTACT AND REQUEST-TO-EXIT SENSOR BUILT INTO INTEGRATED CARD READER.

## CARD READER PAIR W/ ELECTRIC LOCK SCALE: NONE
