Public Works  
Department  
Martyn Detz

At the Mill Park entrance, our objective is to improve the line of sight for residents when they leave the Mill Park neighborhood. We accomplish this by eliminating the parking spaces immediately to the left and right of the entrance to the neighborhood by building out landscaped medians. Furthermore, with the road shifting two feet to the west, the existing 3 landscape islands need to be built out further to prevent anyone from parking in front of these medians where the mailboxes are located.

Rope Mill Rd  
East Side  
Mill Park Entrance  
PW-19 266

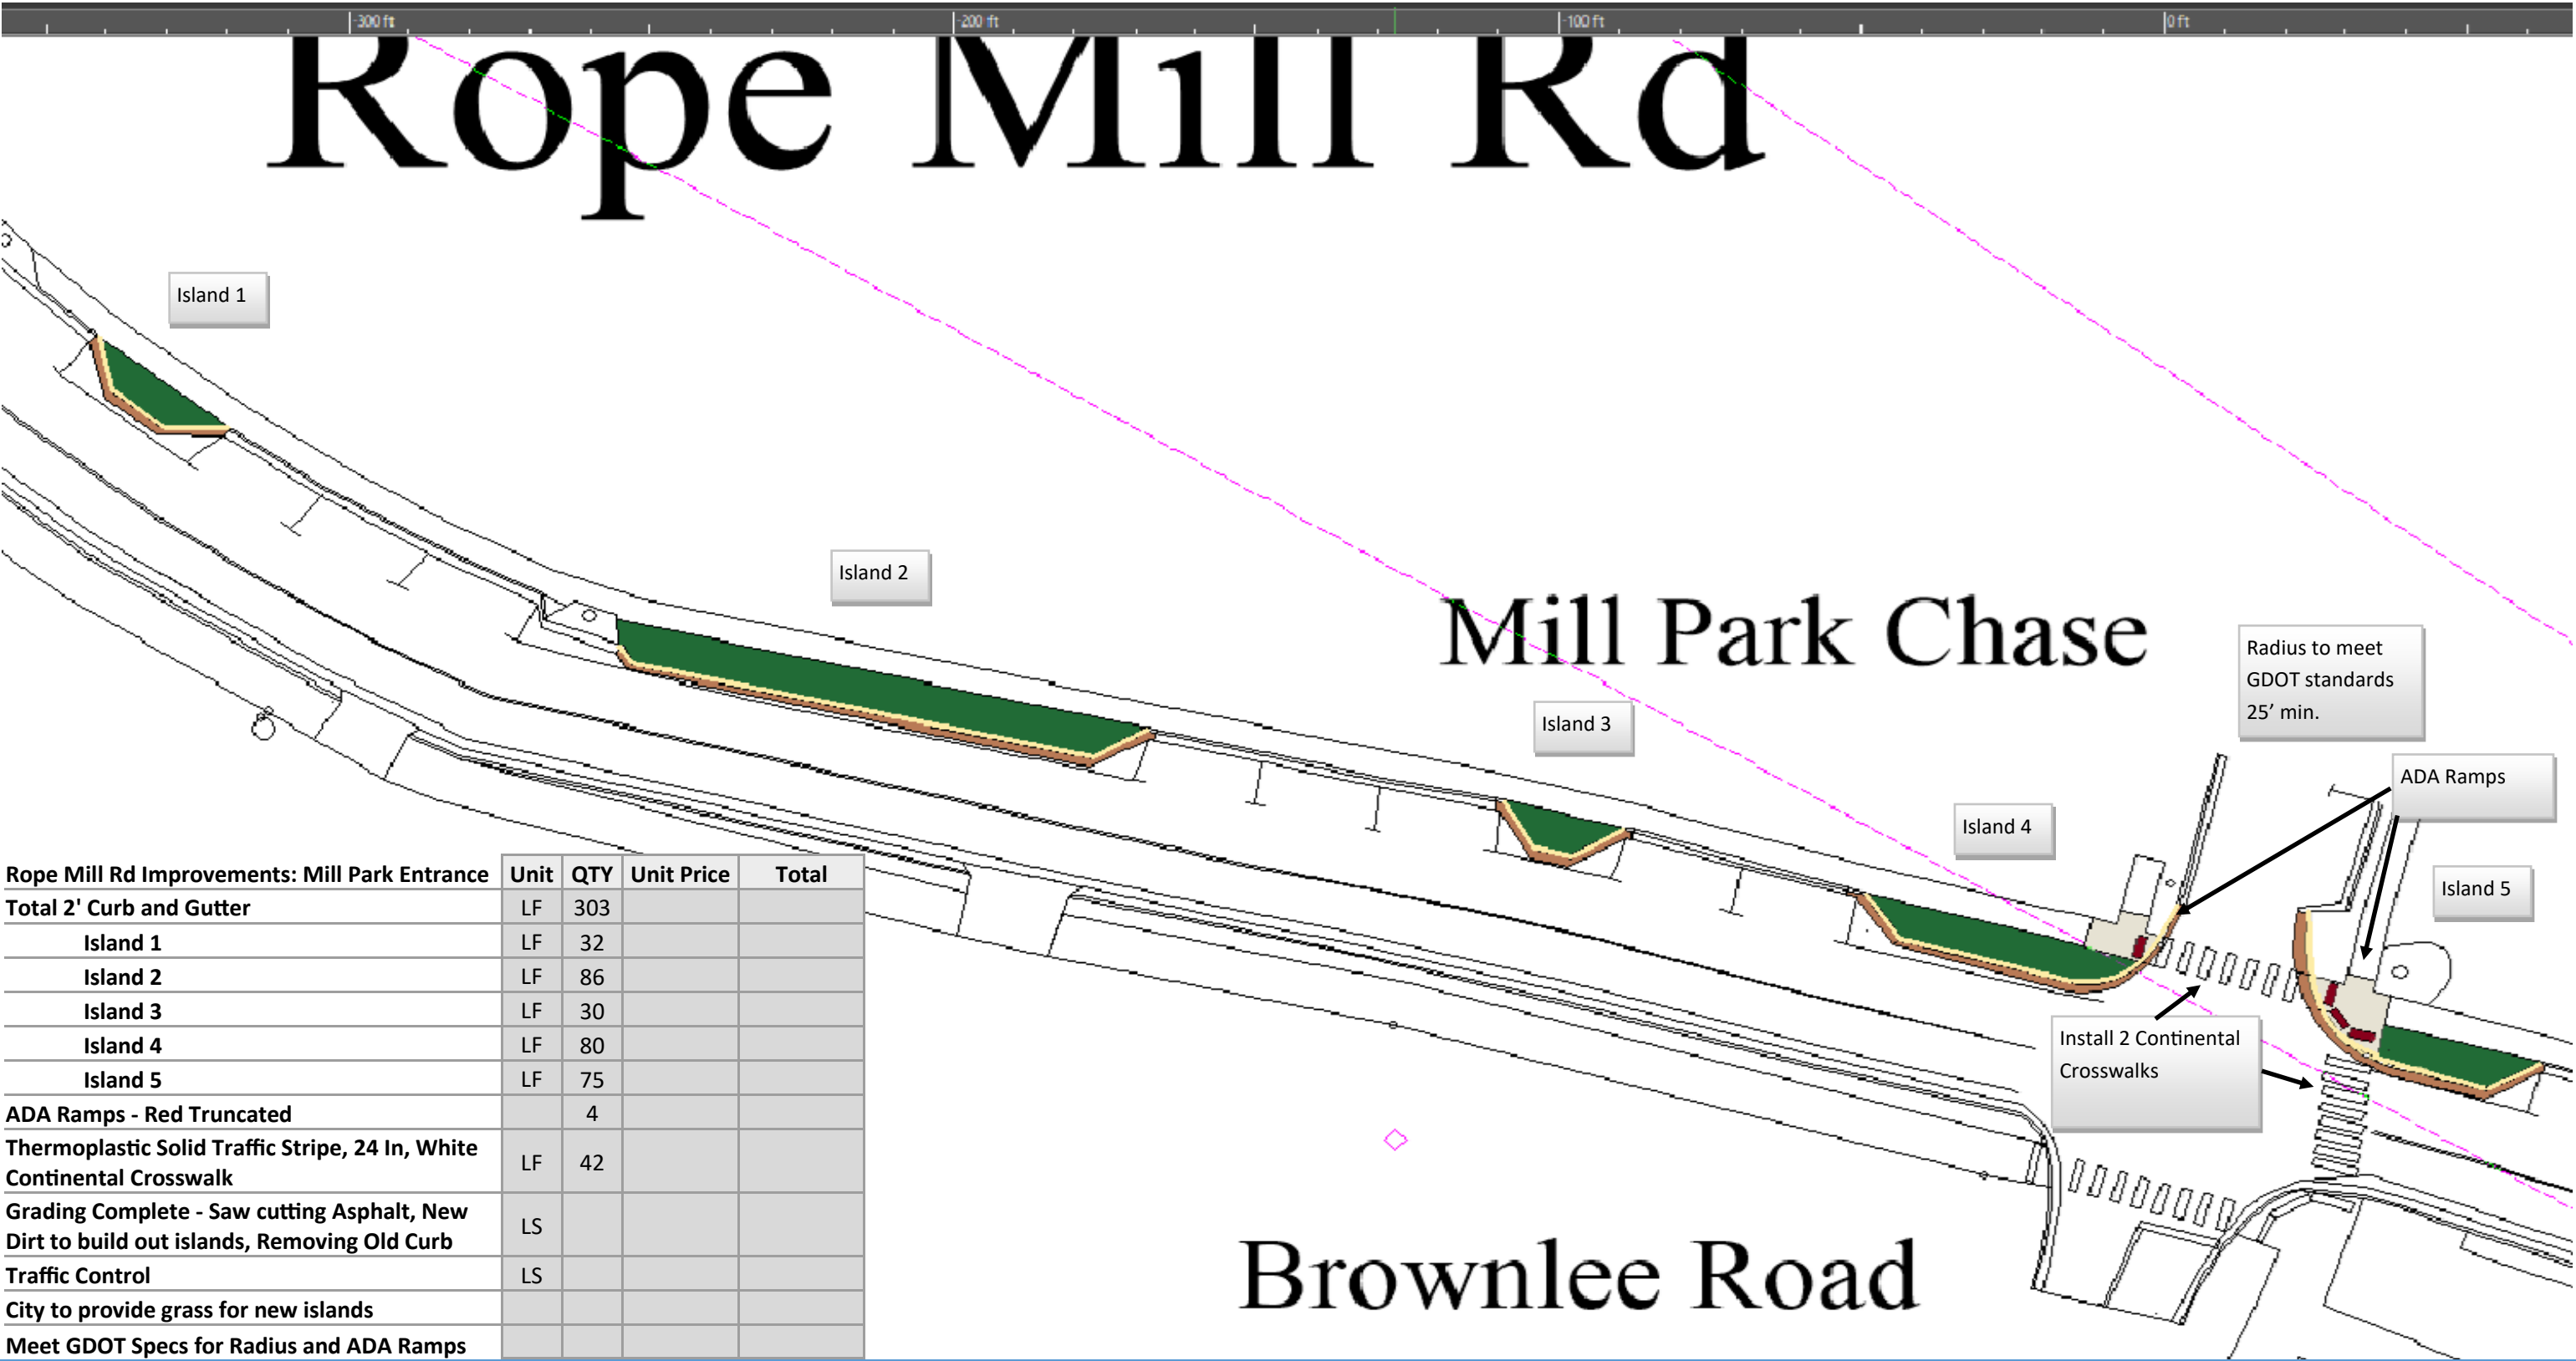
Rope Mill Rd Improvements: Mill Park Entrance				
Total 2' Curb and Gutter	LF	303		
Island 1	LF	32		
Island 2	LF	86		
Island 3	LF	30		
Island 4	LF	80		
Island 5	LF	75		
ADA Ramps - Red Truncated		4		
Thermoplastic Solid Traffic Stripe, 24 In, White Continental Crosswalk	LF	42		
Grading Complete - Saw cutting Asphalt, New Dirt to build out islands, Removing Old Curb	LS			
Traffic Control	LS			
City to provide grass for new islands				
Meet GDOT Specs for Radius and ADA Ramps

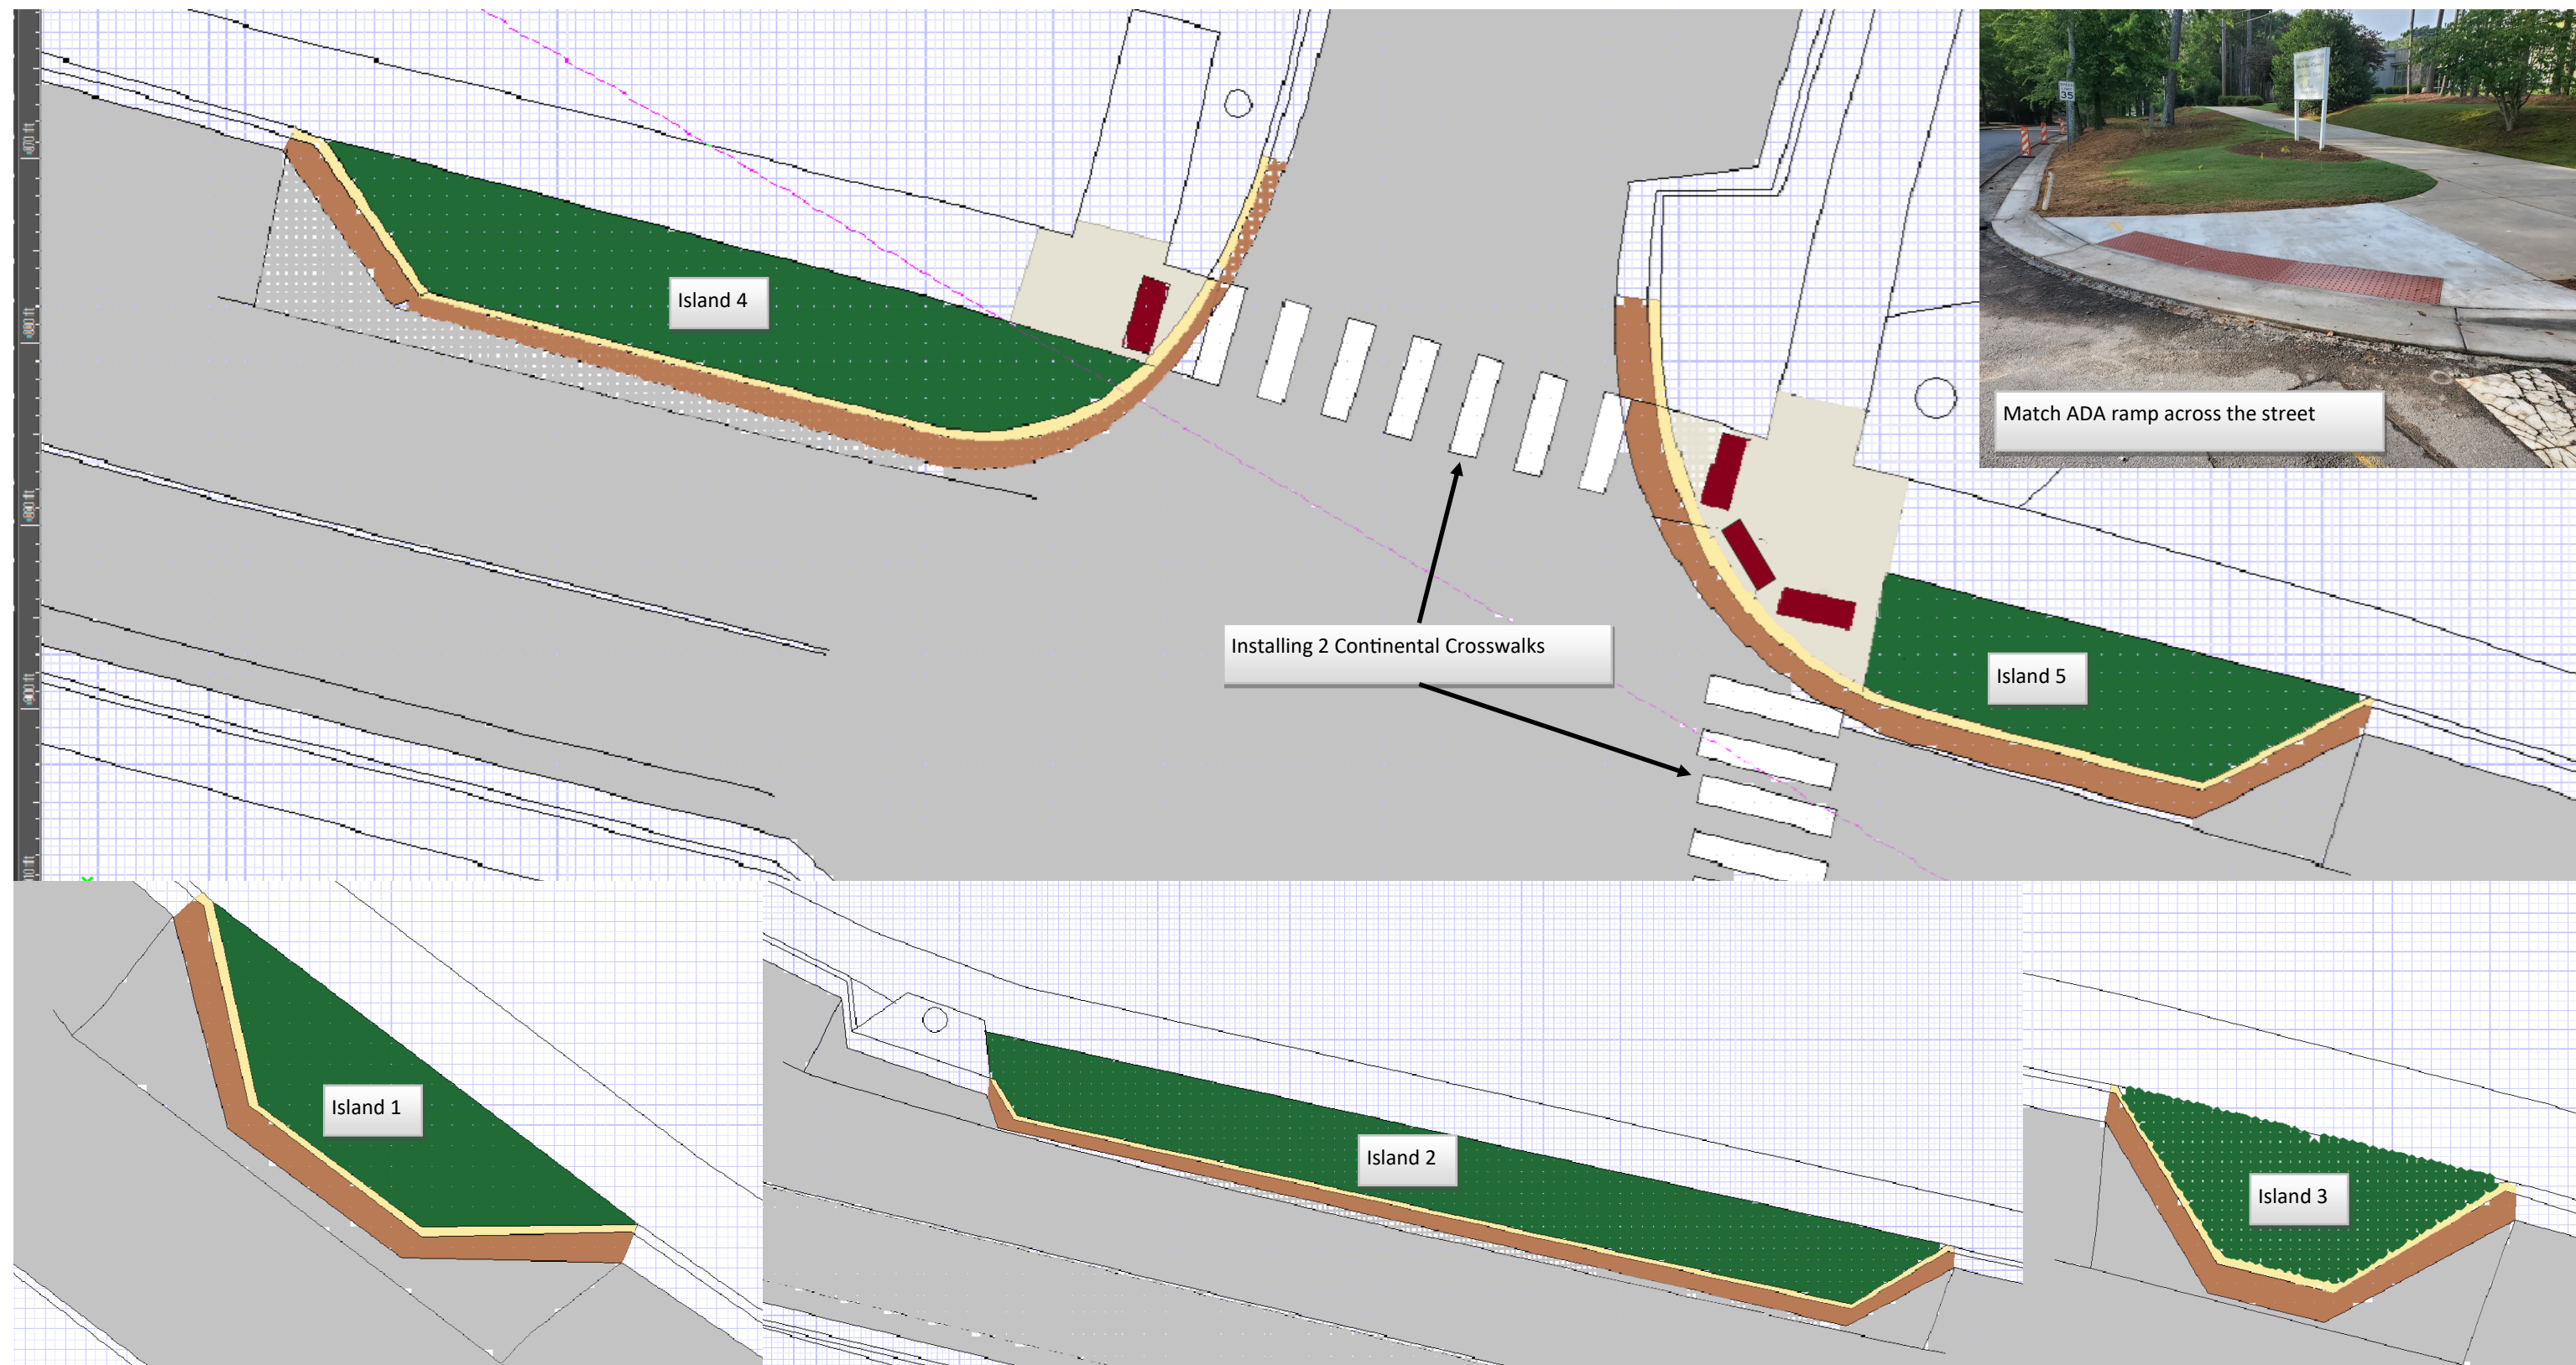
At the Mill Park entrance, our objective is to improve the line of sight for residents when they leave the Mill Park neighborhood. We accomplish this by eliminating the parking spaces immediately to the left and right of the entrance to the neighborhood by building out landscaped medians. Furthermore, with the road shifting two feet to the west, the existing 3 landscape islands need to be built out further to prevent anyone from parking in front of these medians where the mailboxes are located.

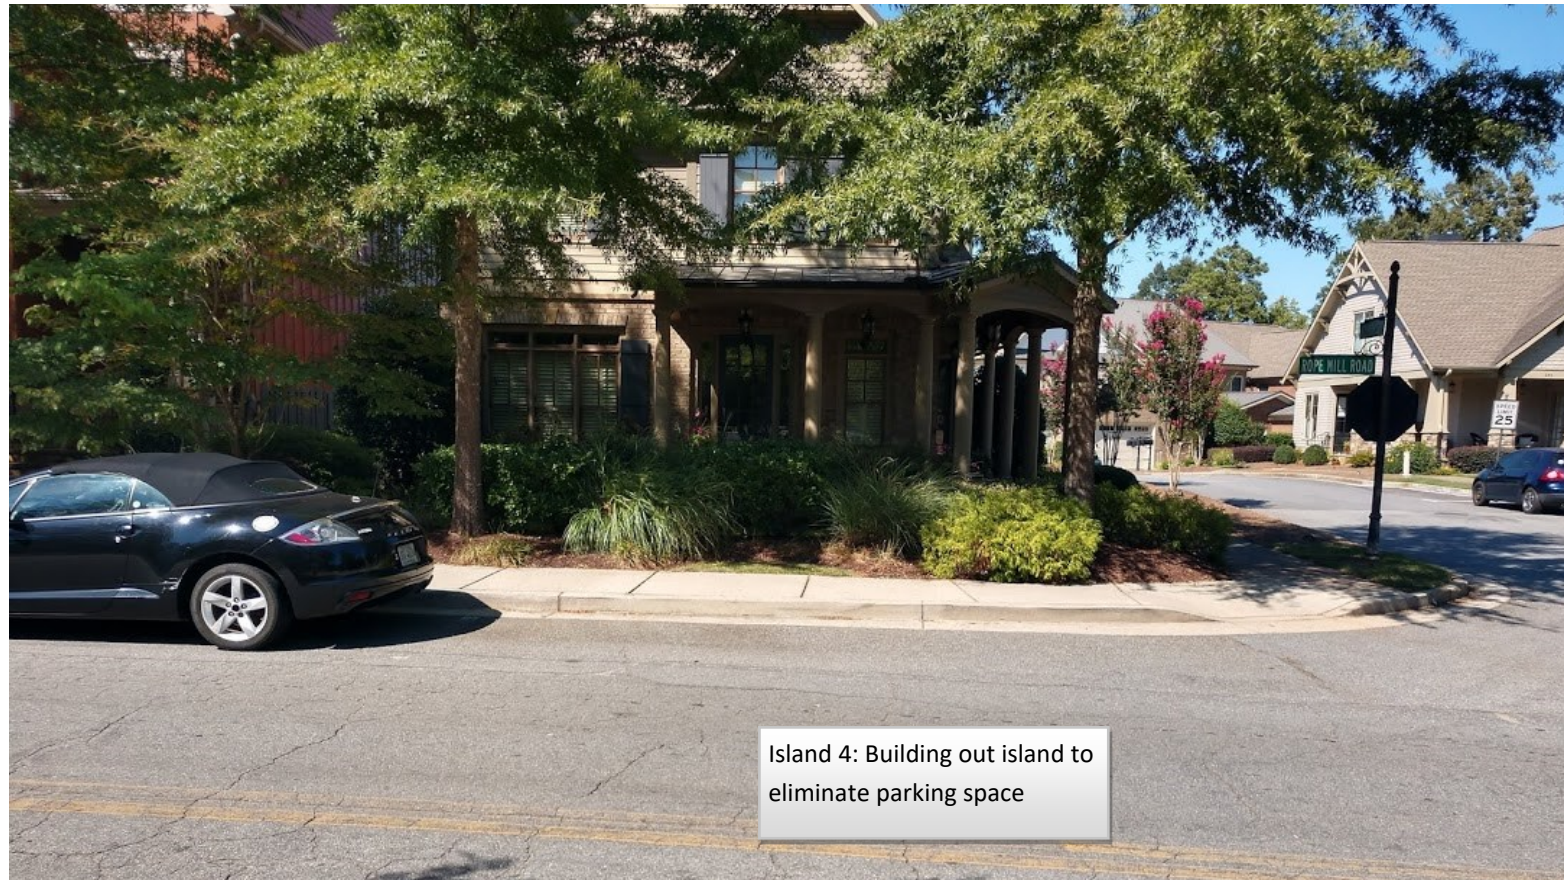
Island 4: Building out island to eliminate parking space

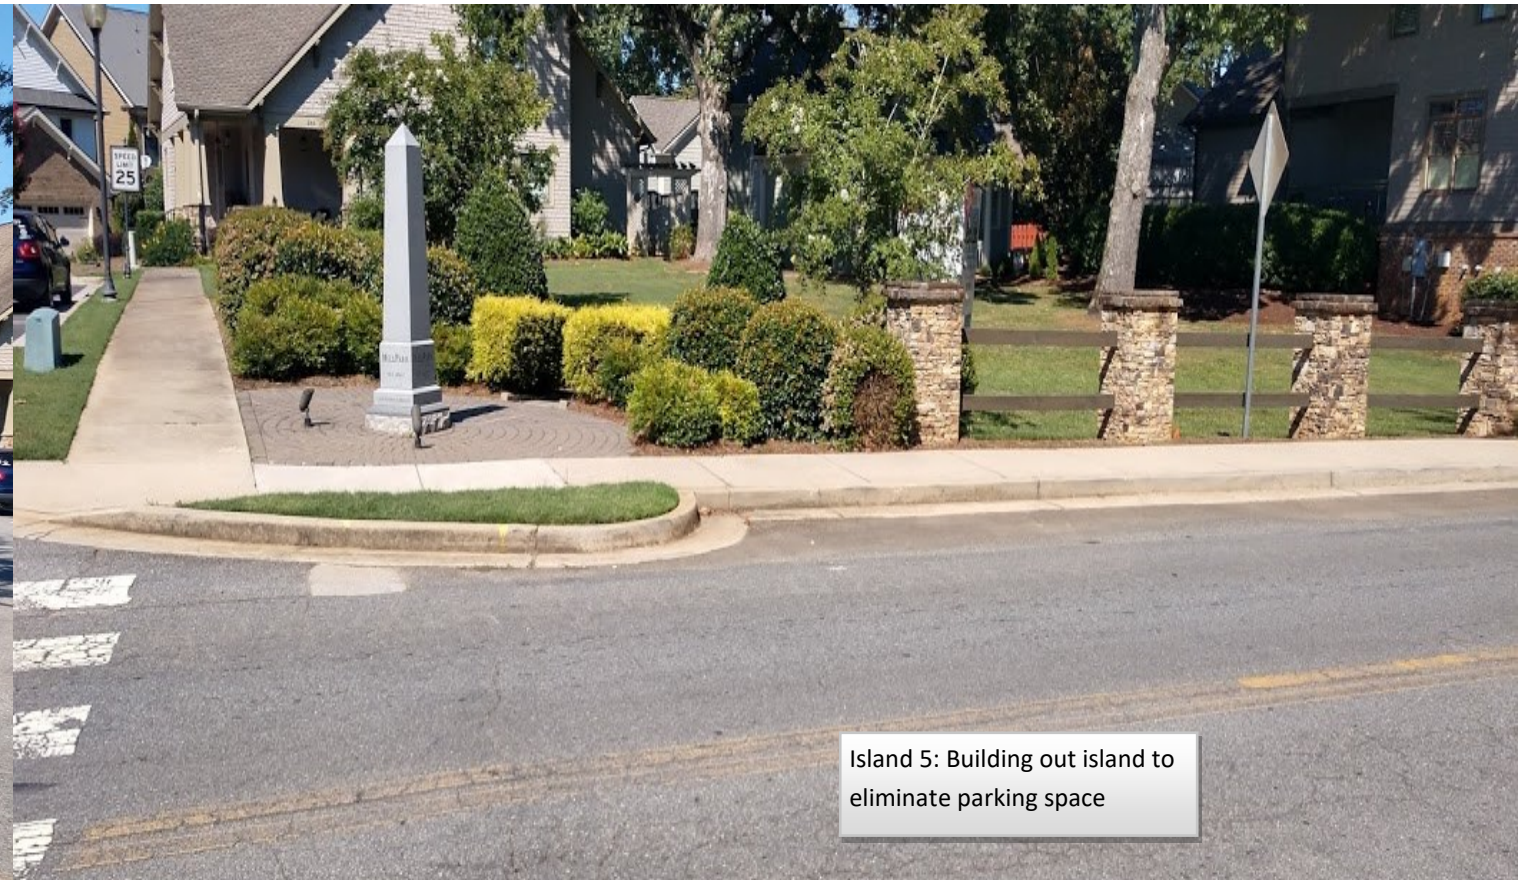
Island 5: Building out island to eliminate parking space

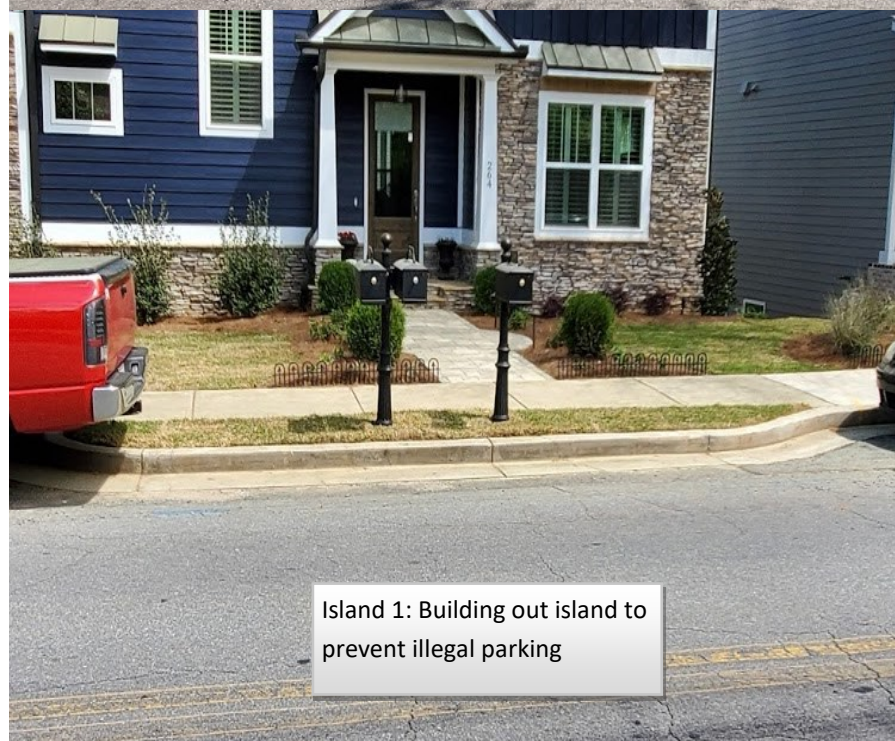
Island 1: Building out island to prevent illegal parking

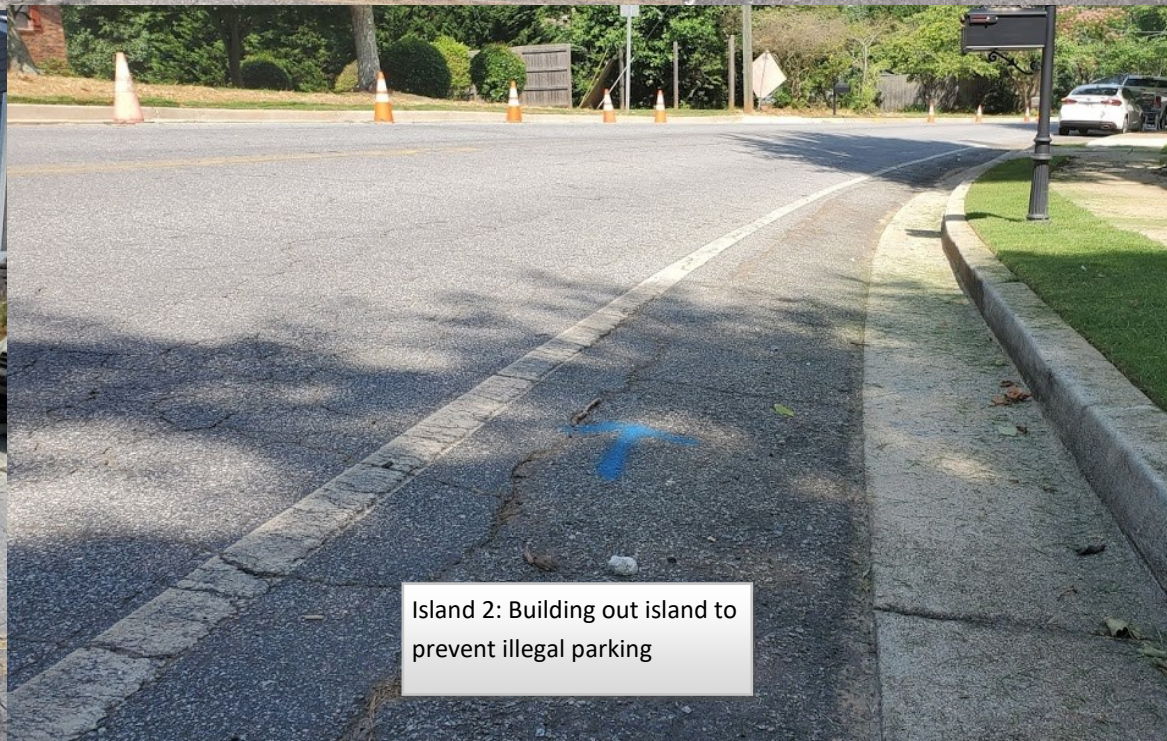
Island 2: Building out island to prevent illegal parking

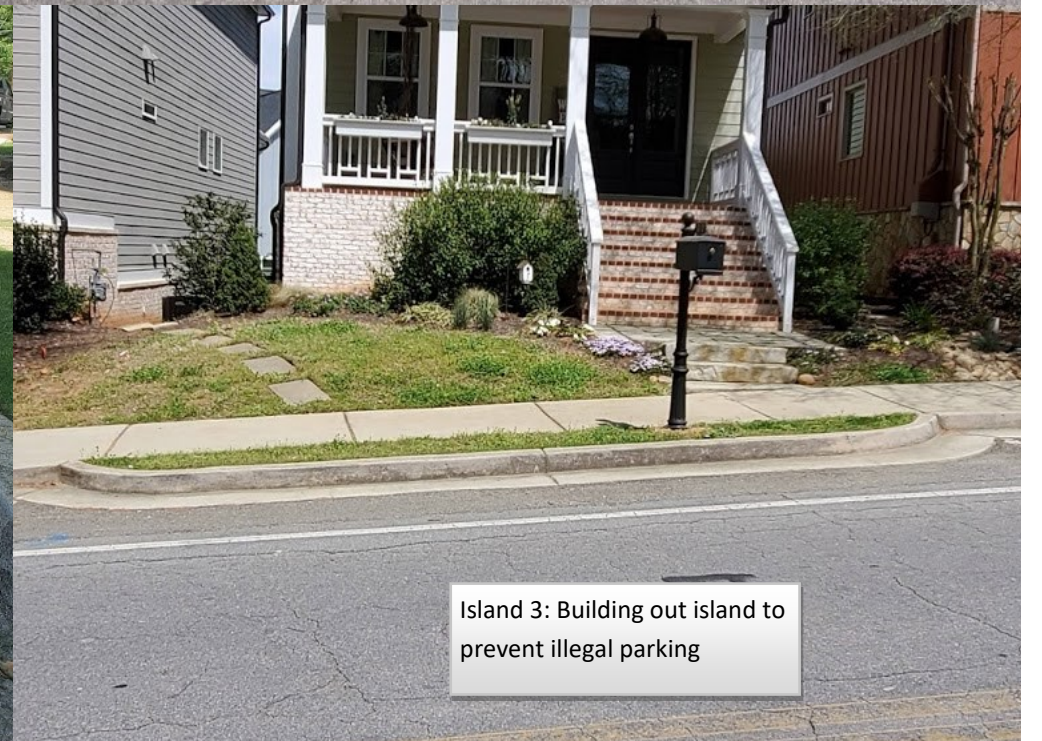
Island 3: Building out island to prevent illegal parking

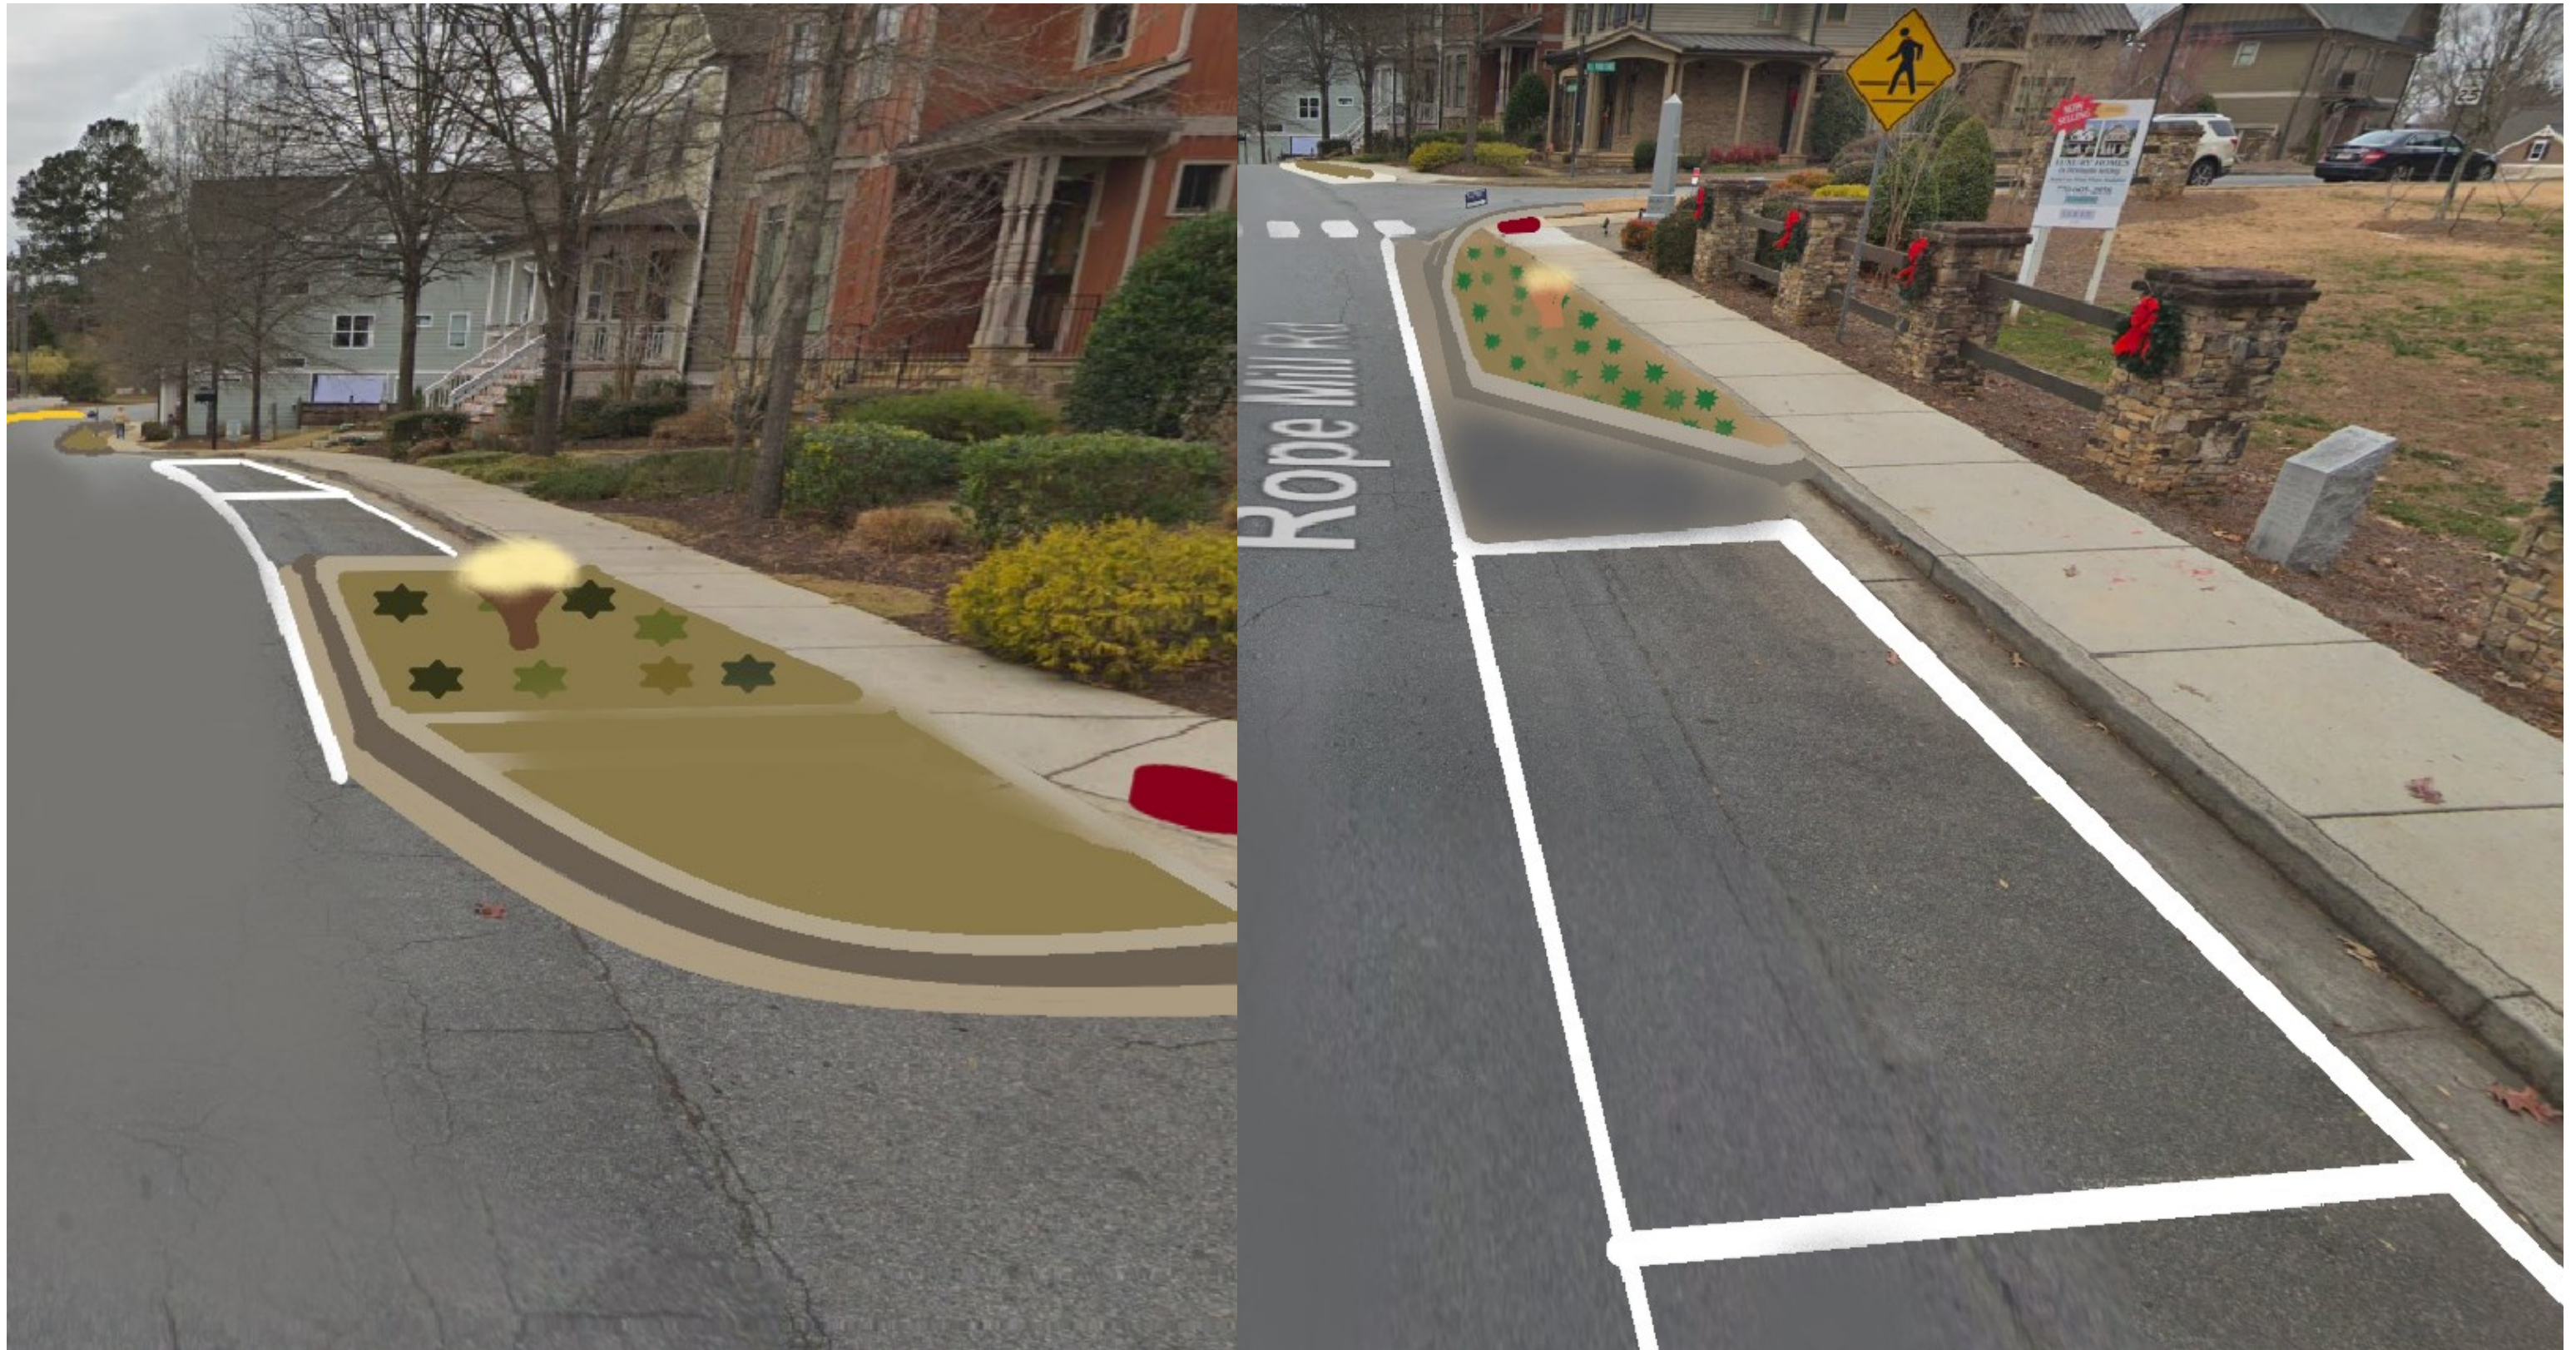
At the Mill Park entrance, our objective is to improve the line of sight for residents when they leave the Mill Park neighborhood. We accomplish this by eliminating the parking spaces immediately to the left and right of the entrance to the neighborhood by building out landscaped medians. Furthermore, with the road shifting two feet to the west, the existing 3 landscape islands need to be built out further to prevent anyone from parking in front of these medians where the mailboxes are located.
