**EVALUATION OF THE
5,000,000 GALLON CONCRETE GROUND STORAGE TANK**

**“RESERVOIR NO. 2”
CARLSBAD, NEW MEXICO**

**SOUDER, MILLER & ASSOCIATES
ALBUQUERQUE, NEW MEXICO**

April 27 through May 5, 2016

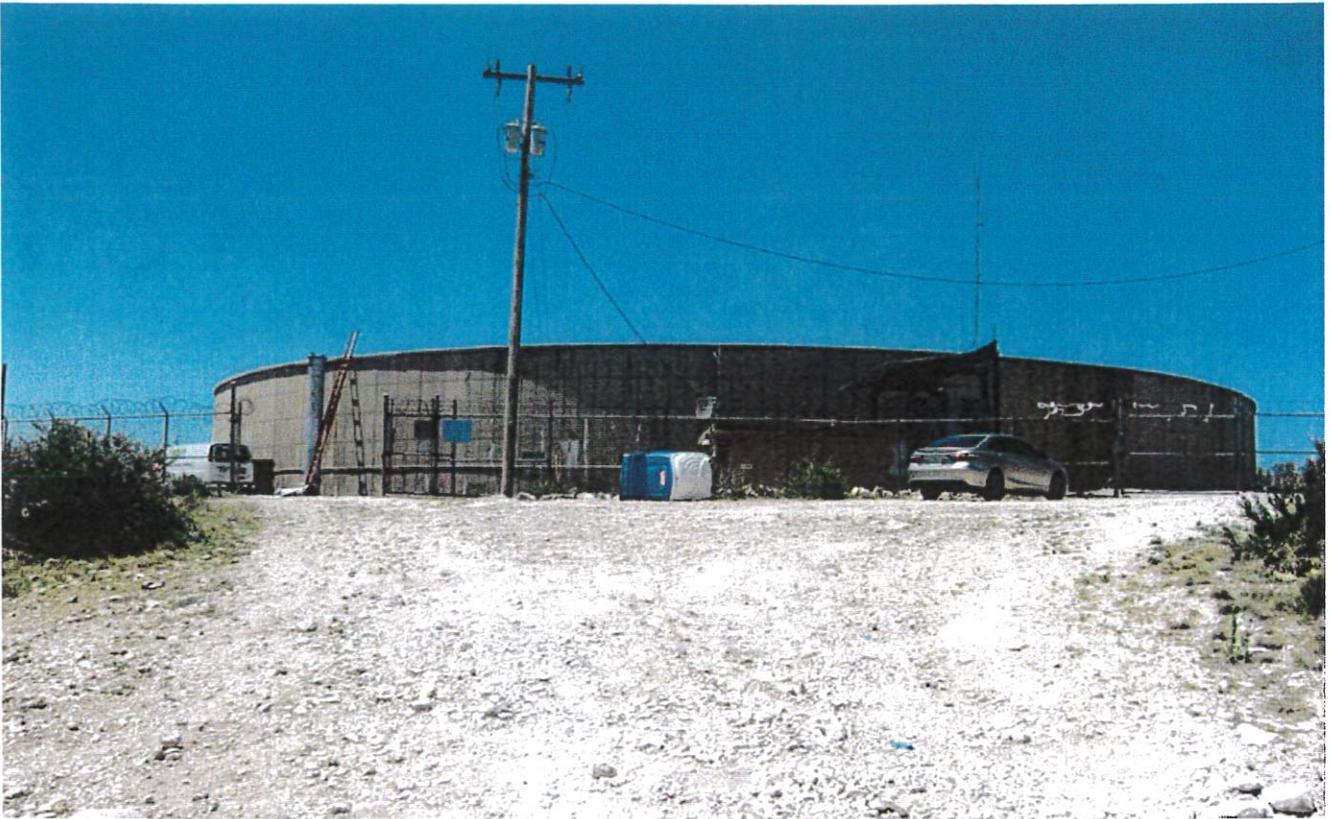
1. Tank and site.

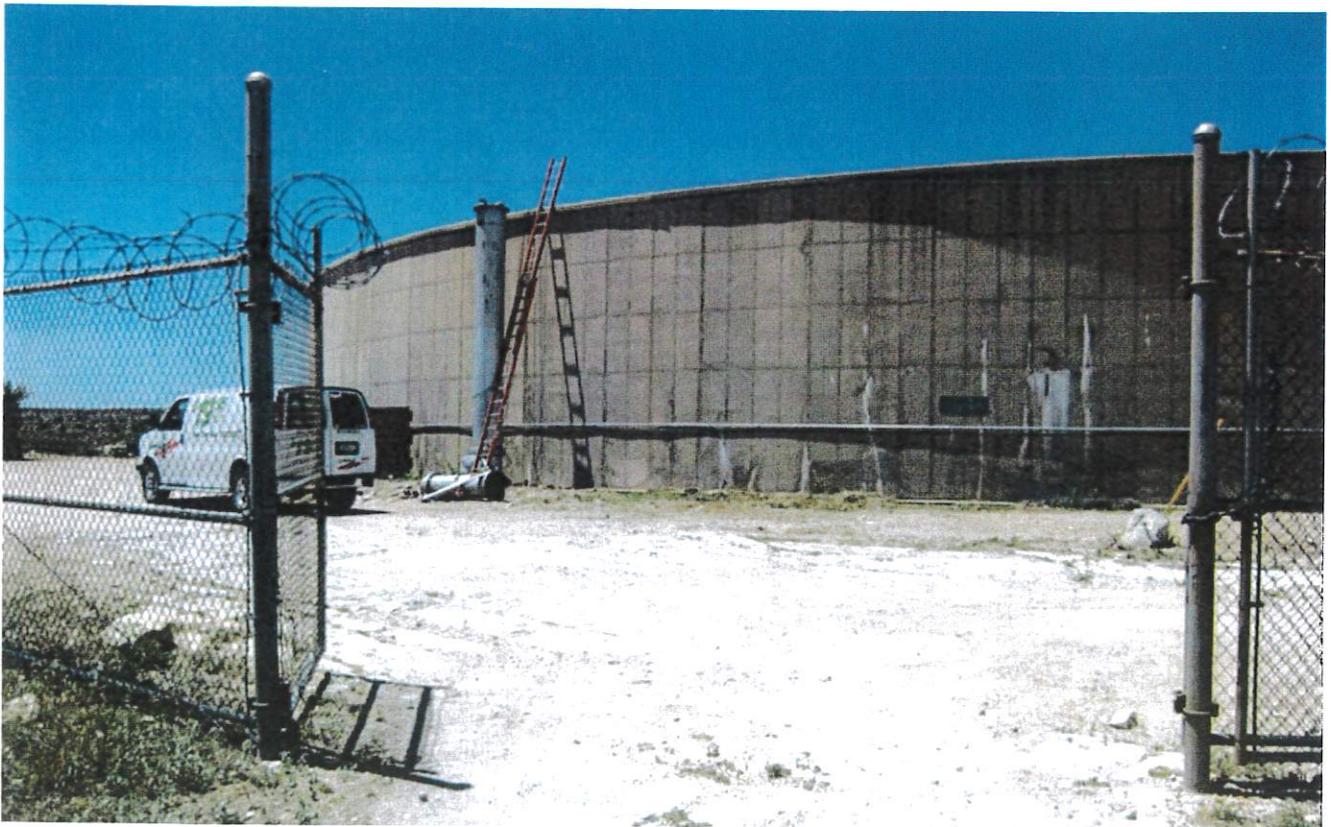
4. Site access.

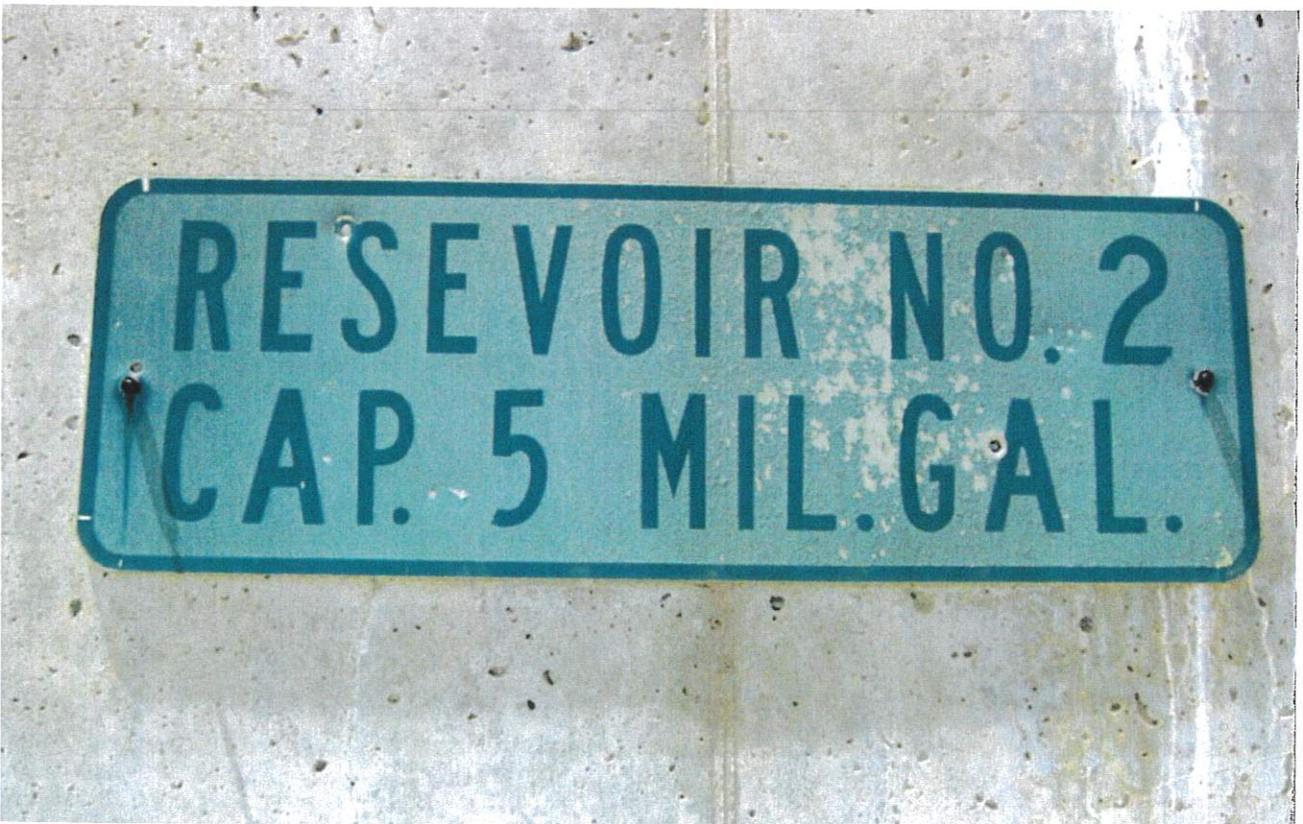
10. Sign on tank.

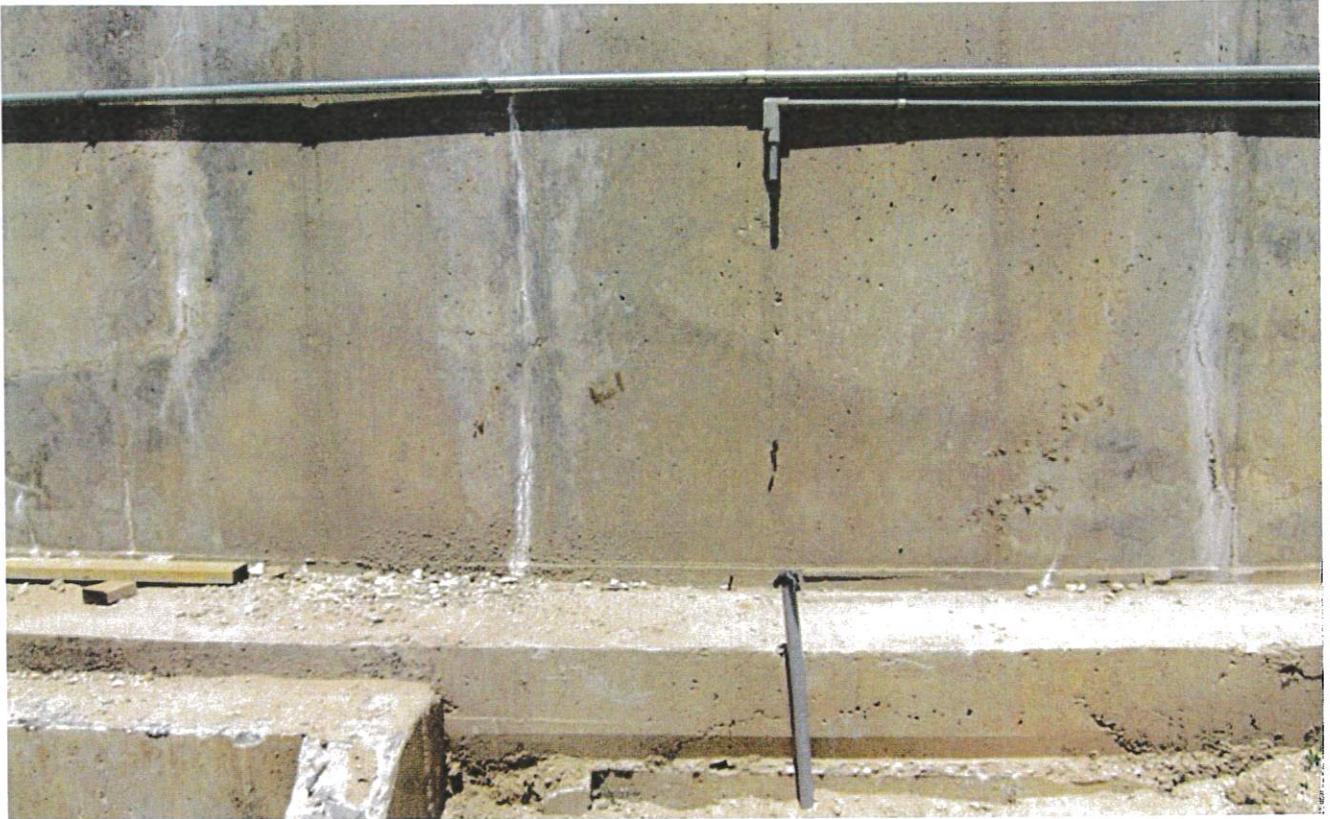
17. Concrete tank foundation and conduits on concrete shell.

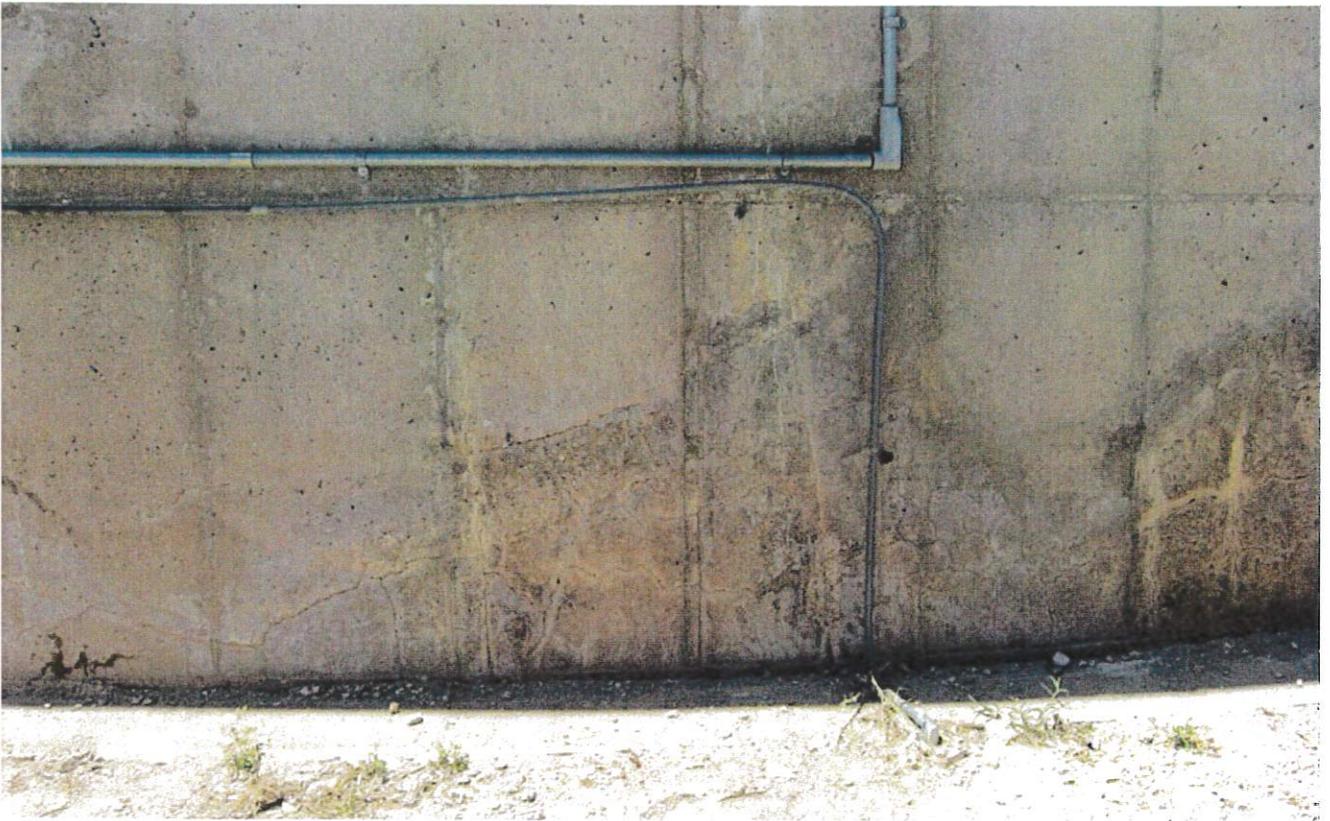
19. Conduits on shell.

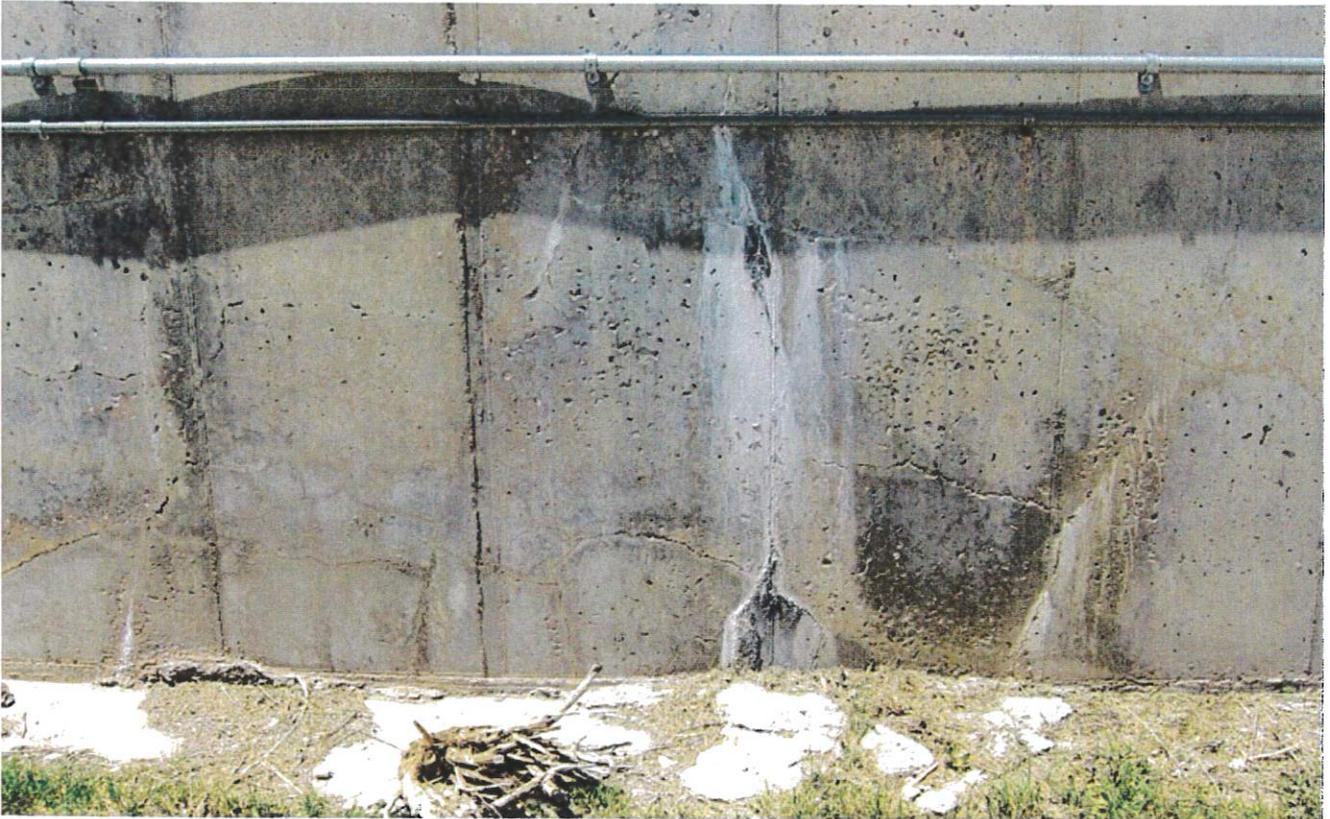
21. Cracks and efflorescence at bottom of shell.

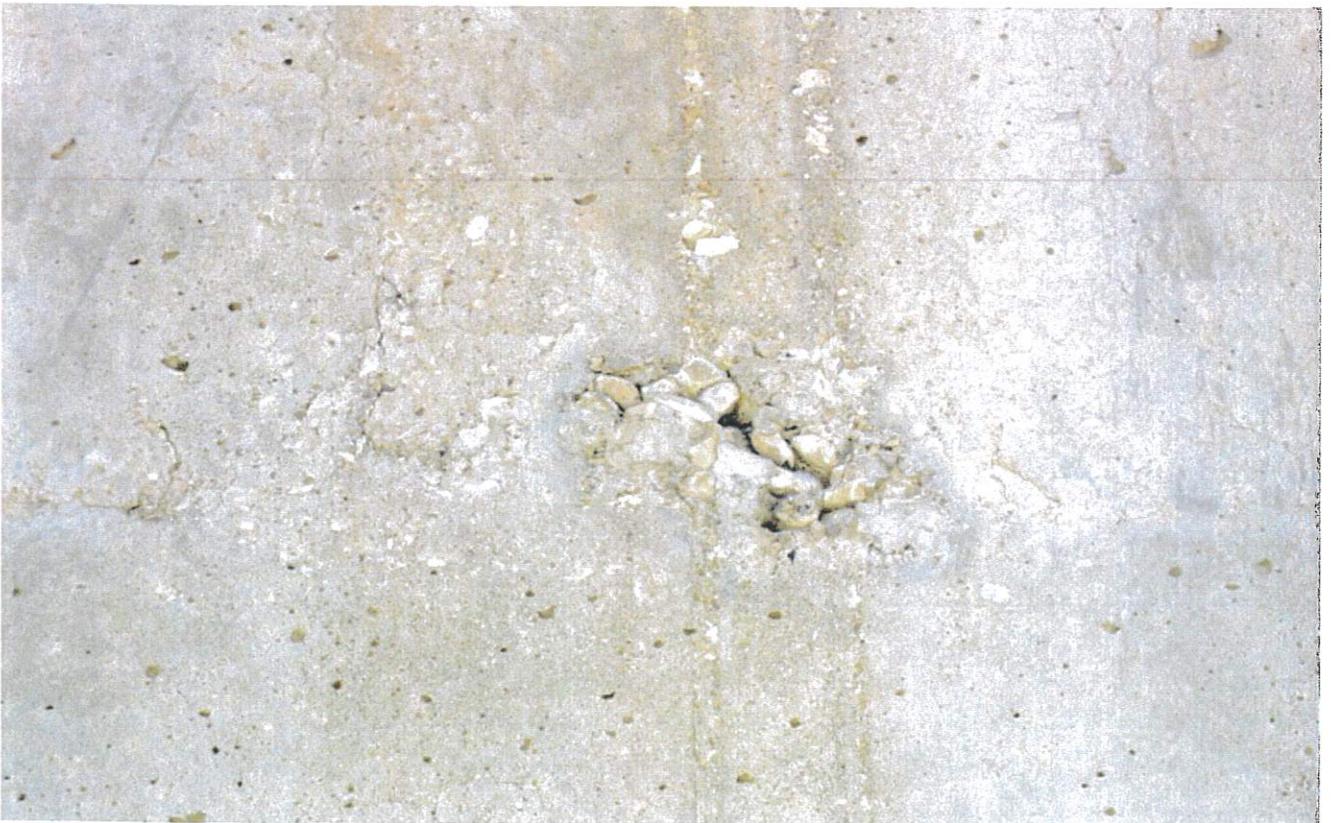
26. Exposed aggregate in shell.

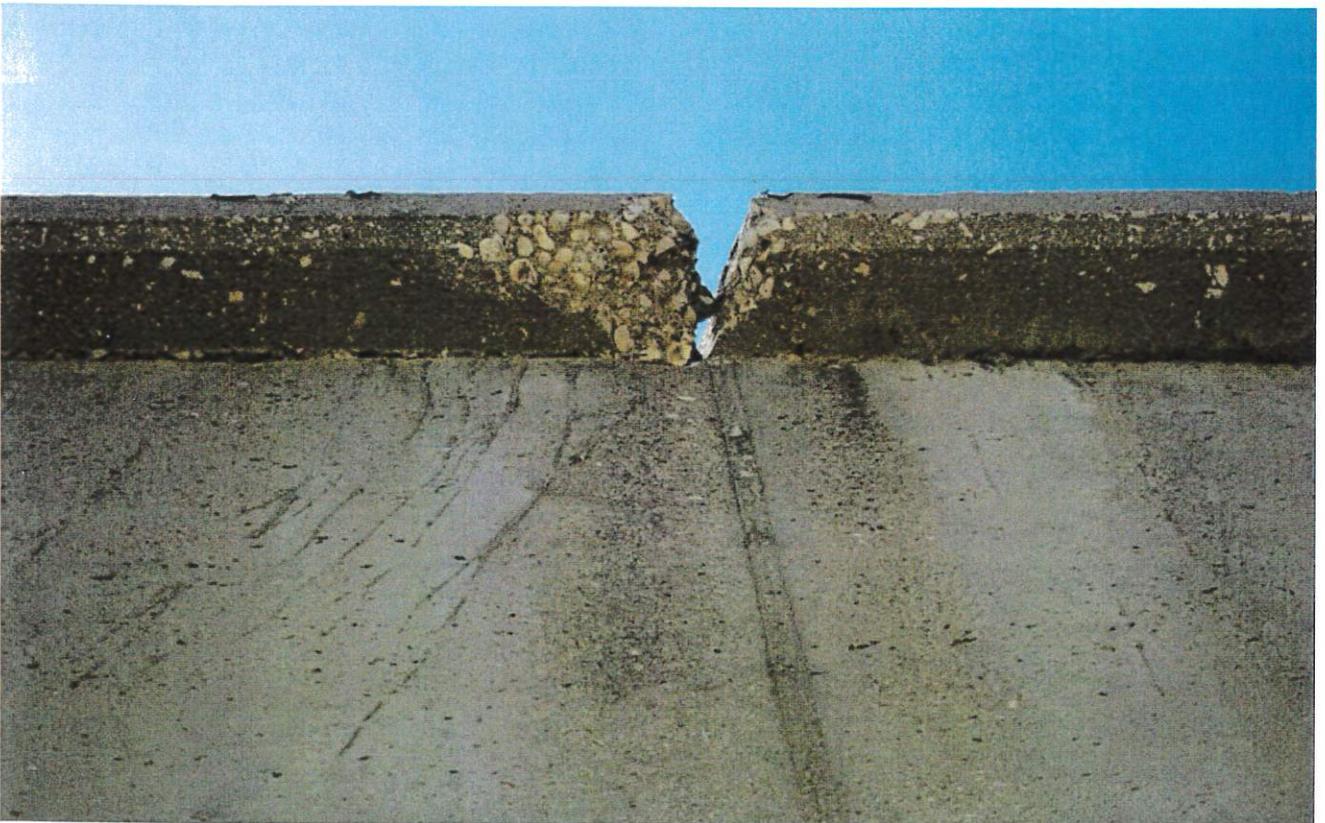
3. **Roof Condition:** The roof appeared relatively flat, and some evidence of ponding water was observed on the roof. The concrete roof measured approximately 6 in. thick at the roof perimeter. A large chip was noted at the north end of the roof construction joint at the roof perimeter. A bituminous sealant was located in the roof construction joints. The sealant appeared to be in poor condition and was missing in places. Vegetation was observed within the roof construction joints and in a few cracks in the roof. Some rocks and debris were noted on the roof. Isolated spots of exposed steel reinforcing were observed in the roof, and widespread locations of tie wires projecting from the exterior roof were noted. The exterior roof exhibited spider web looking cracking at the apparent locations of the interior columns. (See photos 29-42)

30. Chipped concrete at end of construction joint at roof perimeter.

3. **Roof Construction Joints:** The existing bituminous sealant which appeared to be in poor condition and the vegetation should be removed from the roof construction joints and the joints resealed.

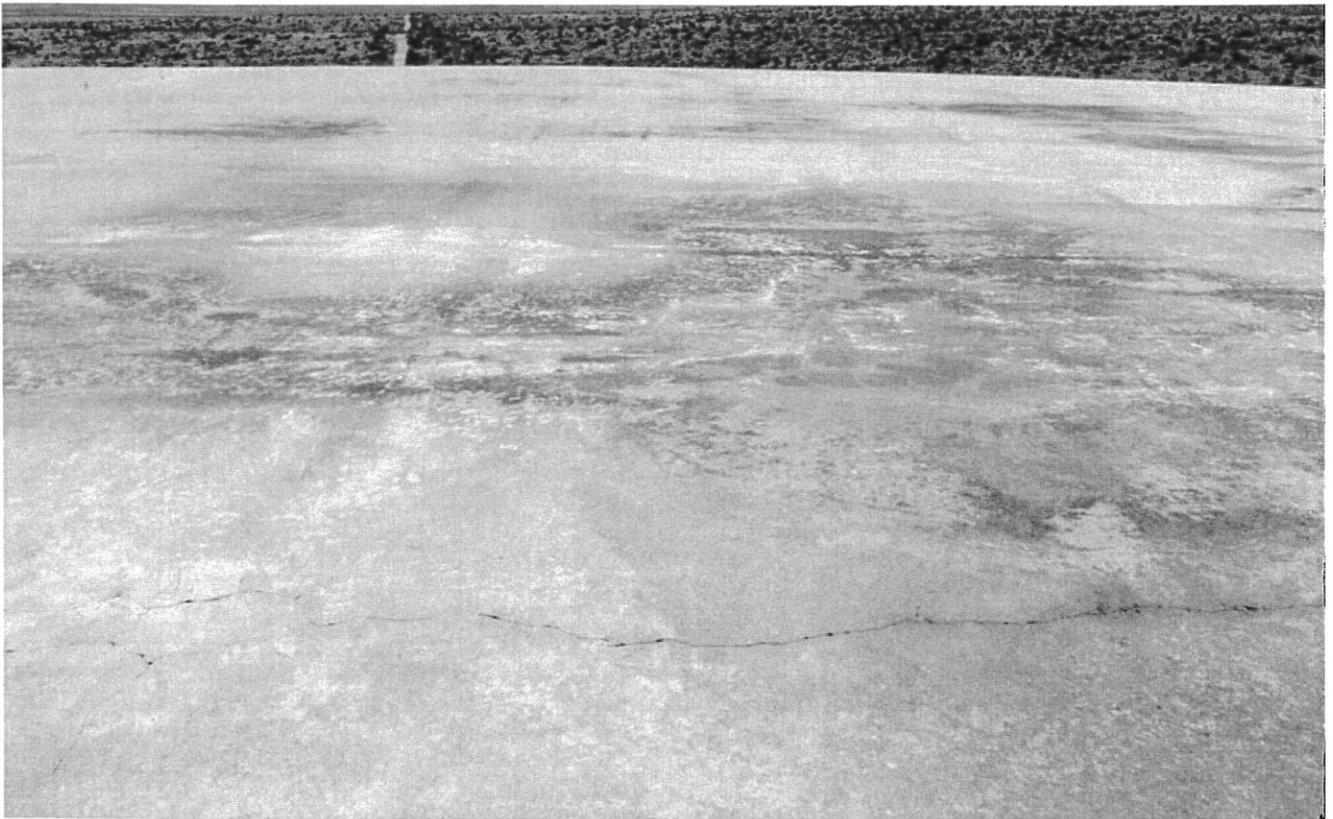
33. Exterior roof.

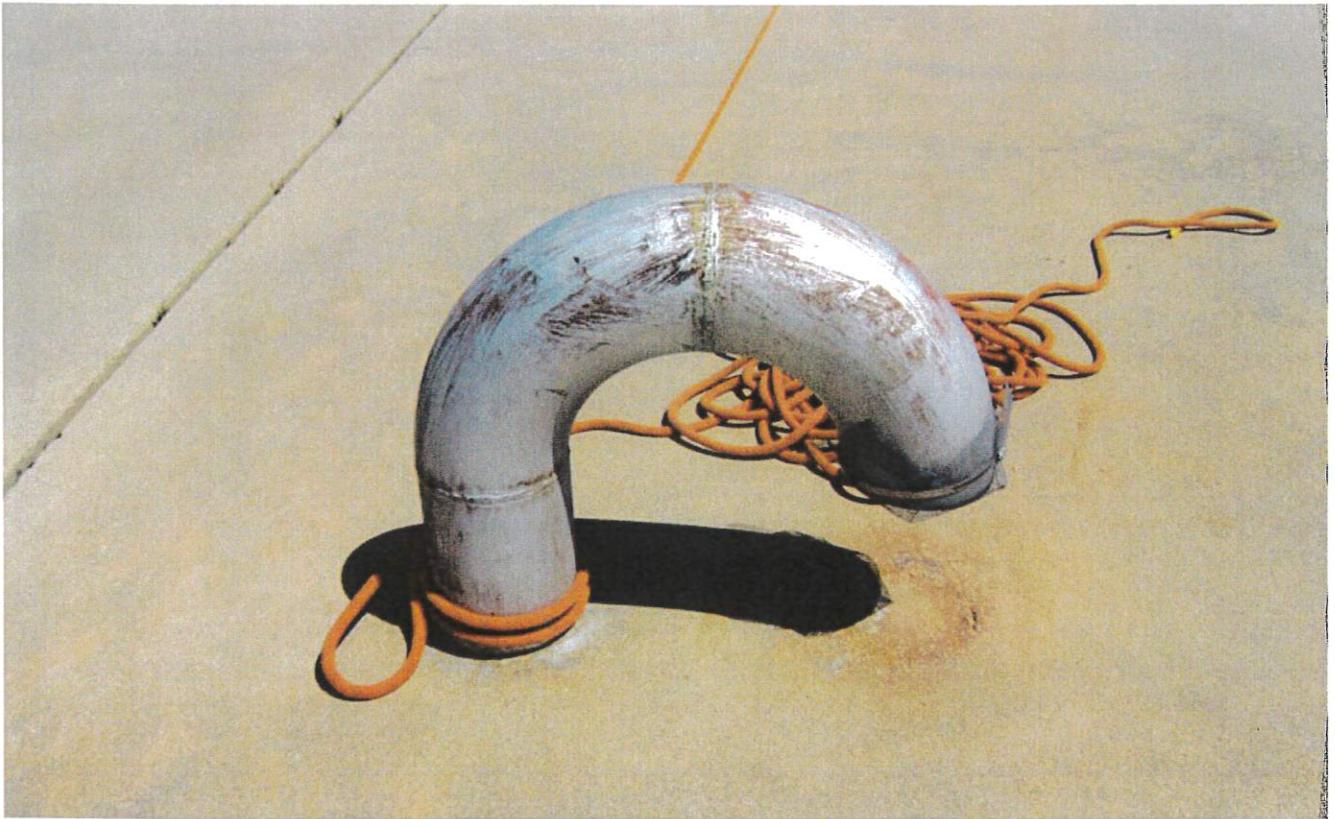
43. Gooseneck roof vent.

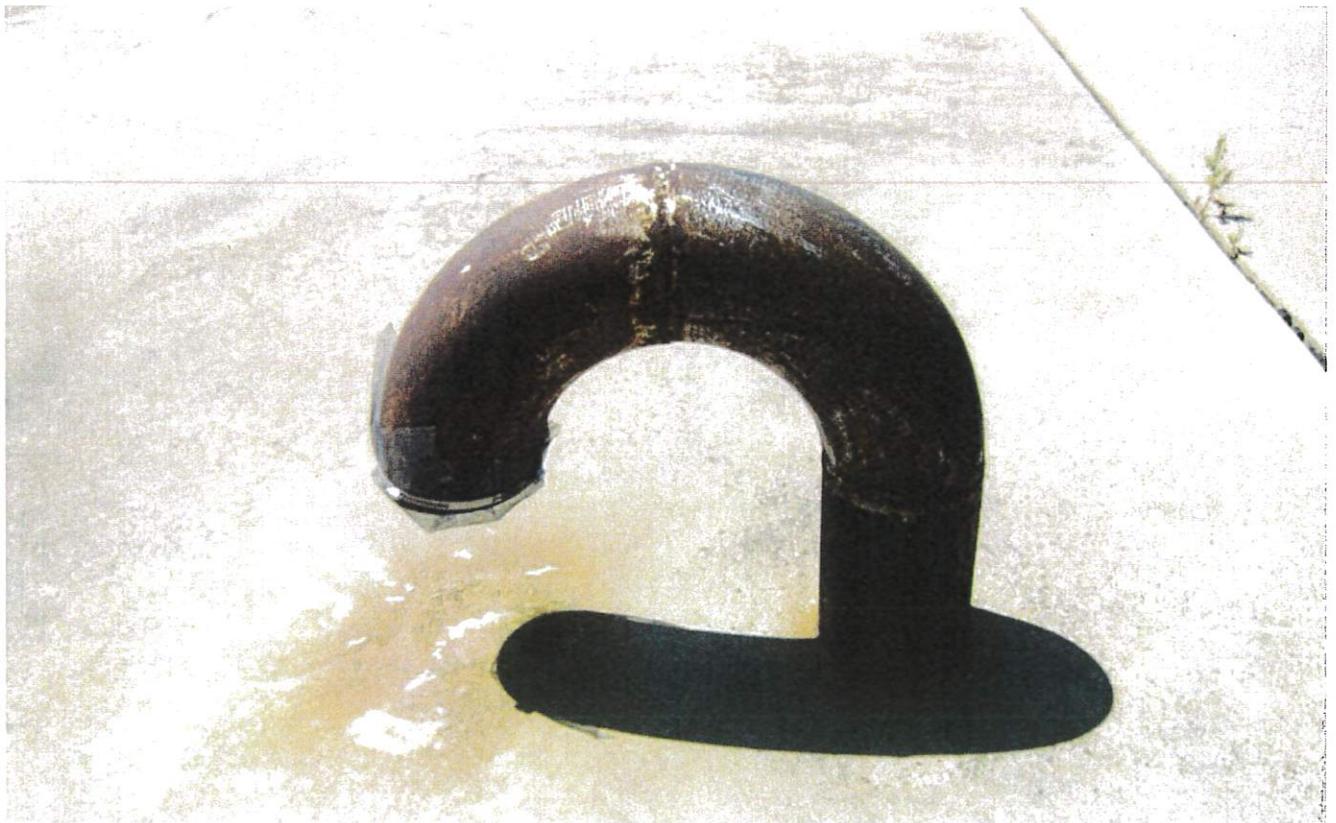
48. Gooseneck roof vent.

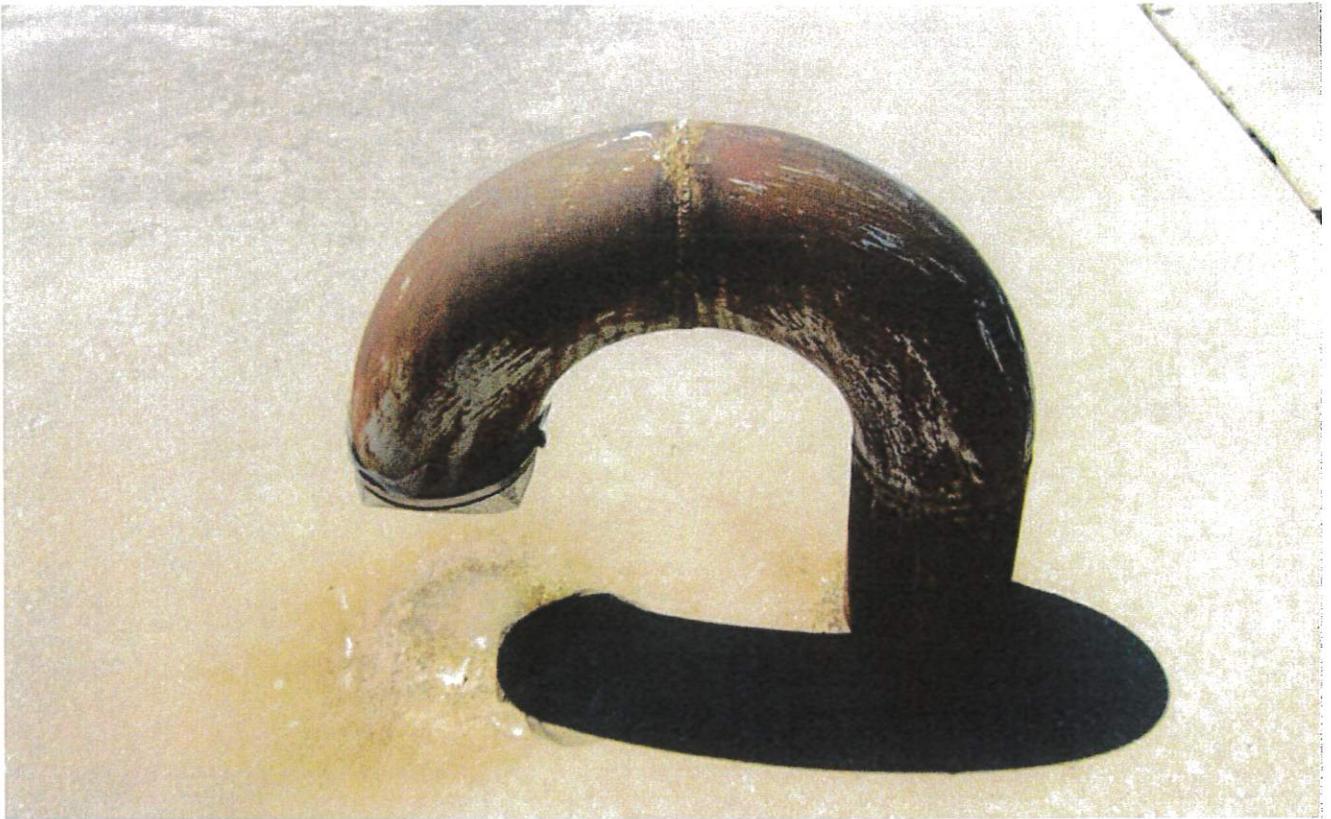
49. Gooseneck roof vent.

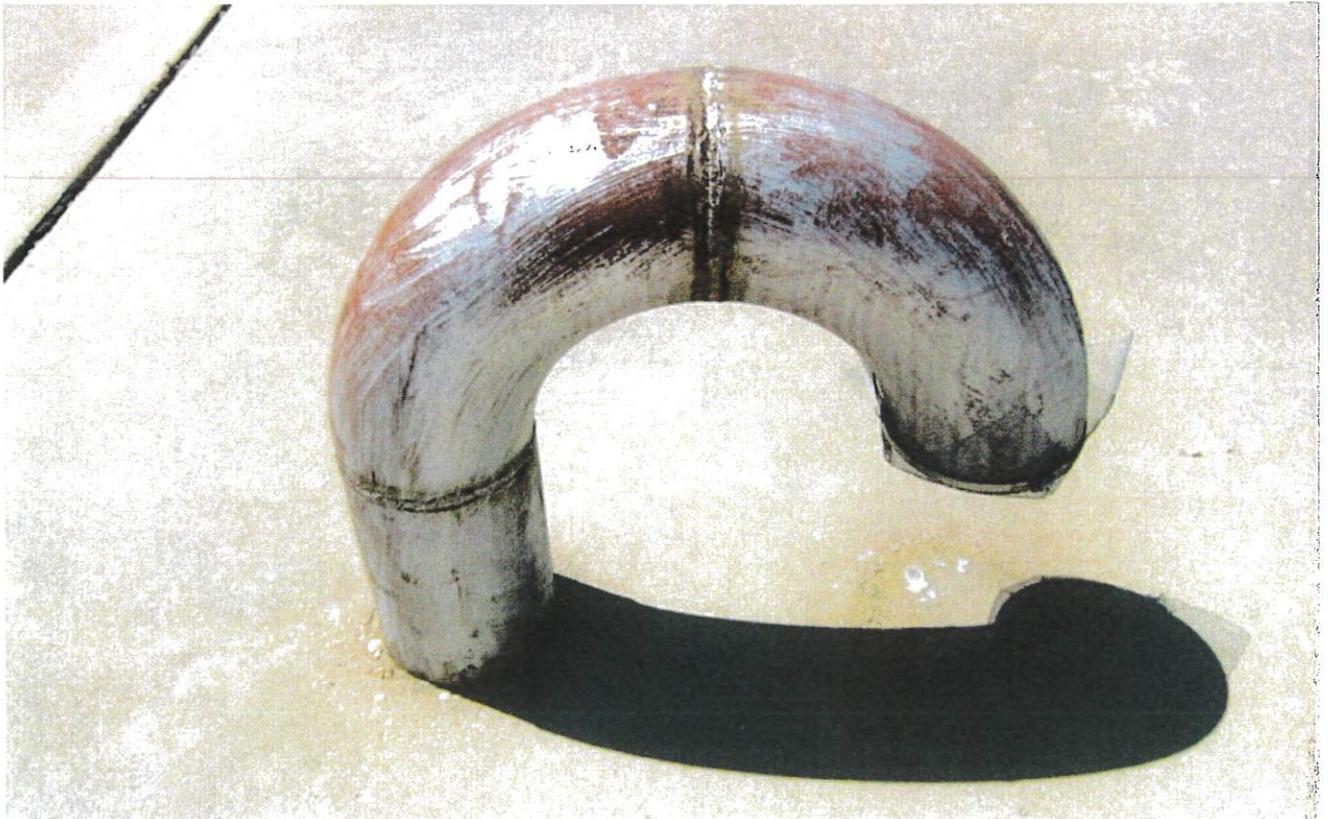
50. Gooseneck roof vent.

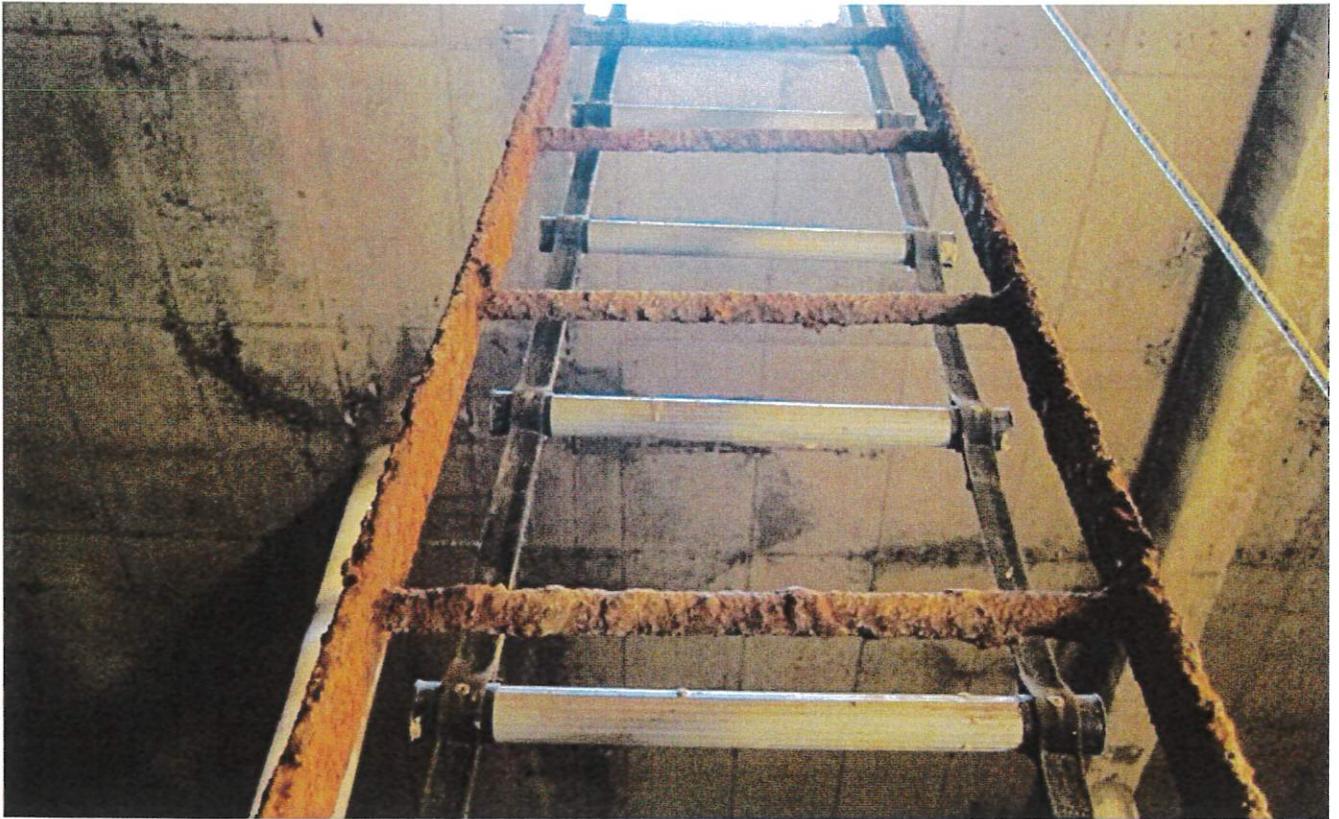
53. Corrosion and metal loss on interior ladder.

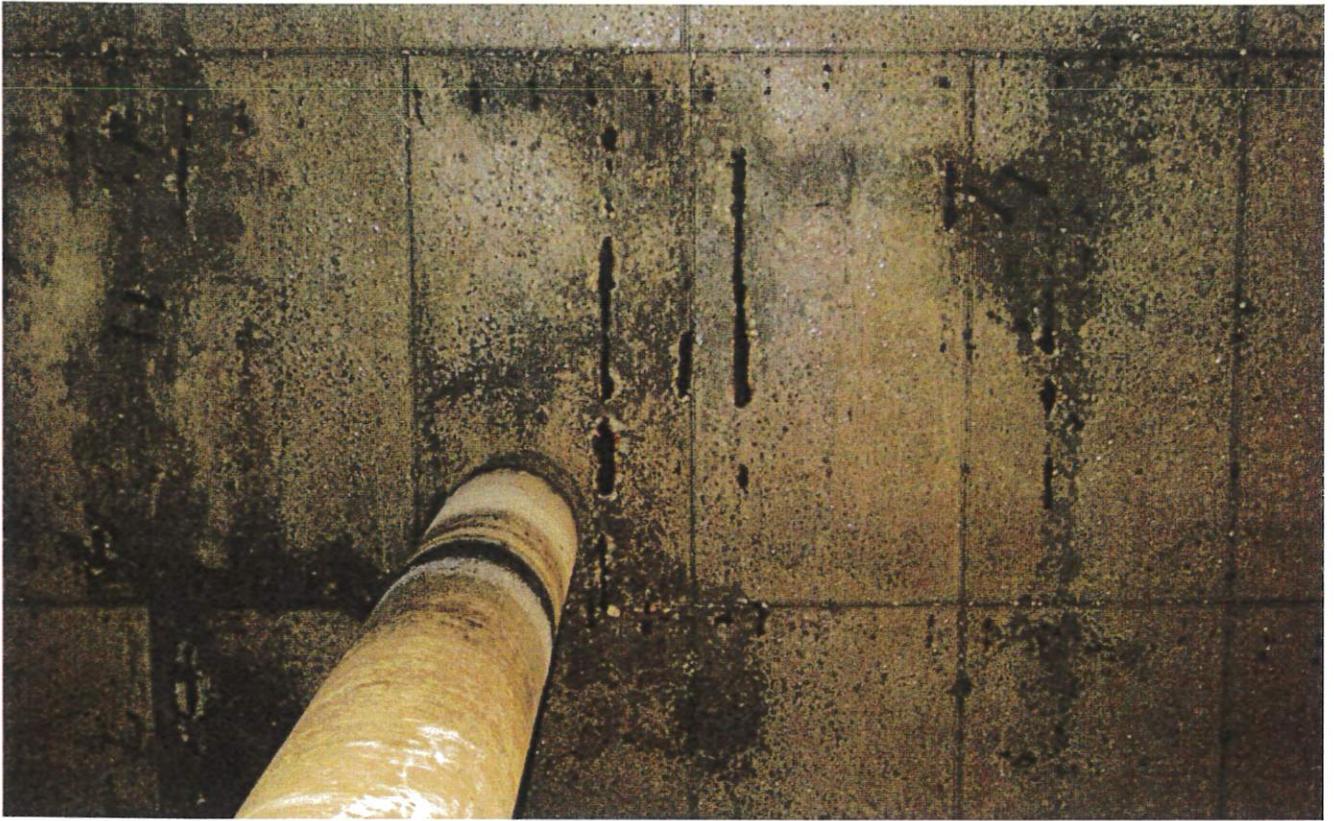
55. Exposed reinforcing bars in interior roof.

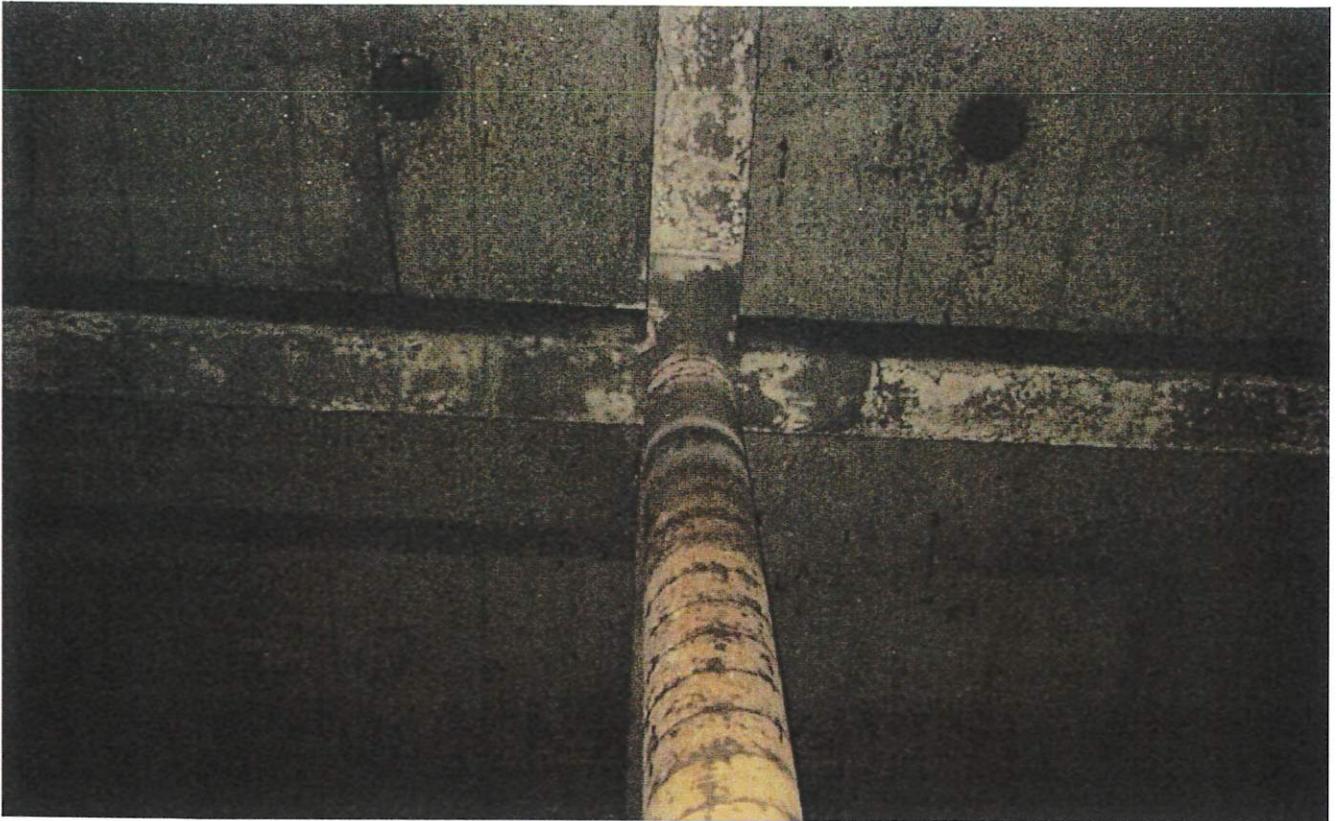
57. Interior roof, beams, and column.

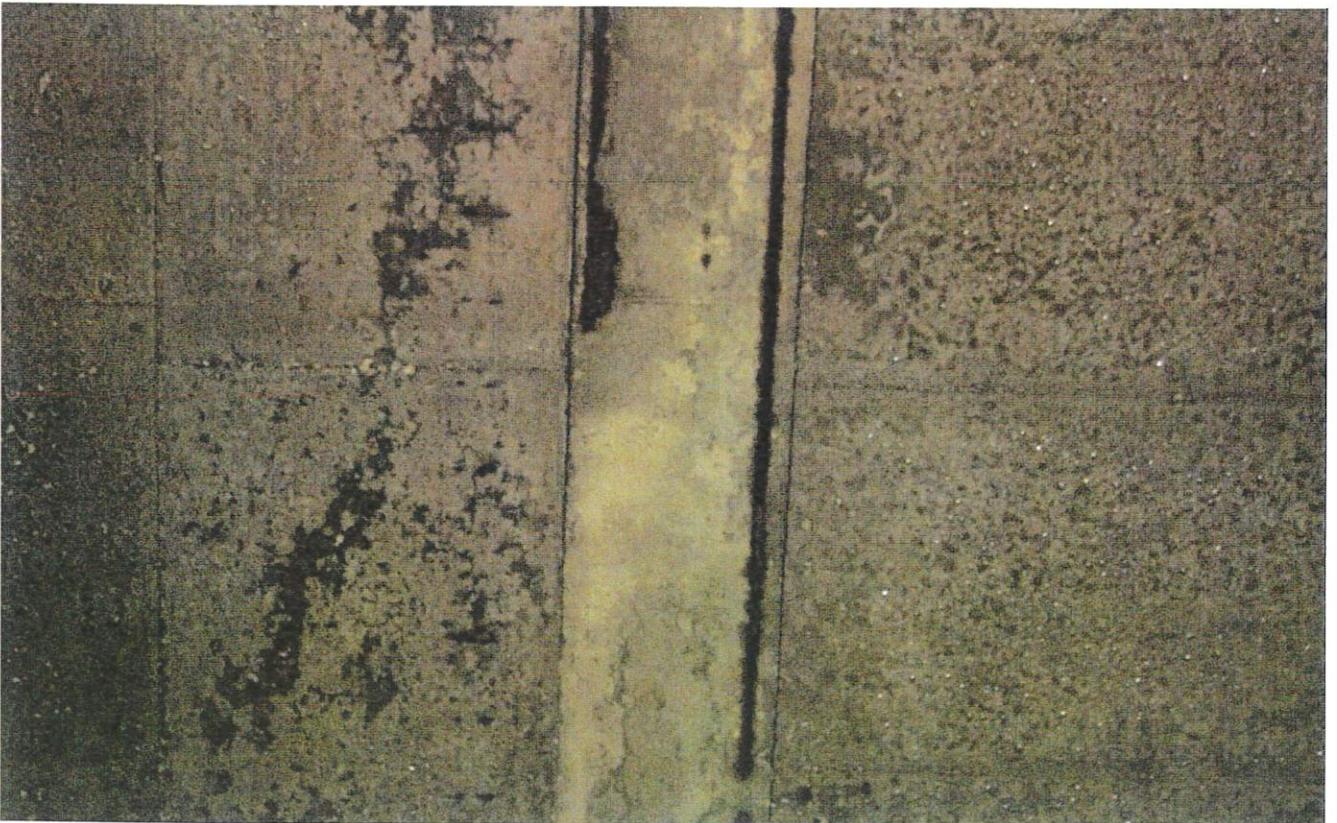
58. Interior roof beam.

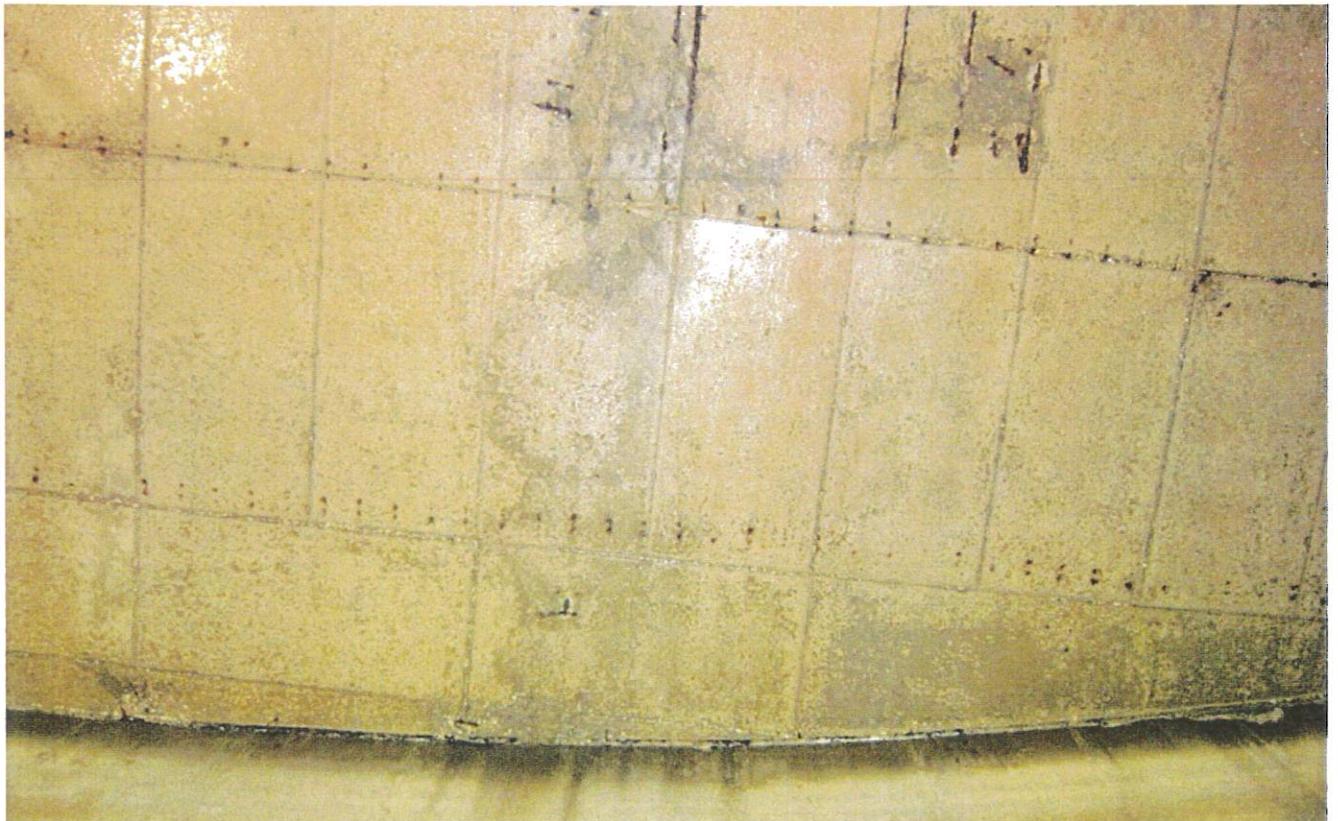
60. Exposed reinforcing bars and tie wires in interior roof.

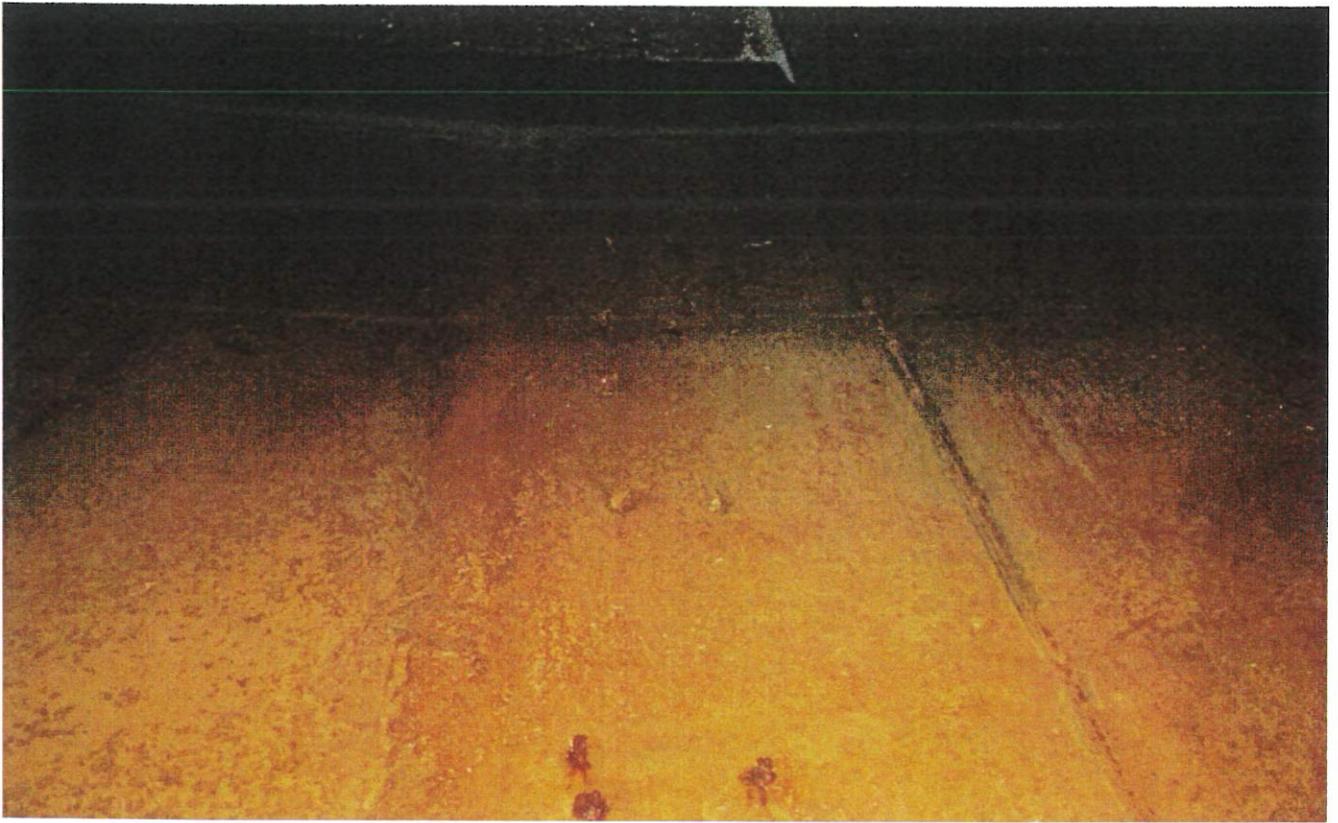
63. Interior shell.

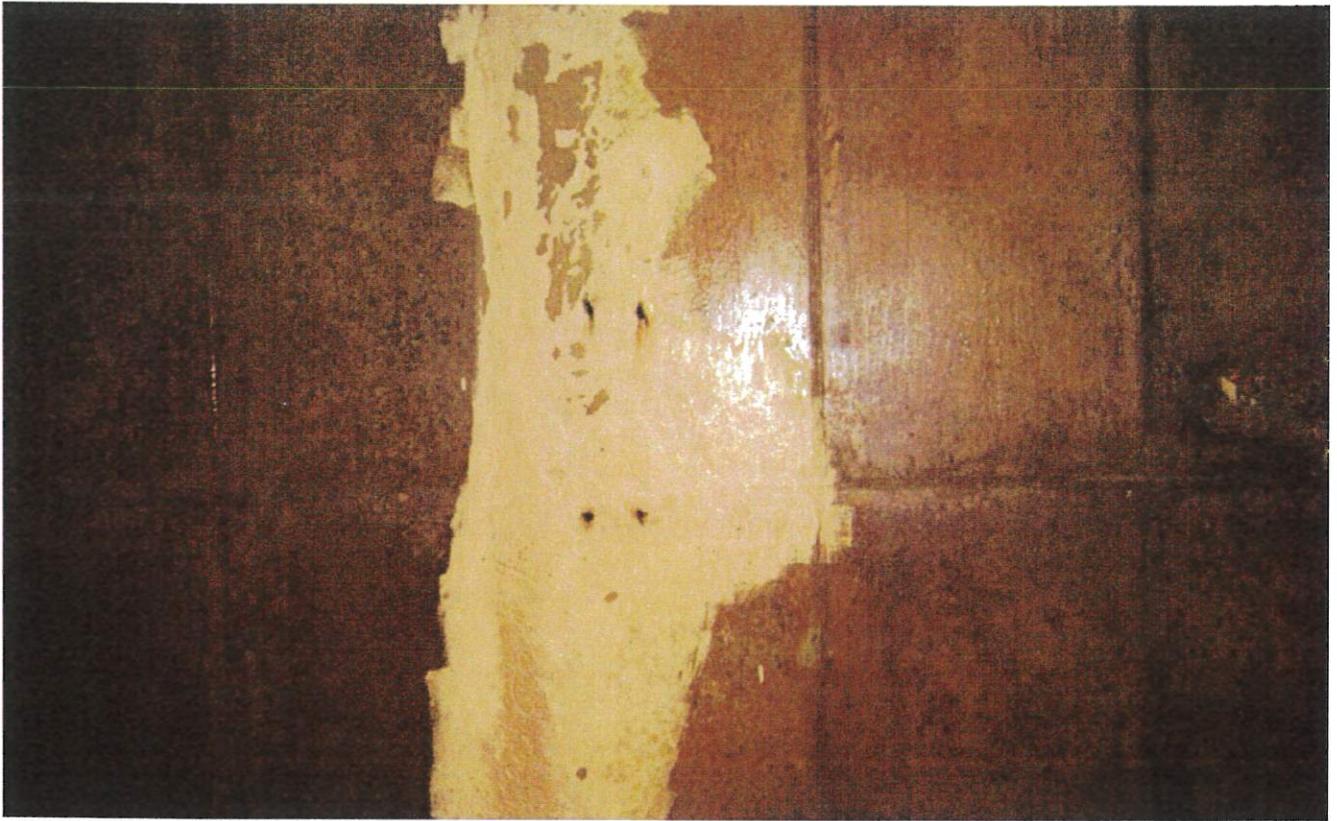
65. Interior shell.
