**EVALUATION OF THE
5,000,000 GALLON CONCRETE GROUND STORAGE TANK**

**“RESERVOIR NO. 2”
CARLSBAD, NEW MEXICO**

**SOUDER, MILLER & ASSOCIATES
ALBUQUERQUE, NEW MEXICO**

April 27 through May 5, 2016

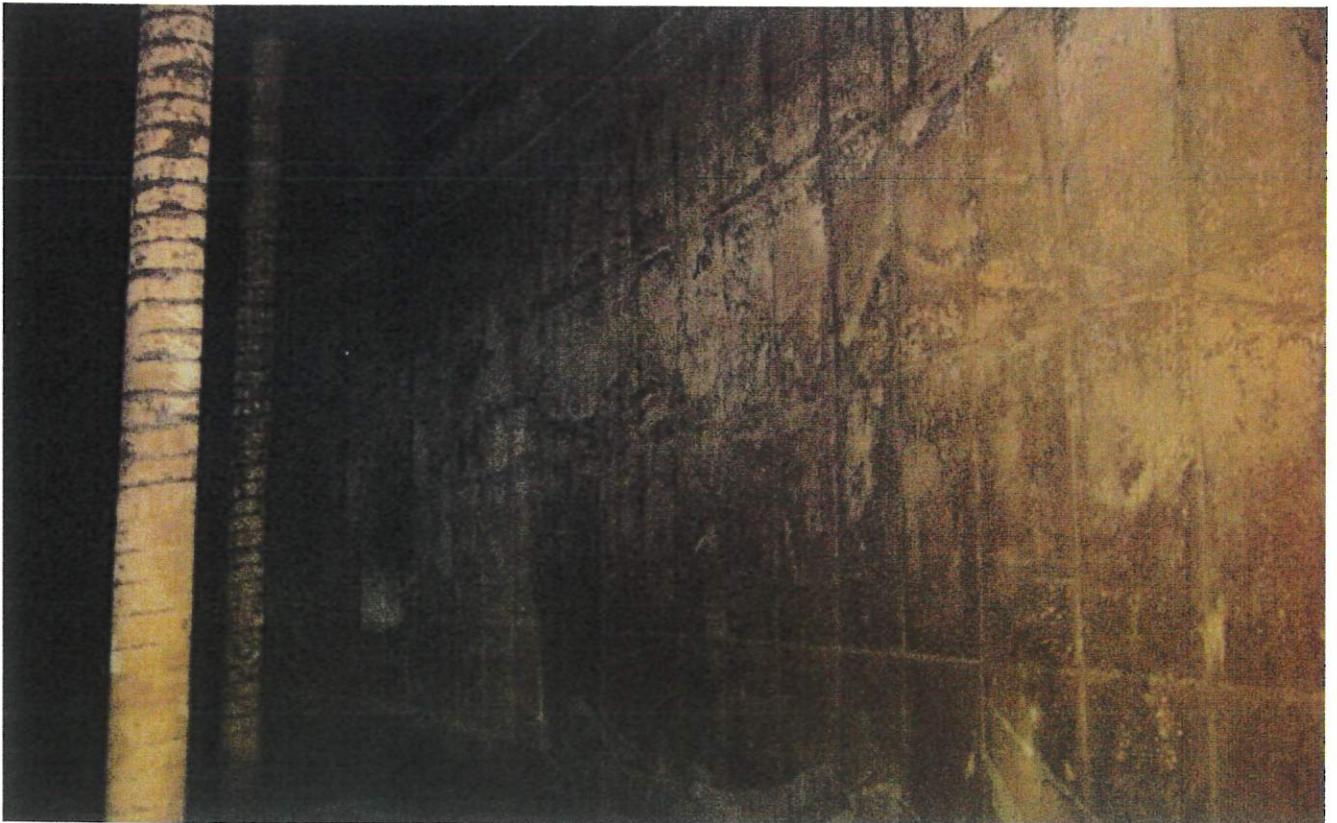
66. Interior shell and columns.

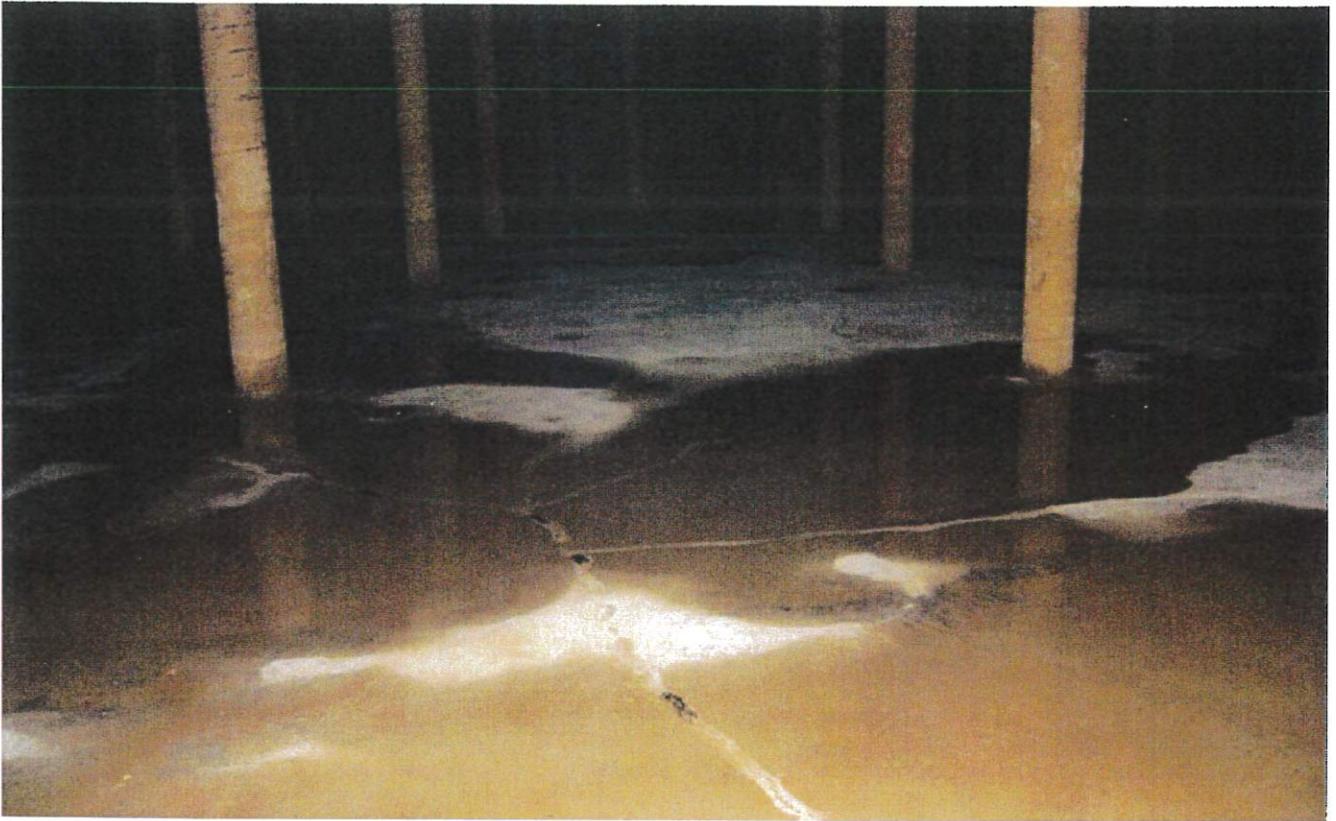
69. Interior floor and columns. Note cracking in floor.

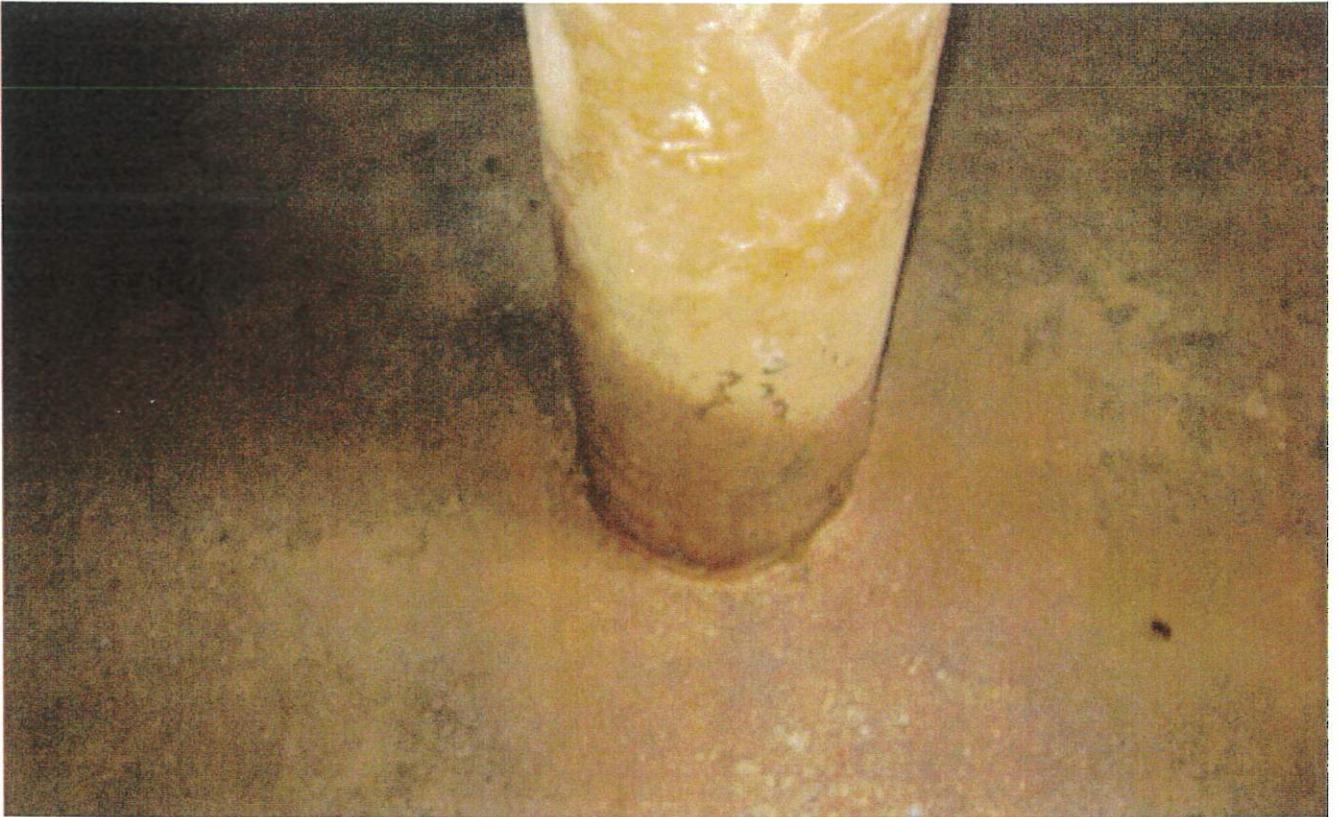
71. Interior floor and column.

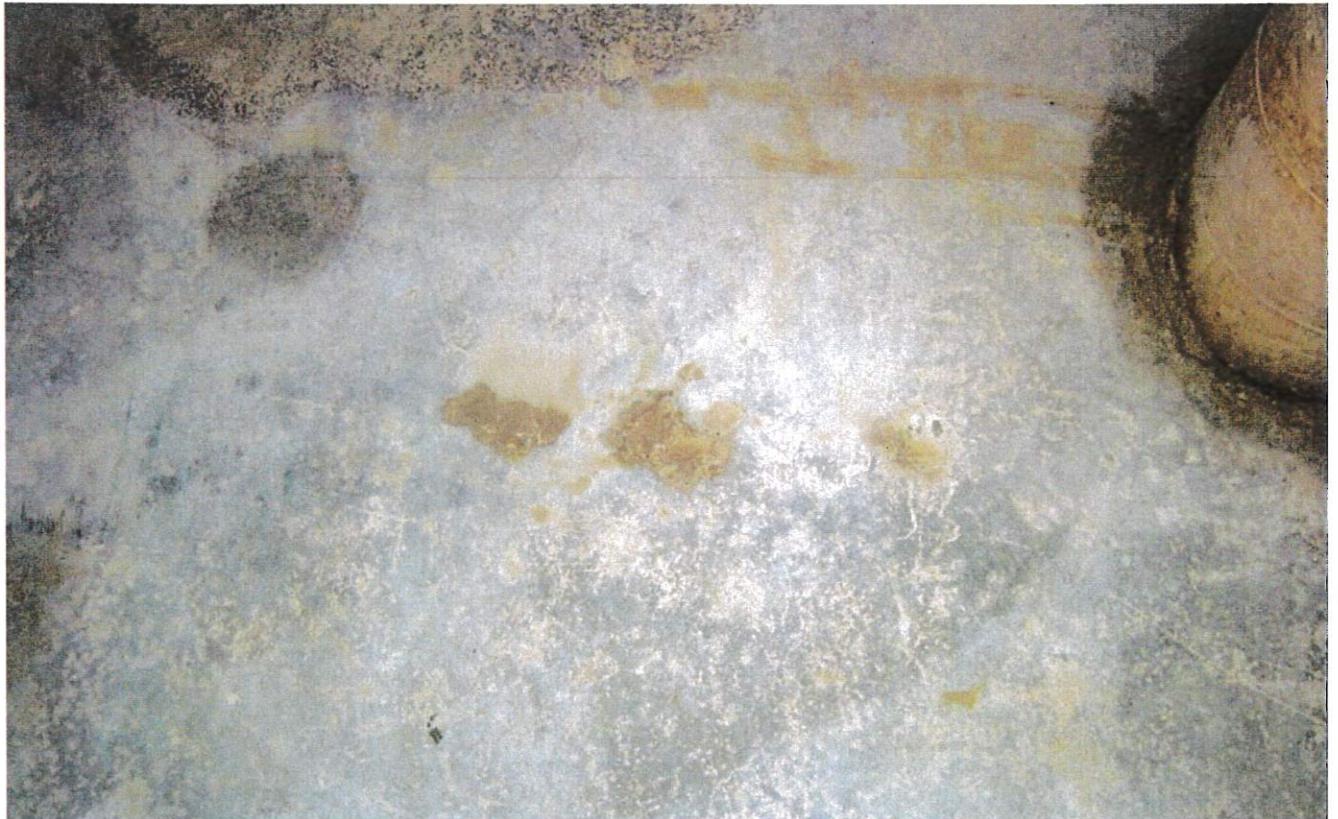
72. Interior floor.

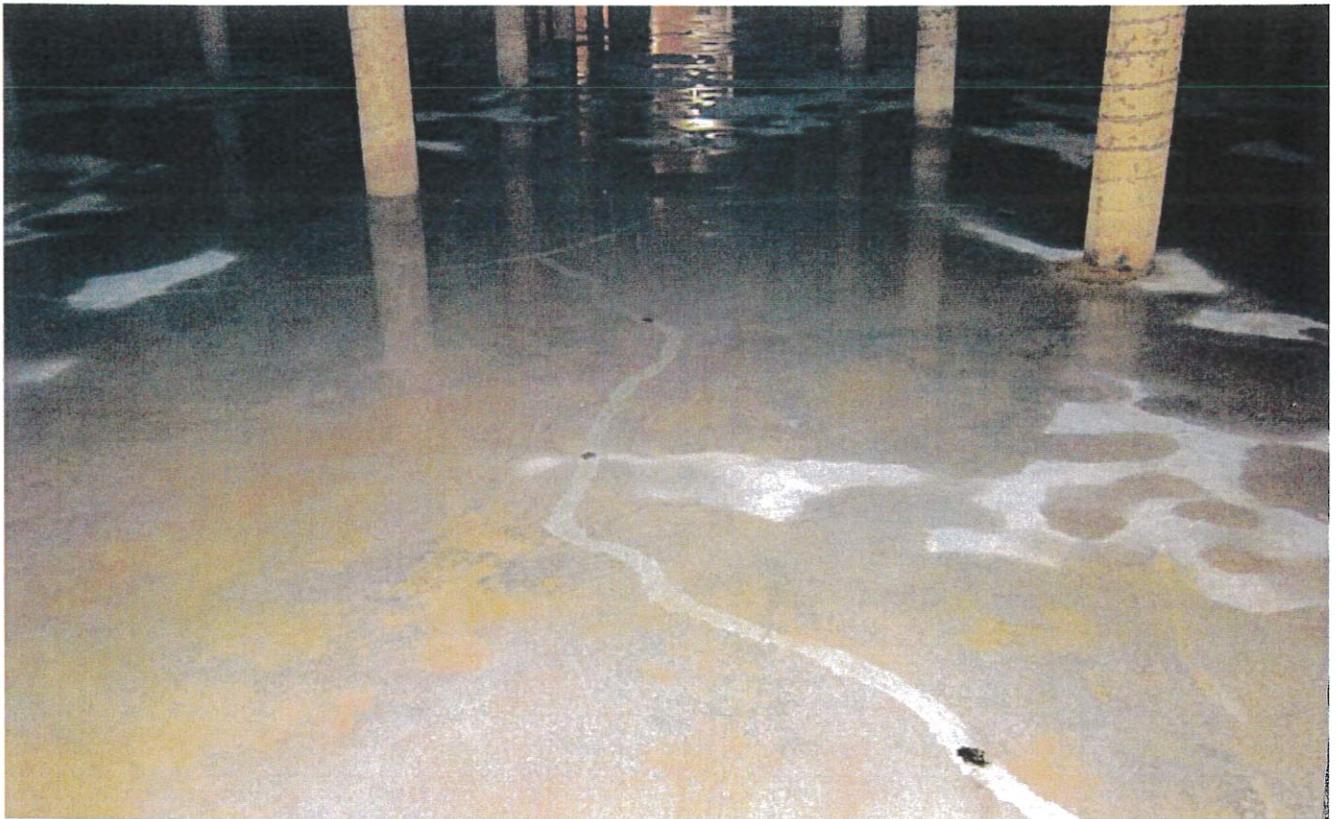
73. Interior floor.

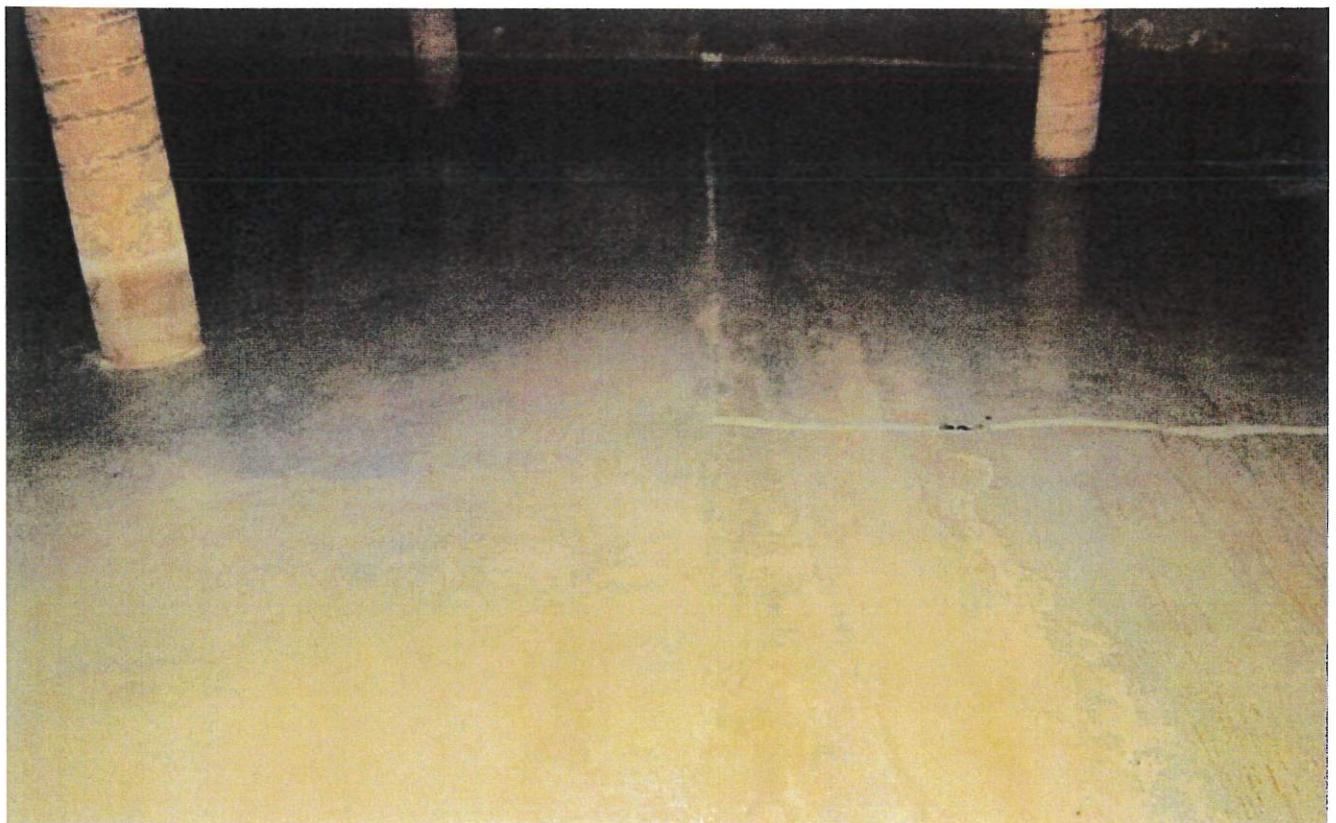
74. Interior floor.

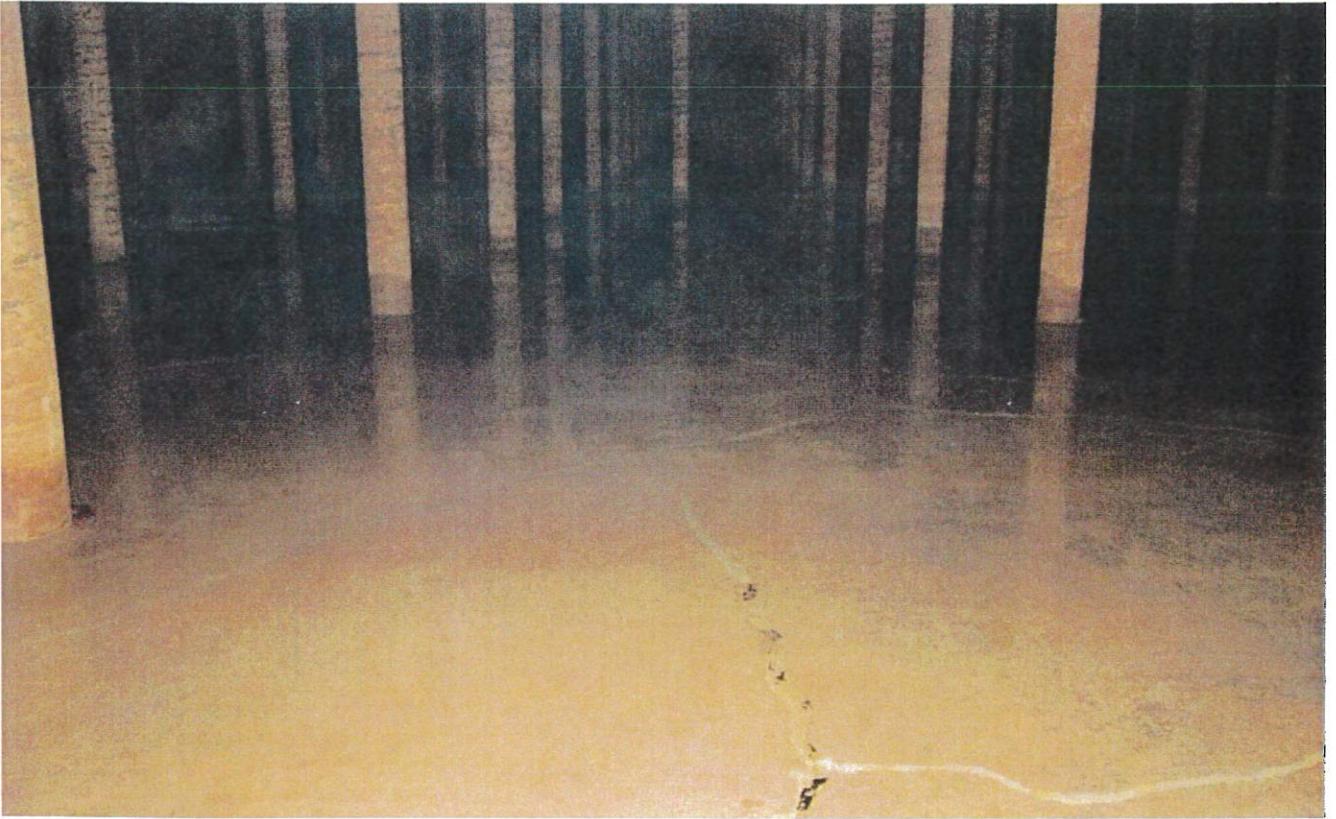
75. Interior floor.

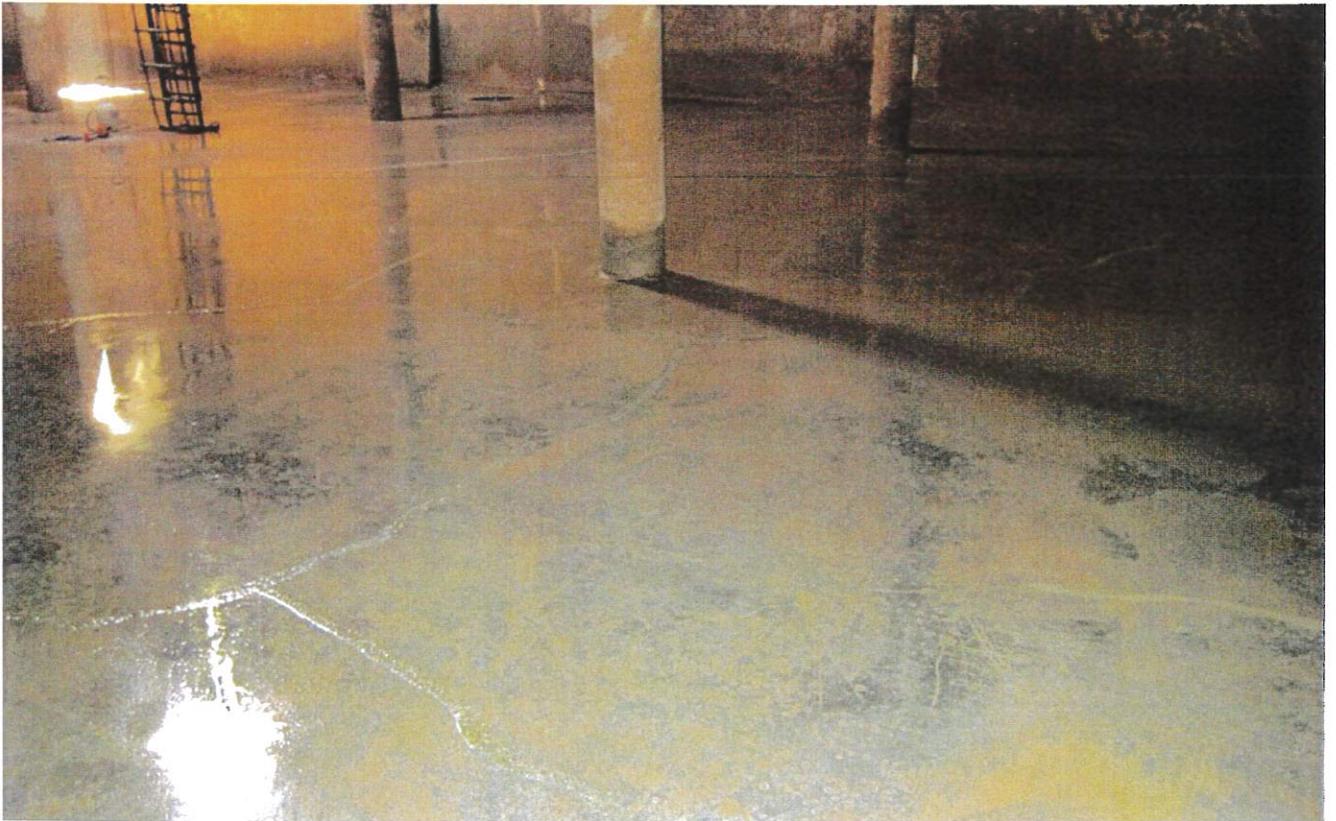
76. Interior floor.

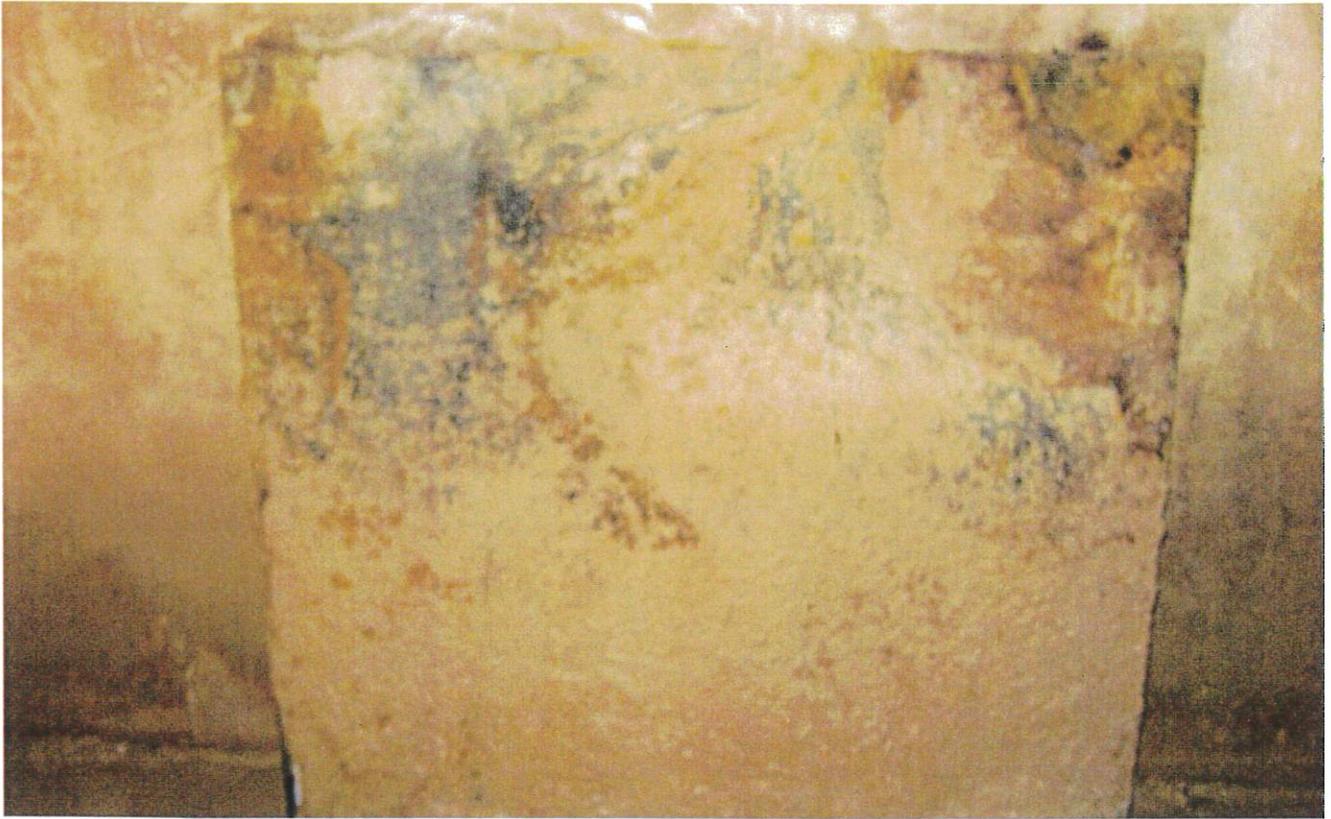
77. Abandoned tray located in tank.

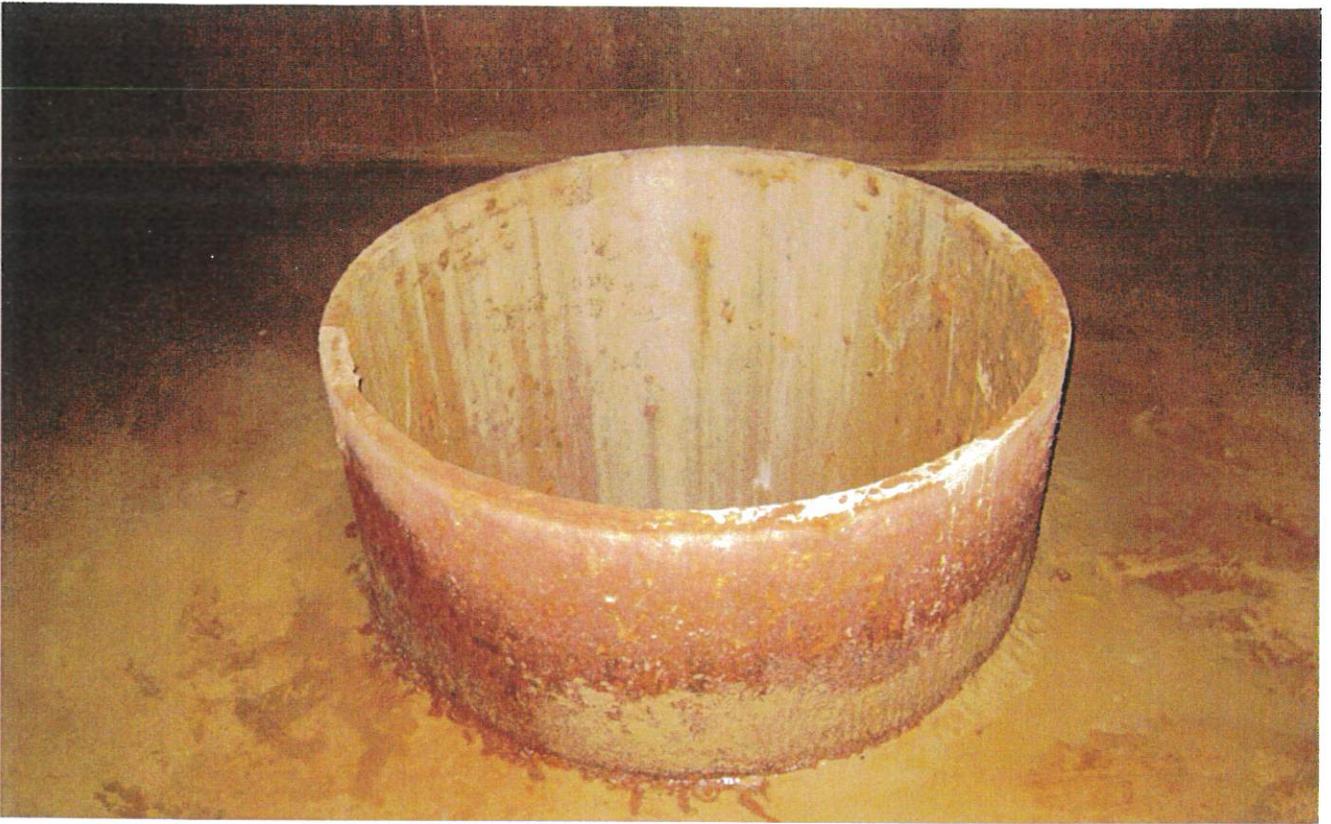
79. Outlet pipe in floor of tank.

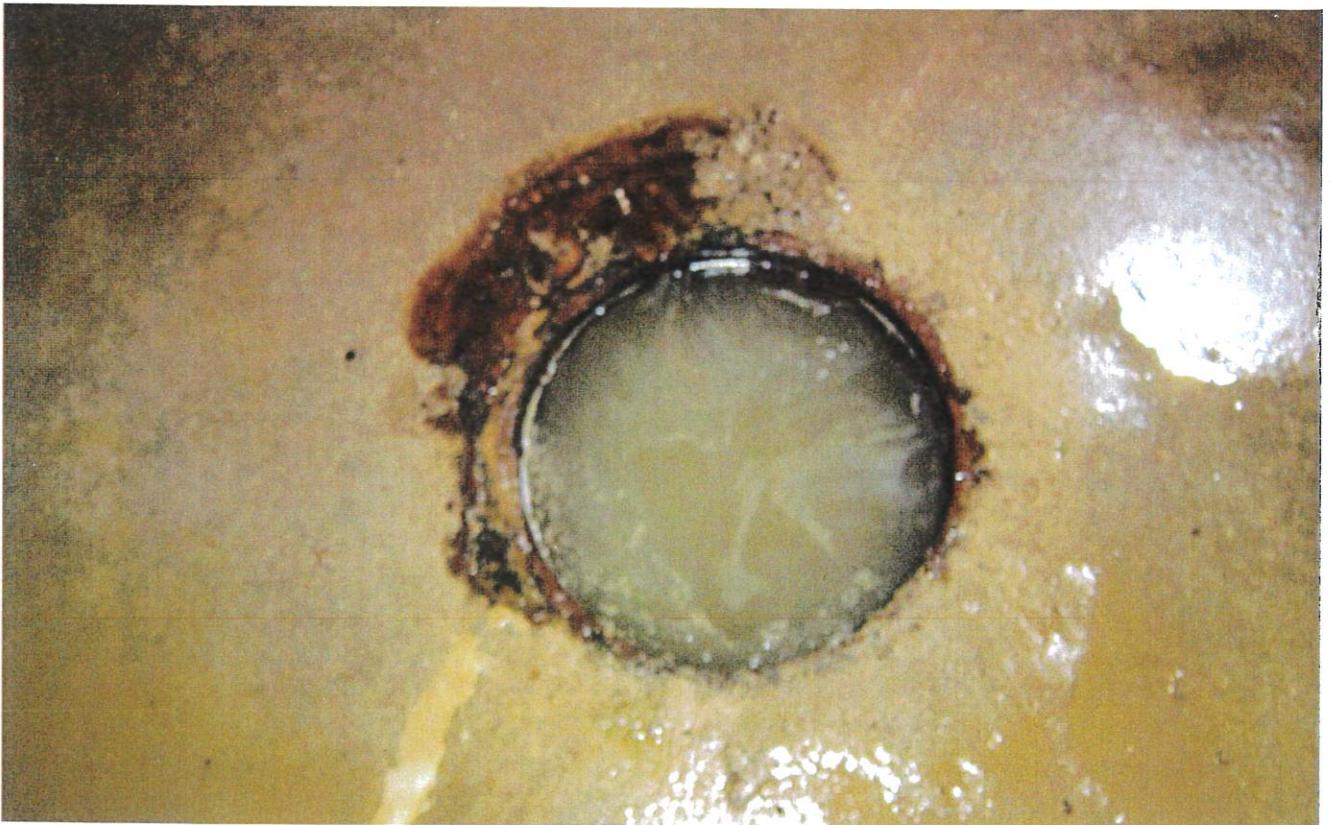
80. Overflow/drain pipe in floor of tank.
