**HAZARDOUS MATERIALS INSPECTION REPORT
OF THE
VIRGINIA HOSPITAL CENTER FACILITY
LOCATED AT
601 S. CARLIN SPRINGS ROAD
ARLINGTON, VIRGINIA**

AMA Job#: 19415
Contract #: 678-12
PO #: 273316

November 4, 2019

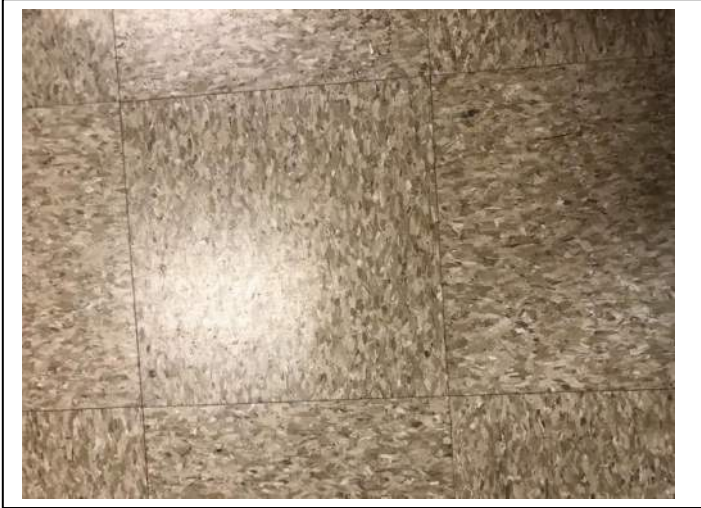
**Photo #5
Material: 12"x12" Tan Mottled Floor Tile
Sample Result: No Asbestos Detected**

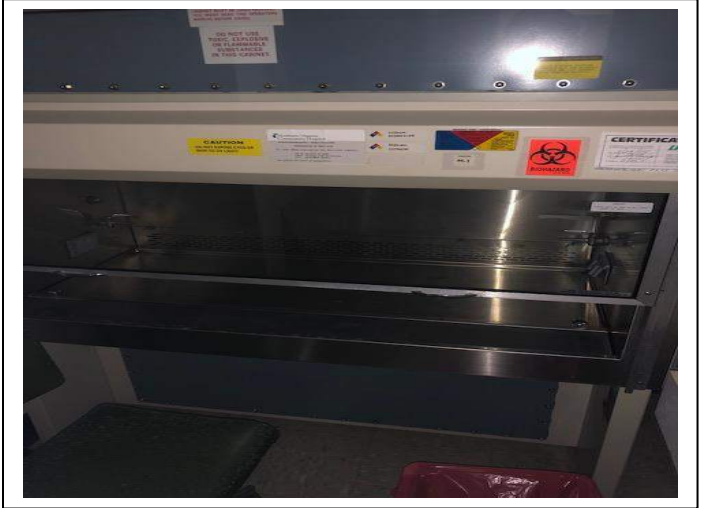
**Photo #6
Material: Transite Fume Hood
Sample Result: Not Sampled**

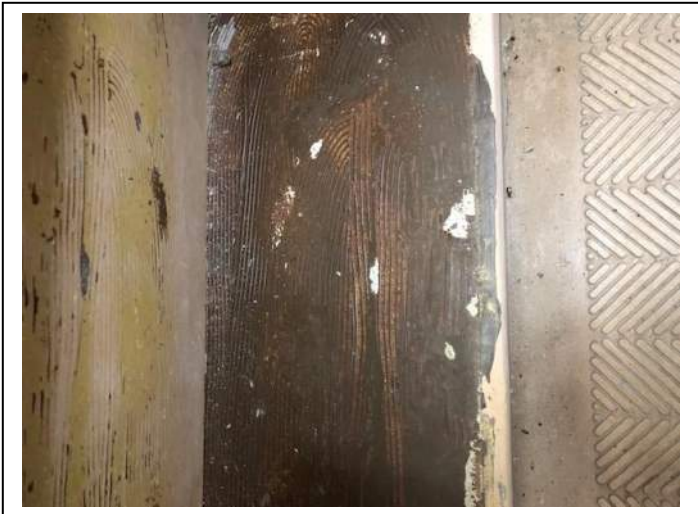
**Photo #11
Material: Sample Result: Brown Stair Tread
Mastic
Sample Result: No Asbestos Detected**

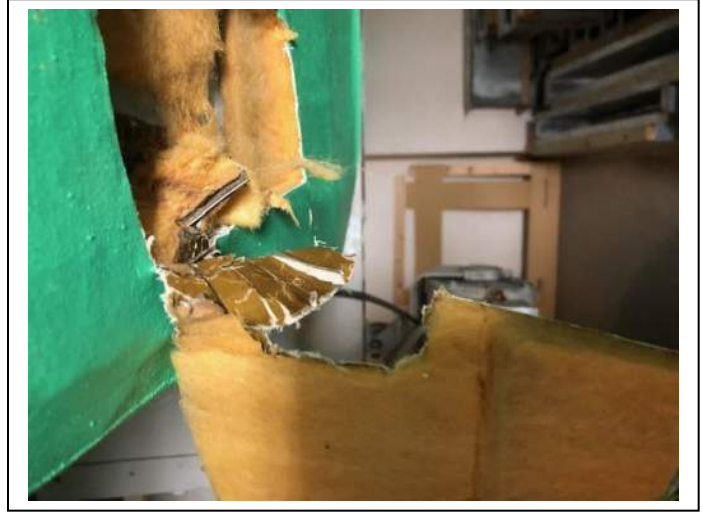
**Photo #18
Material: Green Canvas Duct
Sample Result: No Asbestos Detected**

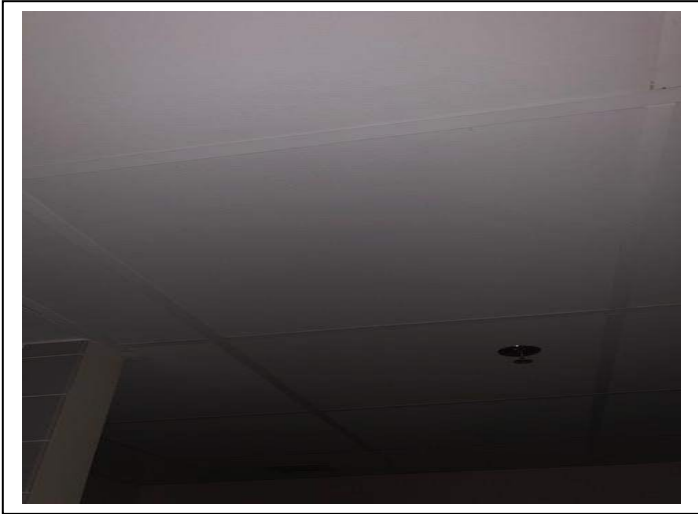
**Photo #21
Material: 2'x4' Smooth Ceiling Tile
Sample Result: No Asbestos Detected**

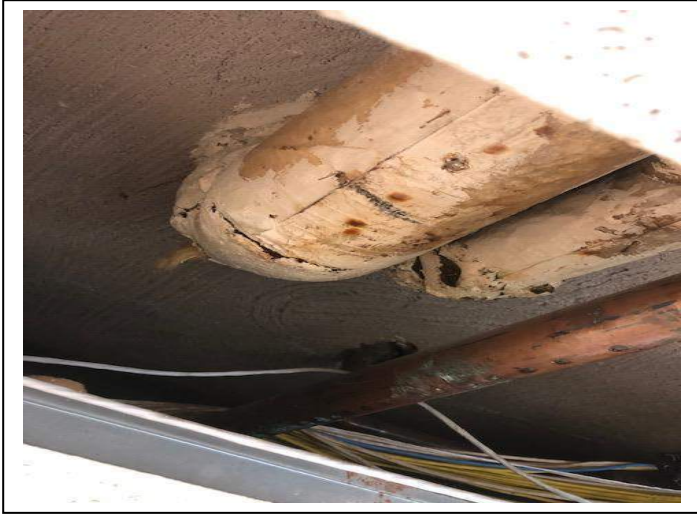
**Photo # 25
Material: Muddied Fitting
Sample Result: 5% Chrysotile**

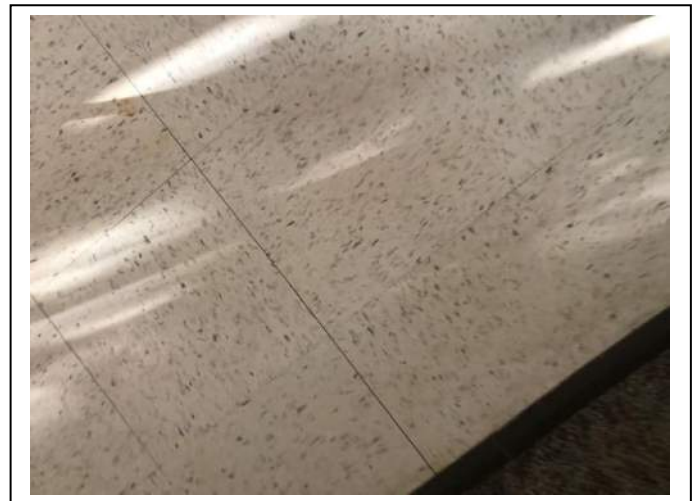
**Photo #28
Material: 12"x12" White With Black Specks
Floor Tile
Sample Result: No Asbestos Detected**

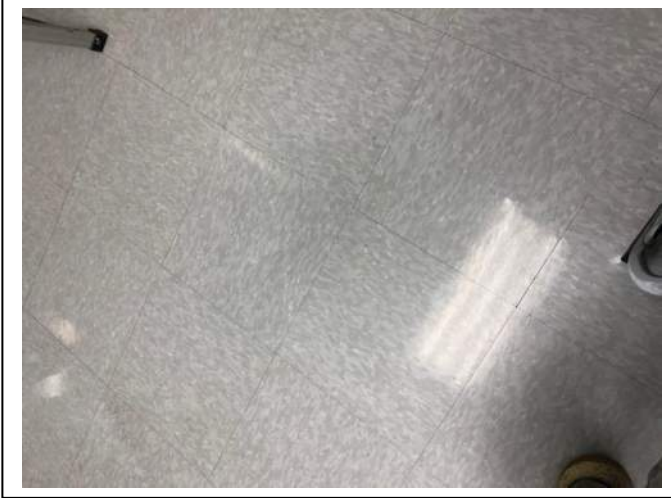
**Photo #29
Material: 12"x12" Gray Mottled Floor Tile
Sample Result: No Asbestos Detected**

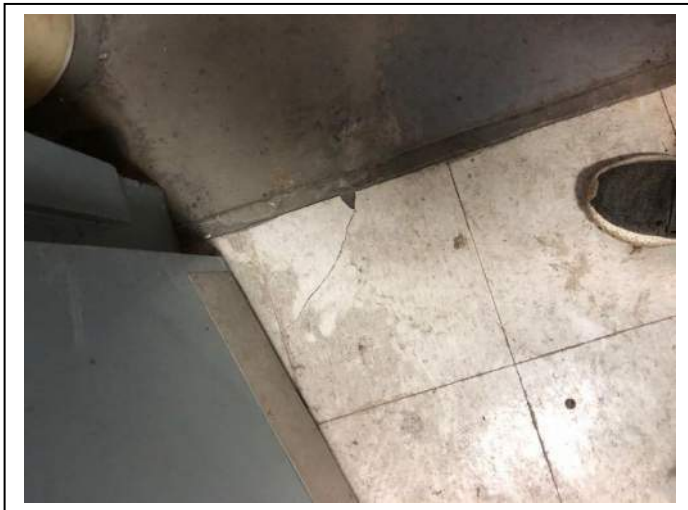
**Photo #35
Material: 12"x12" White Floor Tile
Sample Result: No Asbestos Detected**

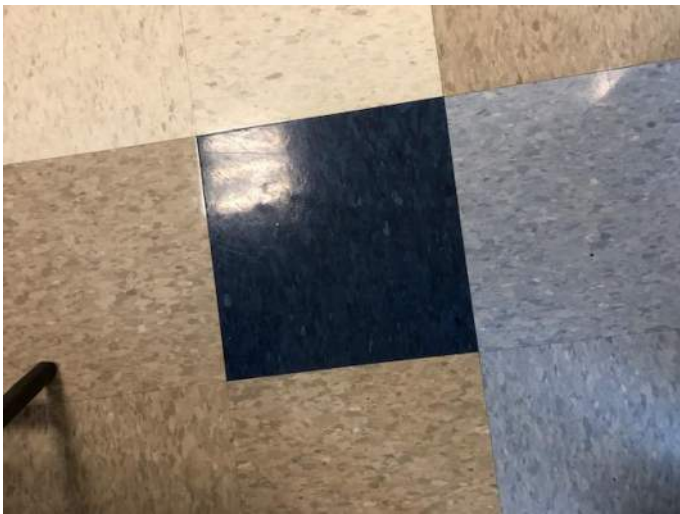
**Photo #71
Material: 12"x12" Dark Blue Mottled
Sample Result: No Asbestos Detected**
