EXHIBIT "C"

COMPREHENSIVE ASBESTOS SURVEYS

COMPREHENSIVE ASBESTOS SURVEY

**COMMERCIAL BUILDING
1240 YEAMANS HALL ROAD
HANAHAN, SC 29410**

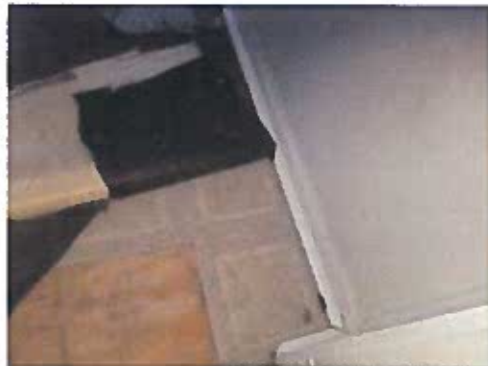
**HOMOGENEOUS AREA 23
VINYL SHEET FLOORING
(DARK WOOD)**

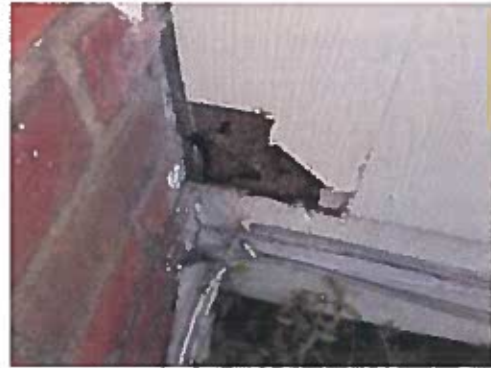
**HOMOGENEOUS AREA 02
SIDING FELT**

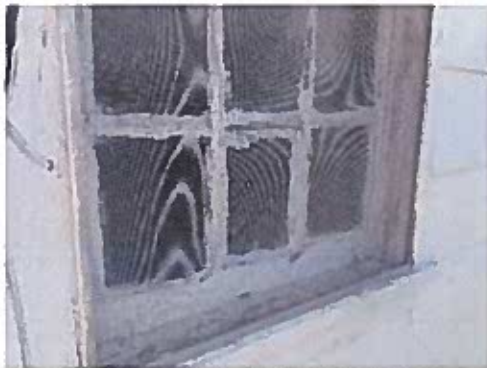
**HOMOGENEOUS AREA 03
WINDOW GLAZING**

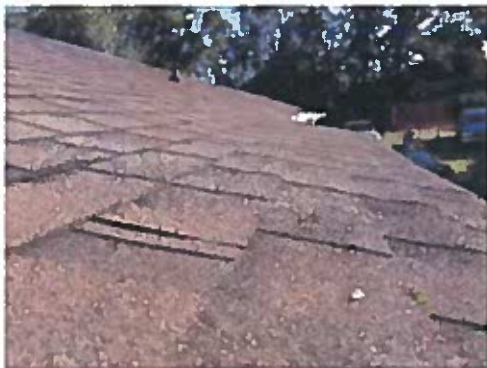
**HOMOGENEOUS AREA 05
ROOF SHINGLE**

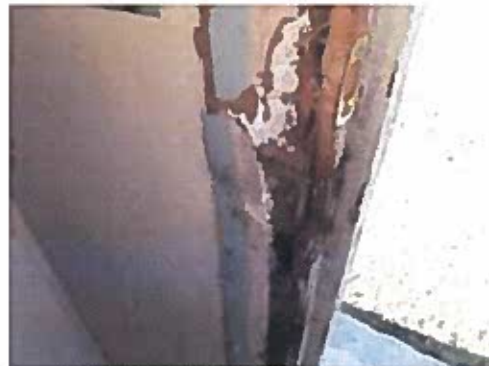
**HOMOGENEOUS AREA 10
JOINT COMPOUND**

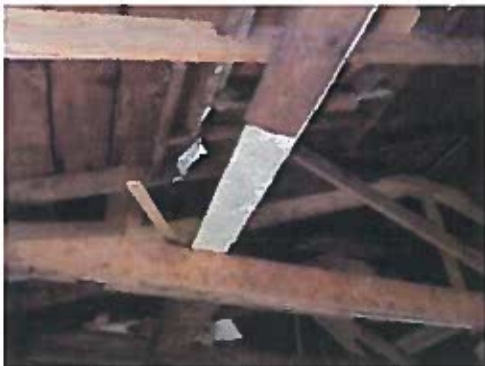
**HOMOGENEOUS AREA 11
CEILING PANEL**

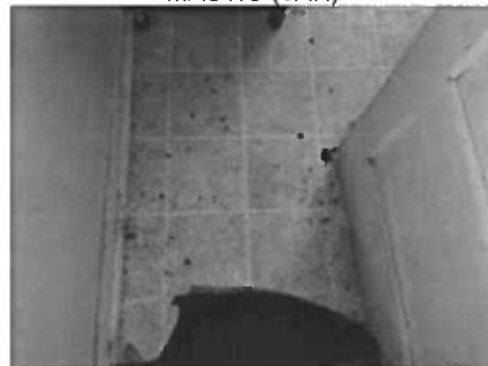
**HOMOGENEOUS AREA 20
VINYL SHEET FLOORING
(9" BEIGE SQUARES)**

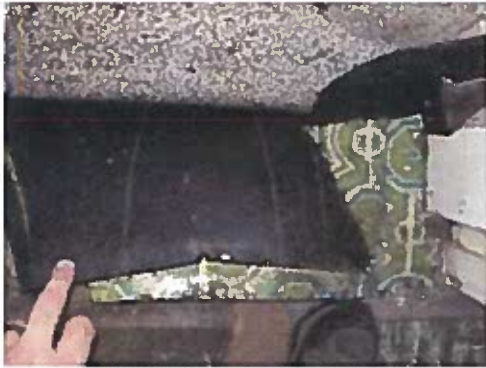
**HOMOGENEOUS AREA 21
FLOOR FELT PAPER**

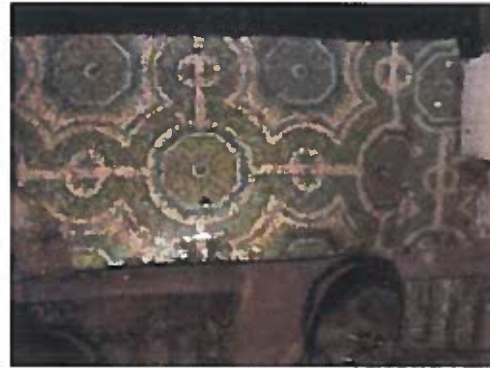
**HOMOGENEOUS AREA 22
VINYL SHEET FLOORING
(GREEN/BEIGE SQUARES)**

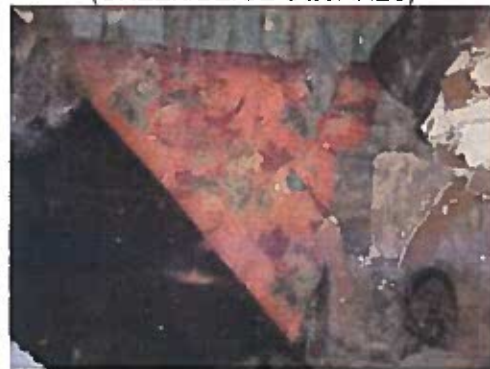
**HOMOGENEOUS AREA 24
VINYL SHEET FLOORING (RED FLOWER)**

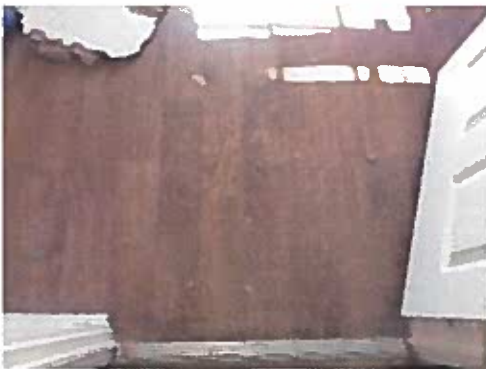
**HOMOGENEOUS AREA 25
VINYL SHEET FLOORING (WOOD)**

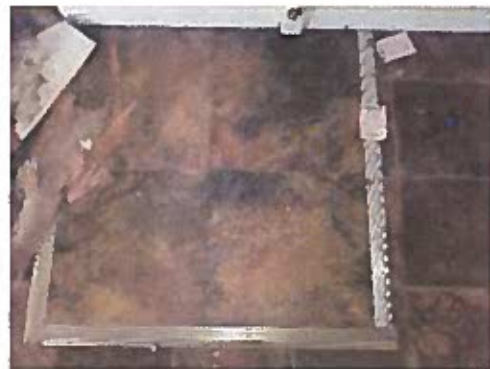
**HOMOGENEOUS AREA 26
12" SELF-STICK TILE (DARK SLATE)**

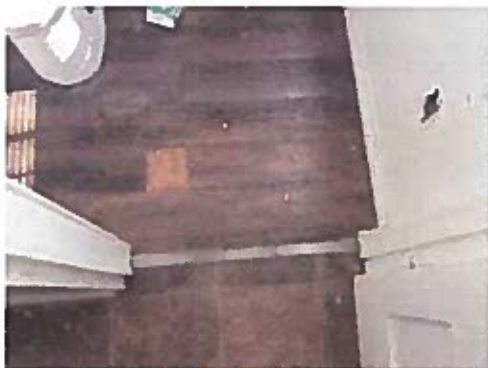
**HOMOGENEOUS AREA 27
VINYL FLOOR PLANKS (DARK WOOD)**

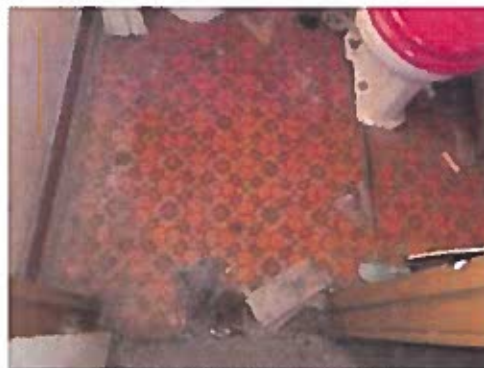
**HOMOGENEOUS AREA 28
VINYL SHEET FLOORING (RED/ORANGE)**
