ASBESTOS INSPECTION REPORT

70 Foxfire Court

Asbestos Inspections, LLC Project # 2023-01-344

Inspection Completed On – September 14, 2023
Report Prepared On – October 4, 2023

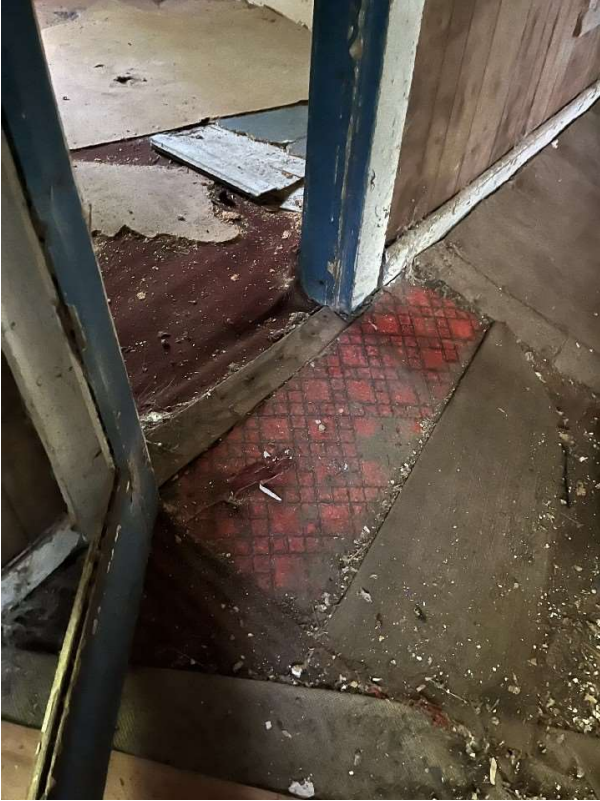
Interior Flooring

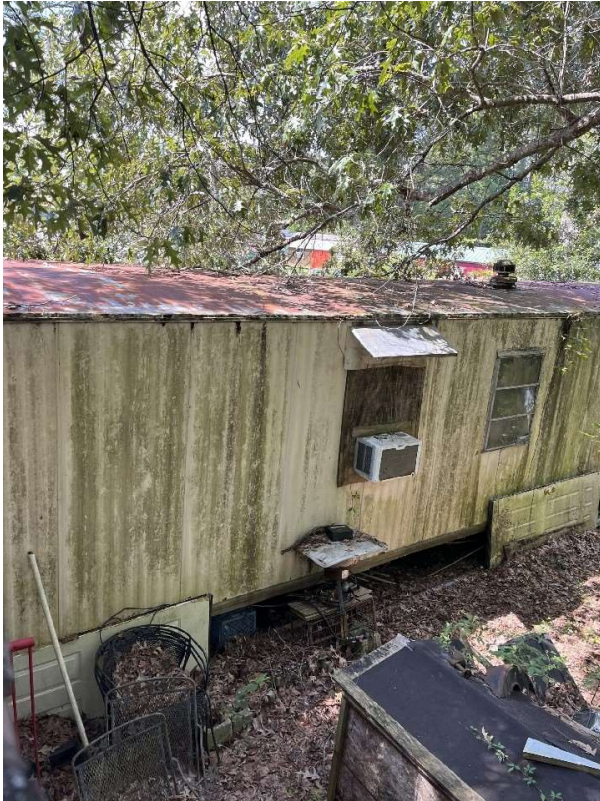
Exterior Mobile Home Roof

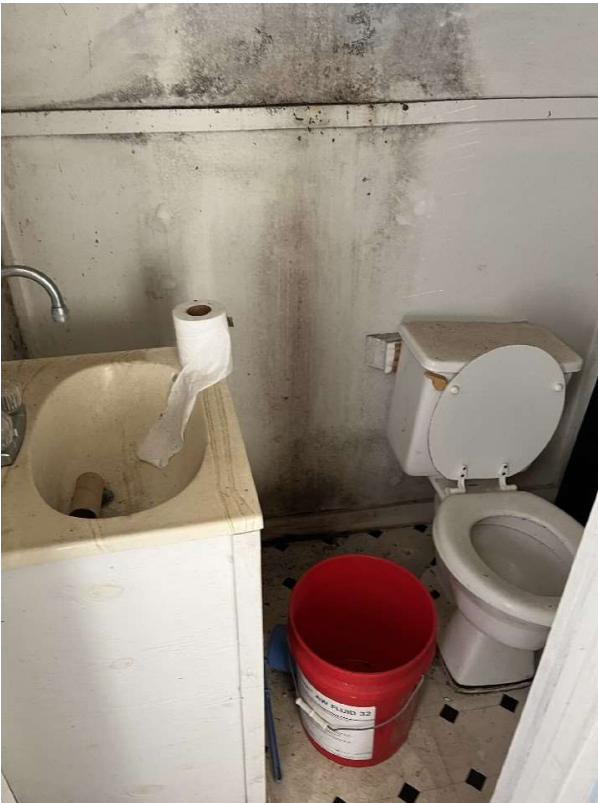
Bathroom Addition

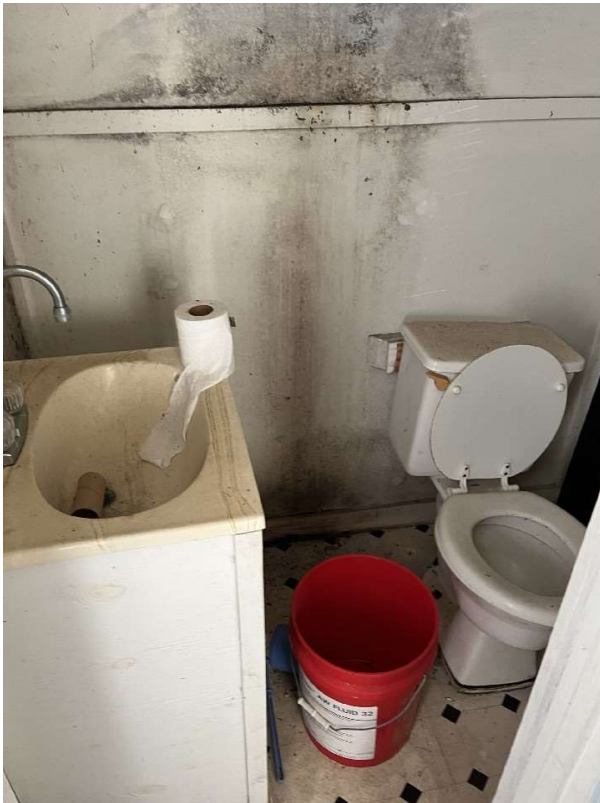
Bathroom Addition

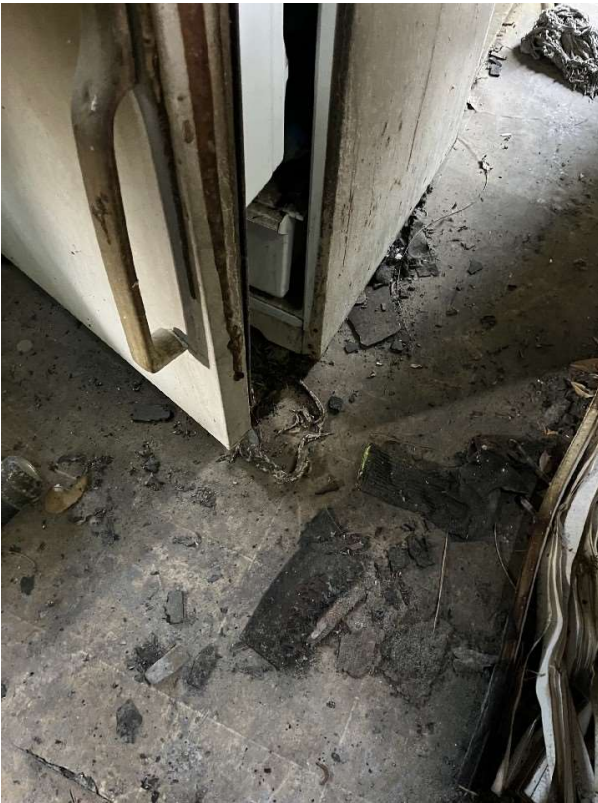
Interior Kitchen Showing Sheet Floor
