ENVIRONMENTAL SERVICE GROUP JOB # AS-1906

ASBESTOS INSPECTION REPORT

COMMERCIAL PROPERTY

**507 9TH AVE. NORTH
MYRTLE BEACH, SC**

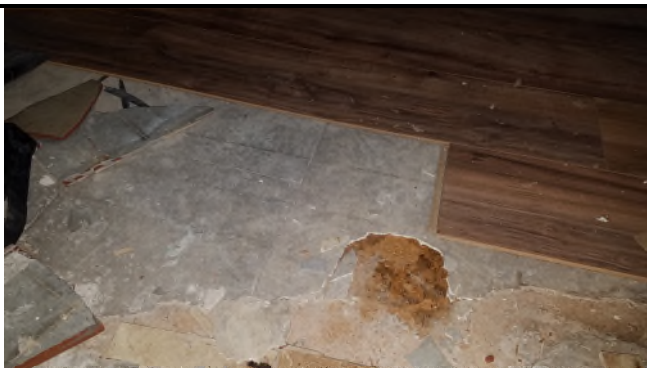
Picture 23 – *HA1 12x12 Floor Tiles w/Mastic (underneath Laminate Flooring)

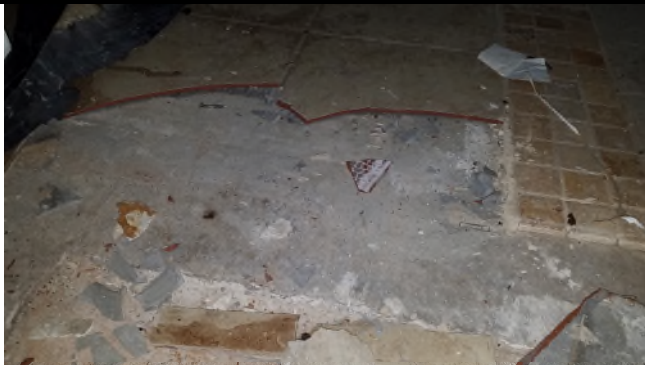
Picture 25 – *HA1 12x12 Floor Tiles w/Mastic
(underneath Ceramic Tile)

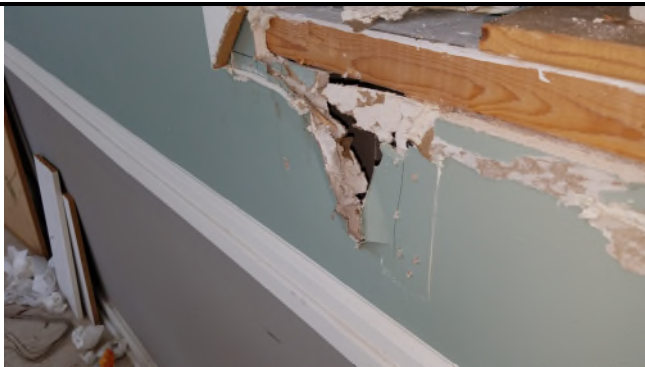
Picture 27 – *HA20 Sheetrock Walls

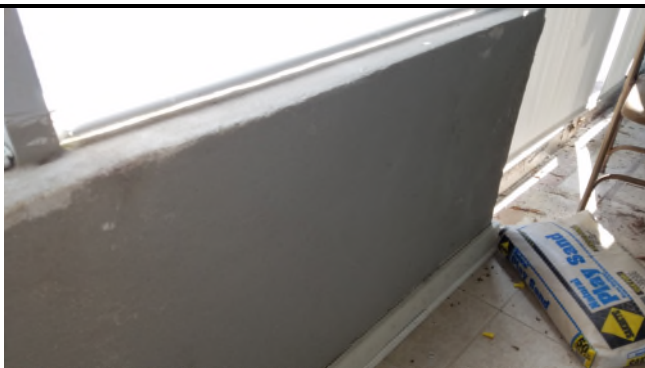
Picture 29 – *HA21 Interior Stucco Wall Covering
2% Chrysotile in Joint Compound-Like Material

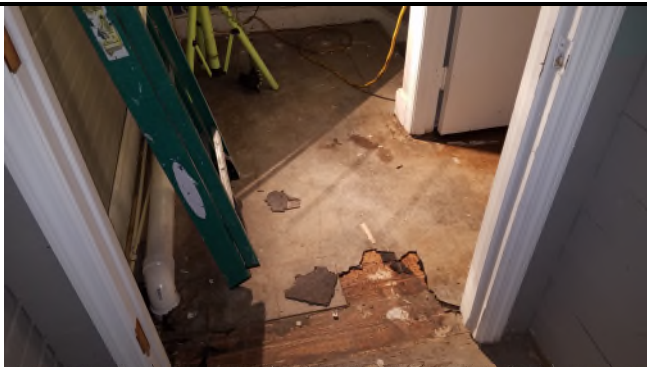
Picture 57 – **HA2 9x9 Floor Tiles w/Mastic
3% Chrysotile Present in Floor Tiles
Mastic NAD*

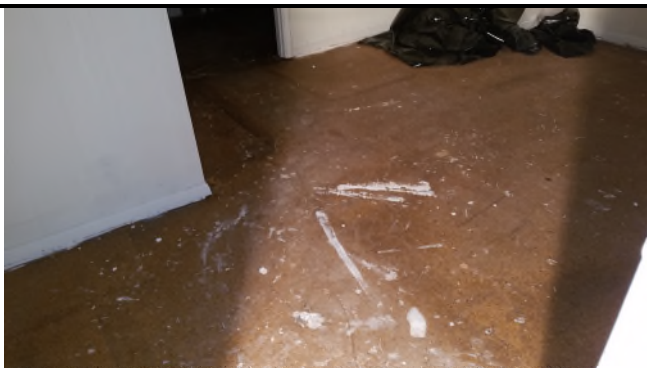
Picture 59 – **HA2 9x9 Floor Tiles w/Mastic
3% Chrysotile Present in Floor Tiles
Mastic NAD*

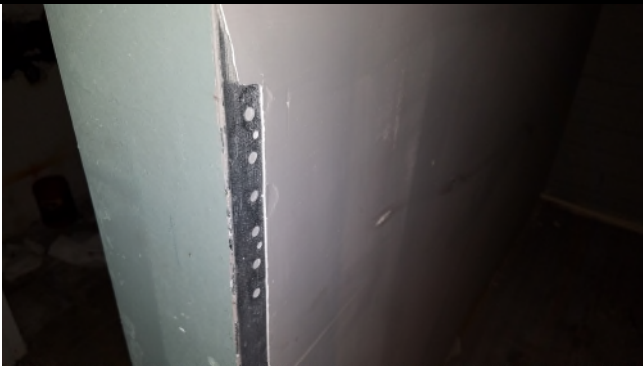
Picture 73 – *HA40 Joint Compound

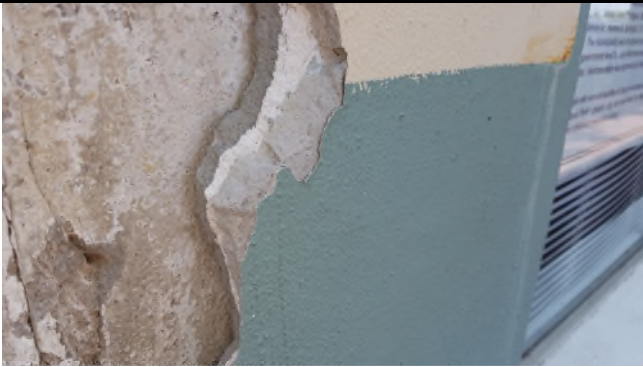
Picture 75 – *HA50 Exterior Wall Covering

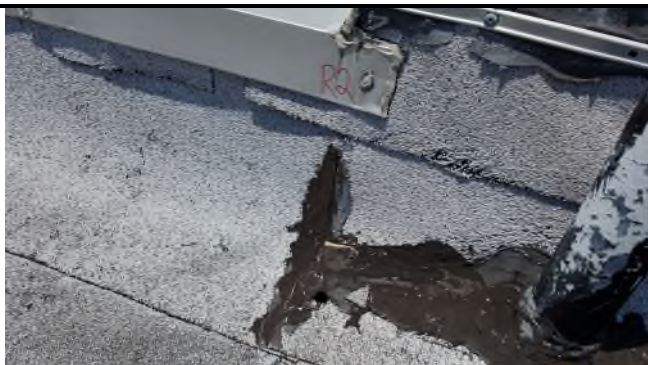
Picture 79 – *HA80 Roofing Materials – Core Sample R2

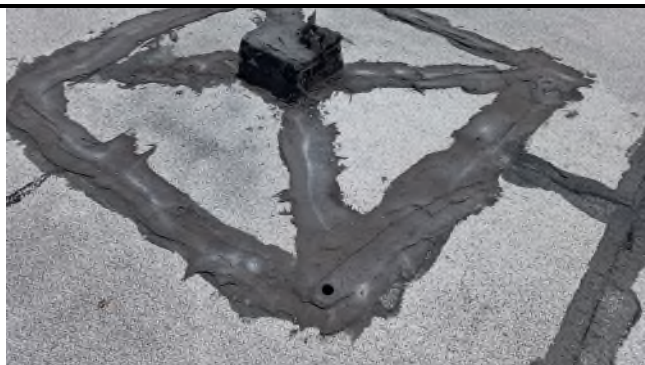
Picture 80 – *HA80 Roofing Materials – Core Sample R3
