**EXHIBIT "A"**  
**SCOPE OF WORK**

REMOVAL OF ASBESTOS  
MATERIALS (ACBM)

# **COMPREHENSIVE ASBESTOS SURVEY**

**COMMERCIAL BUILDING  
1240 YEAMANS HALL ROAD  
HANAHAN, SC 29410**

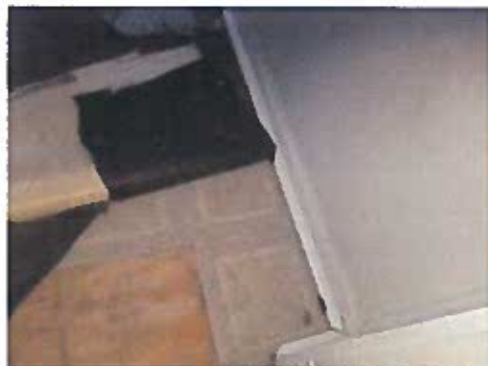
**HOMOGENEOUS AREA 23  
VINYL SHEET FLOORING  
(DARK WOOD)**

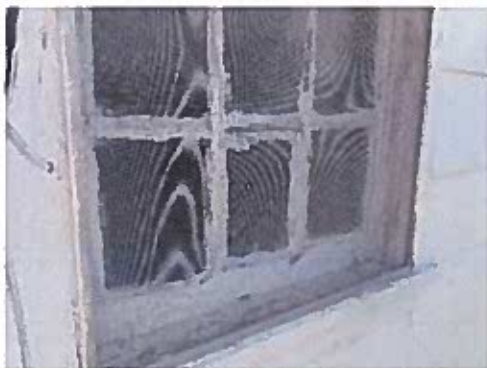
**HOMOGENEOUS AREA 03  
WINDOW GLAZING**

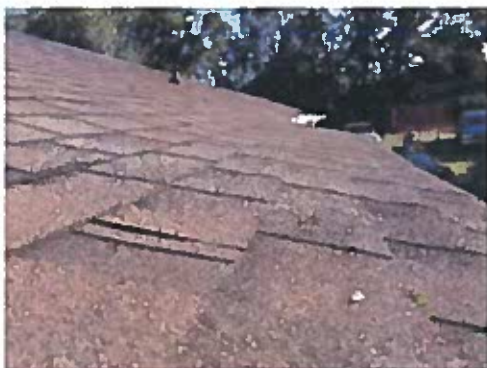
**HOMOGENEOUS AREA 05  
ROOF SHINGLE**

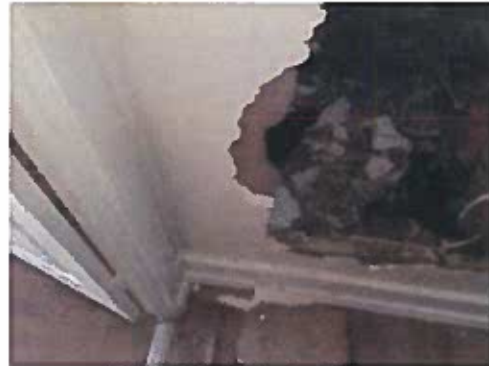
**HOMOGENEOUS AREA 08  
MDF BOARD**

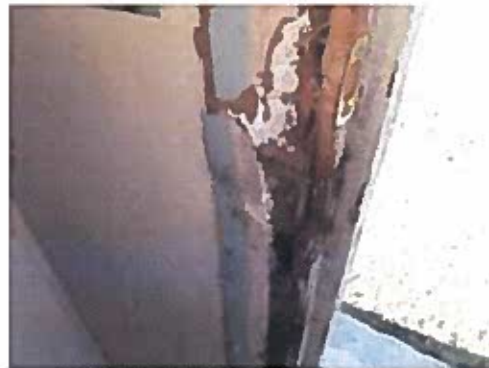
**HOMOGENEOUS AREA 10  
JOINT COMPOUND**

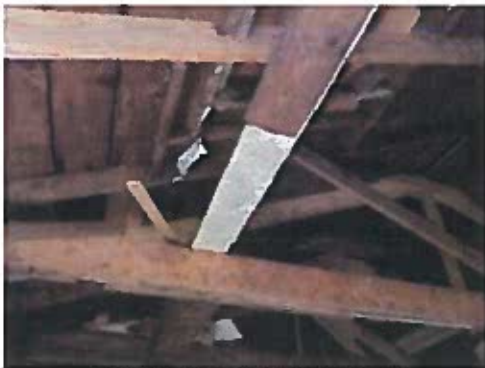
**HOMOGENEOUS AREA 11  
CEILING PANEL**

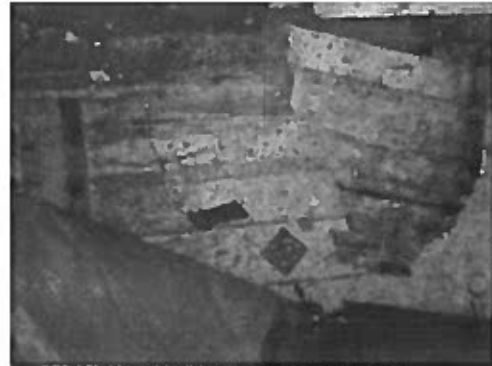
**HOMOGENEOUS AREA 15  
VINYL SHEET FLOORING  
(GRAY/RED/YELLOW)**

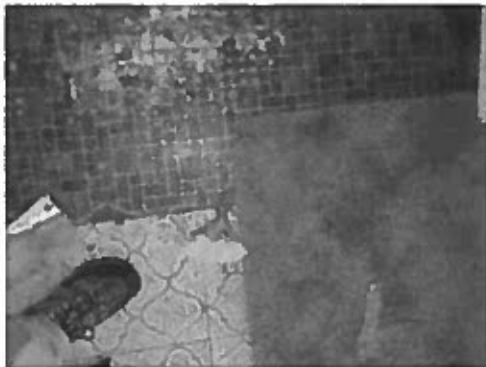
**HOMOGENEOUS AREA 16  
VINYL SHEET FLOORING (RED BRICK)**

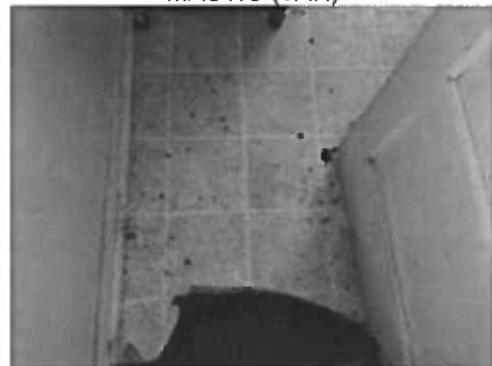
**HOMOGENEOUS AREA 20  
VINYL SHEET FLOORING  
(9" BEIGE SQUARES)**

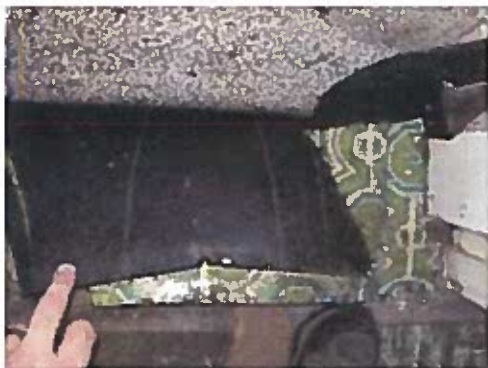
**HOMOGENEOUS AREA 21  
FLOOR FELT PAPER**

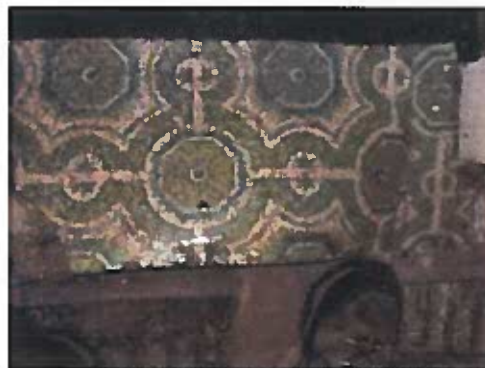
**HOMOGENEOUS AREA 22  
VINYL SHEET FLOORING  
(GREEN/BEIGE SQUARES)**

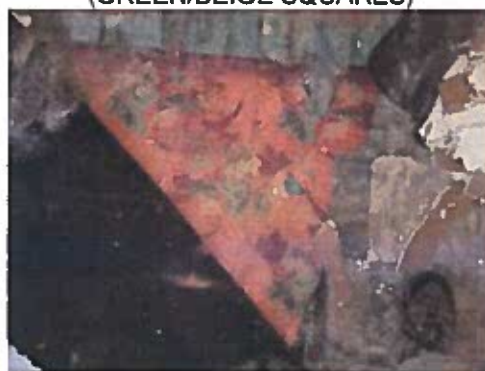
**HOMOGENEOUS AREA 24  
VINYL SHEET FLOORING (RED FLOWER)**

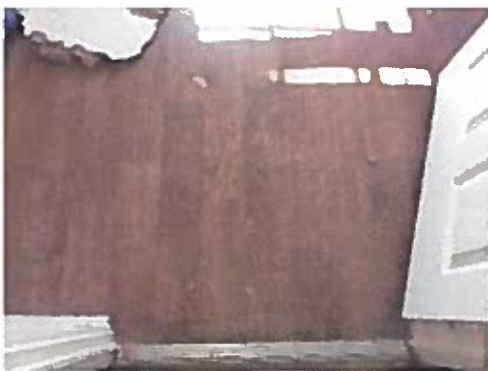
**HOMOGENEOUS AREA 25  
VINYL SHEET FLOORING (WOOD)**

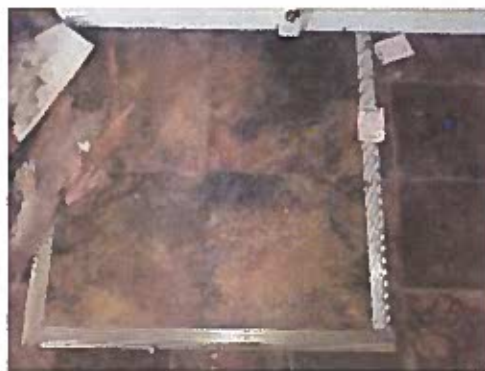
**HOMOGENEOUS AREA 26  
12" SELF-STICK TILE (DARK SLATE)**

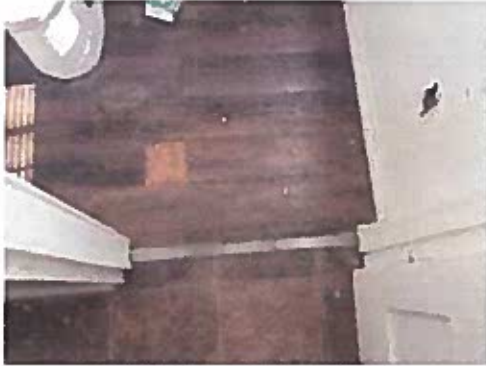
**HOMOGENEOUS AREA 27  
VINYL FLOOR PLANKS (DARK WOOD)**

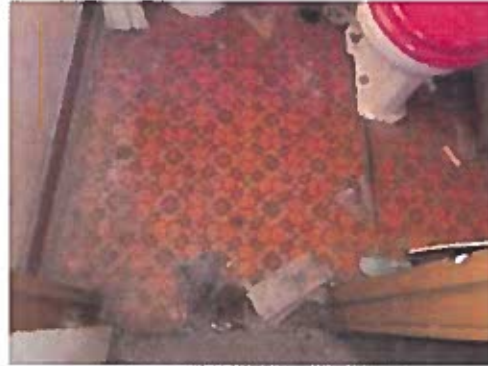
**HOMOGENEOUS AREA 28  
VINYL SHEET FLOORING (RED/ORANGE)**
