REPORT DATE: September 19, 2023

NESHAP ASBESTOS SURVEY REPORT

WILSON MALL

1501 Ward Boulevard, Wilson, Wilson County, North Carolina

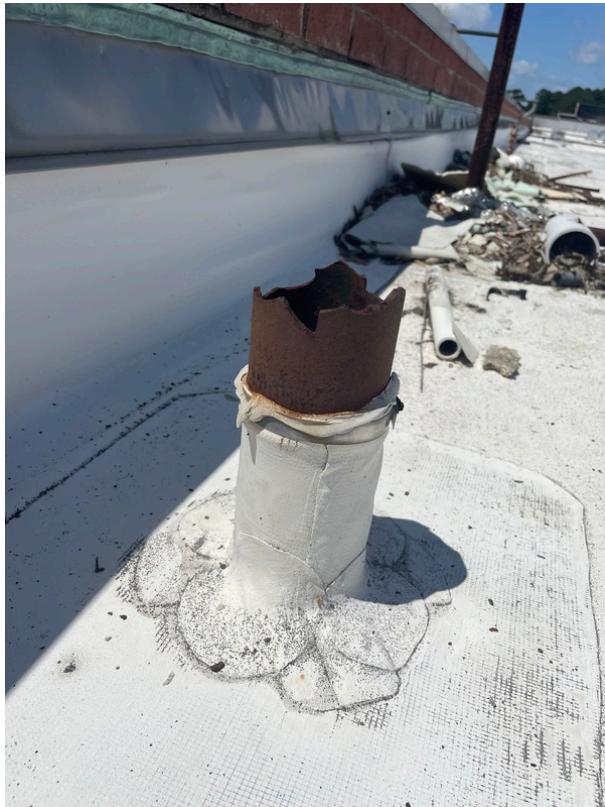
View of asbestos-containing Grey Caulk
beneath Tan Caulk (HA 14)

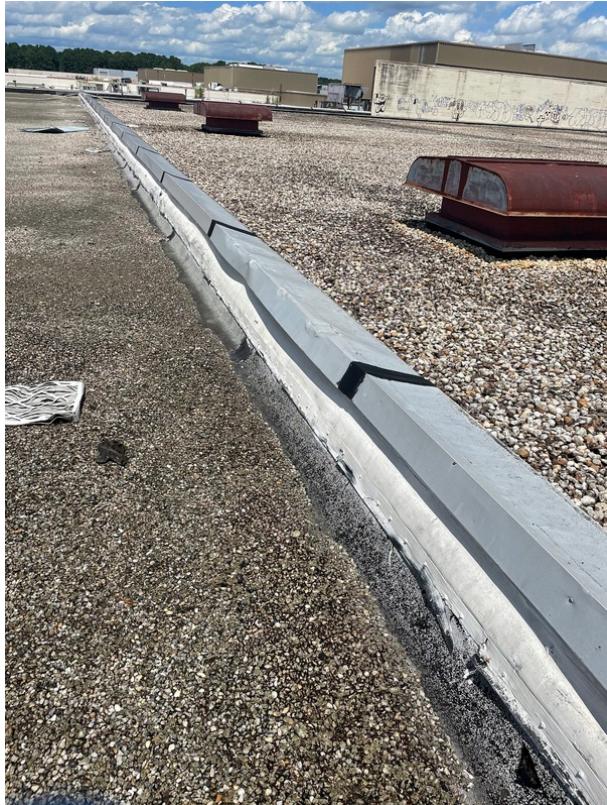
General view of asbestos-containing Black Tarpaper beneath White/Black Rolled Shingle and Black Tar (HA 21)

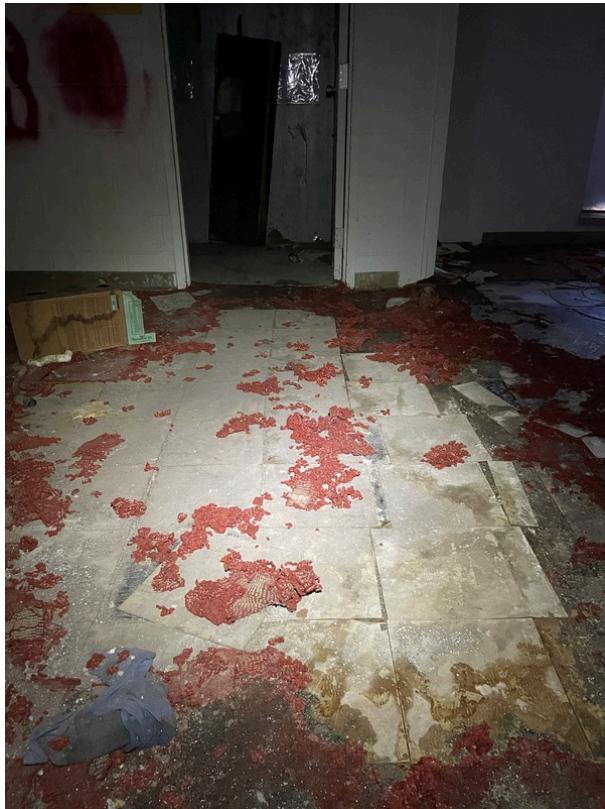
View of asbestos-containing 12" x 12"
Brown/Off-White Floor Tile and its
associated Black Mastic (HA 43)

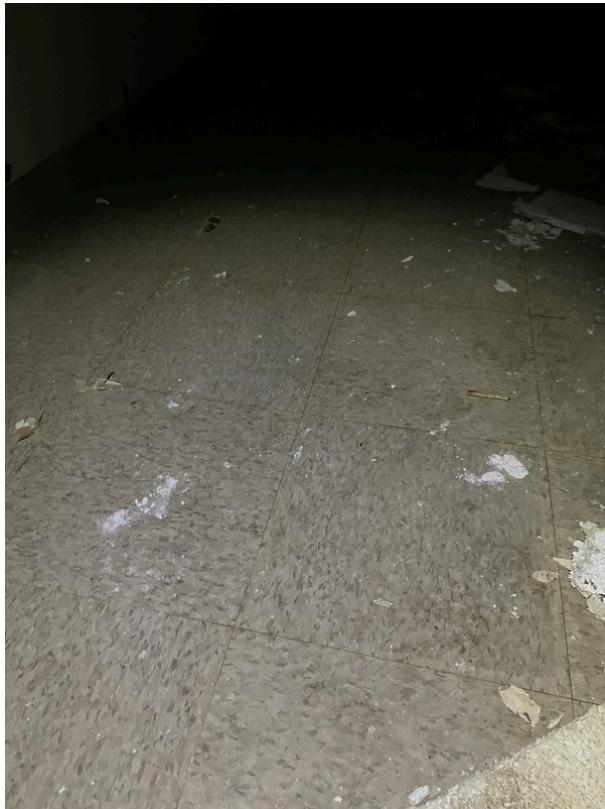
General view of asbestos-containing Black Mastic beneath 12" x 12" Tan Floor Tile
(HA 68)

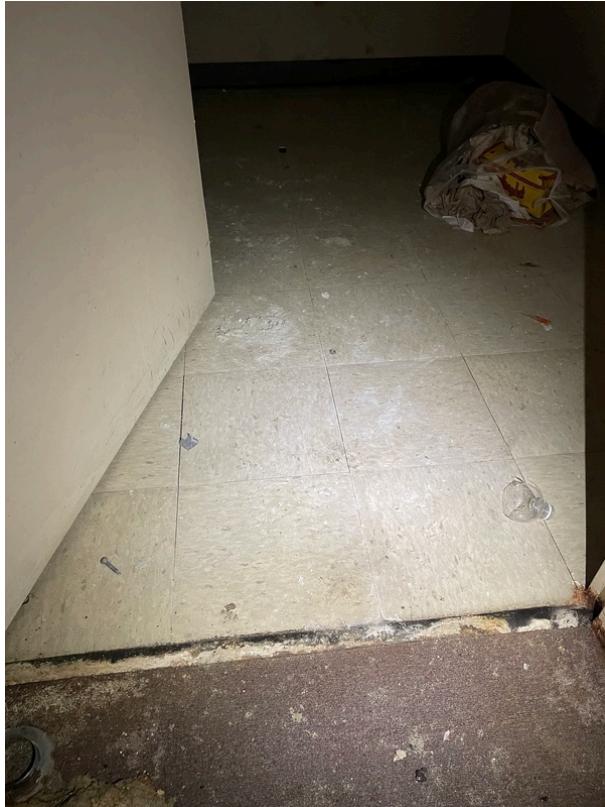
General view of asbestos-containing Black/Tan Mastic beneath 12" x 12" Tan with Brown Specks Floor Tile (HA 75)

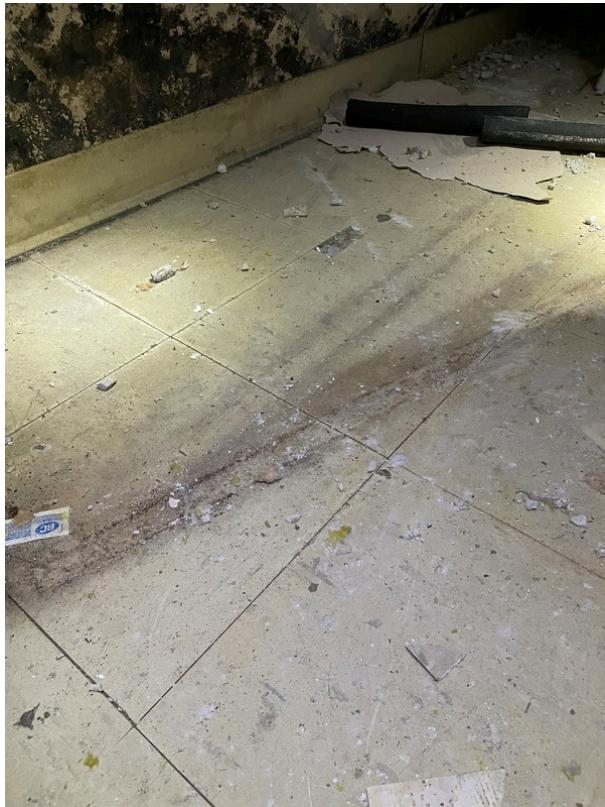
View of asbestos-containing 12" x 12"
Off-White Floor Tile and its associated
Black Mastic (HA 130) in Room 262

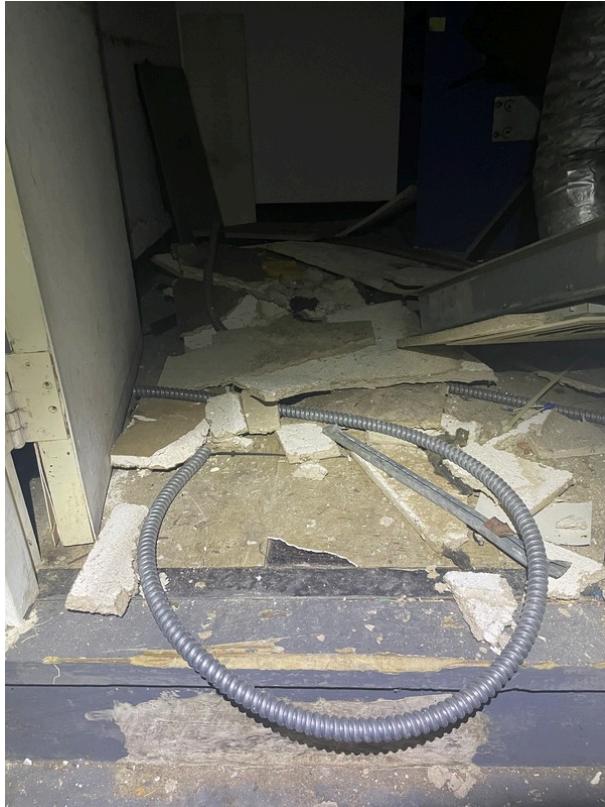
View of asbestos-containing 12" x 12" Tan Floor Tile and its associated Black Mastic (HA 153)

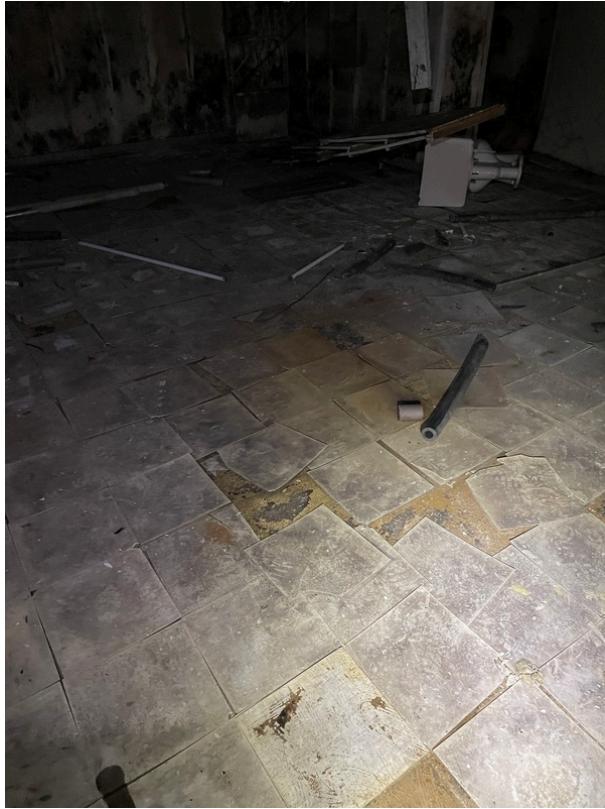
General view of asbestos-containing 12" x 12" Beige Floor Tile and its associated Black Mastic beneath 12" x 12" Tan Floor Tile (HA 184)

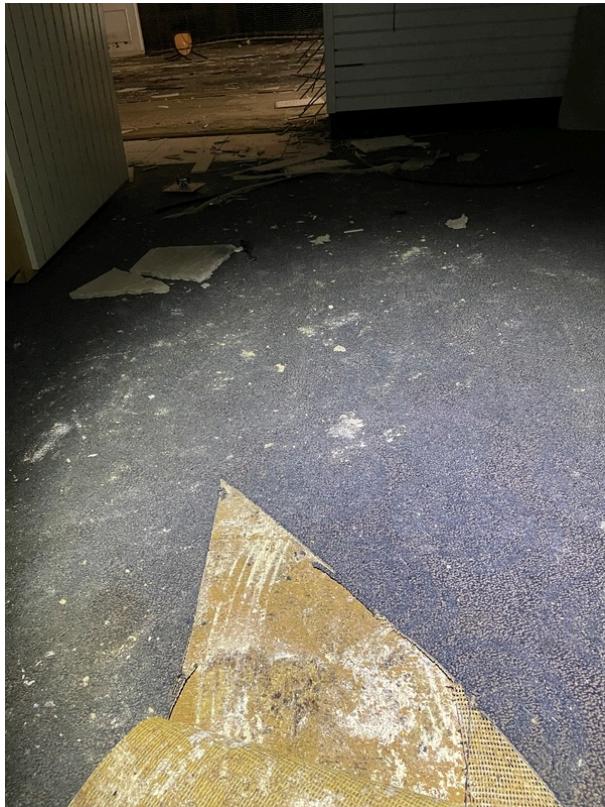
View of asbestos-containing Yellow/Black Carpet Glue (HA 193)

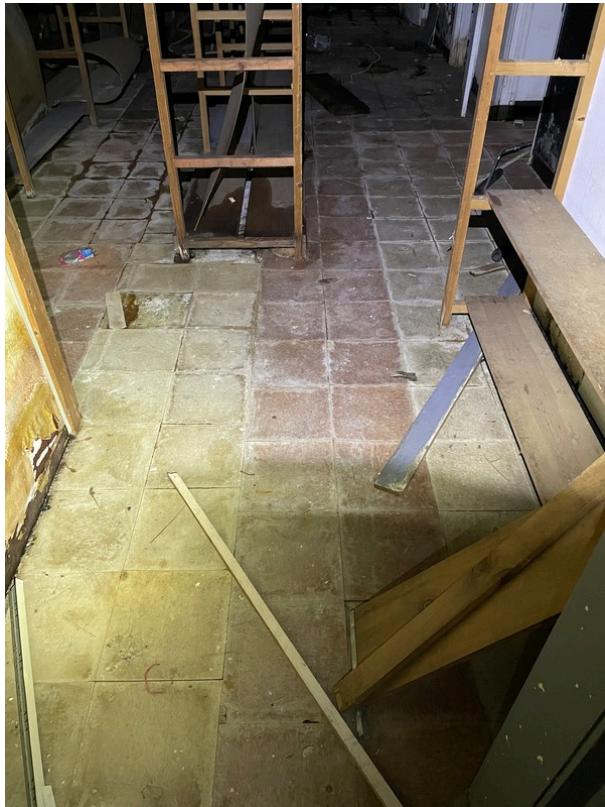
General view of asbestos-containing Black Mastic beneath 12" x 12" Red Floor Tile
(HA 195)

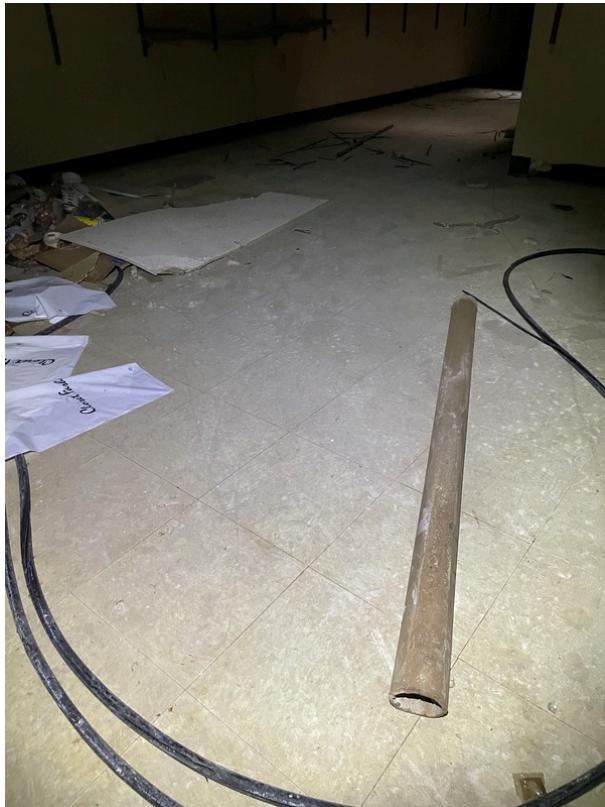
General view of asbestos-containing Black Mastic beneath 12" x 12" Tan Floor Tile (HA 211)
