Existing Condition Assessment Report

DEMOLITION OF CENTRAL BOOKING FACILITY

Escambia County Central Booking and Detention Facility
Condition Assessment Report - June 11, 2015

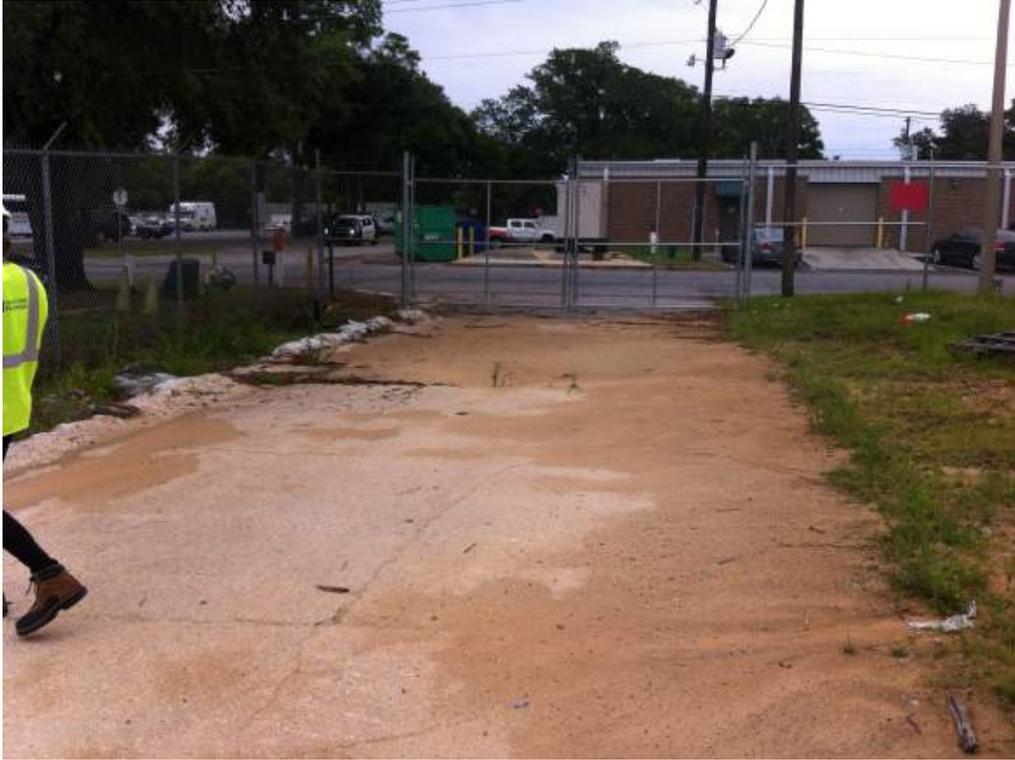
Photo 1: Northeast Road Access Sediment-Looking East

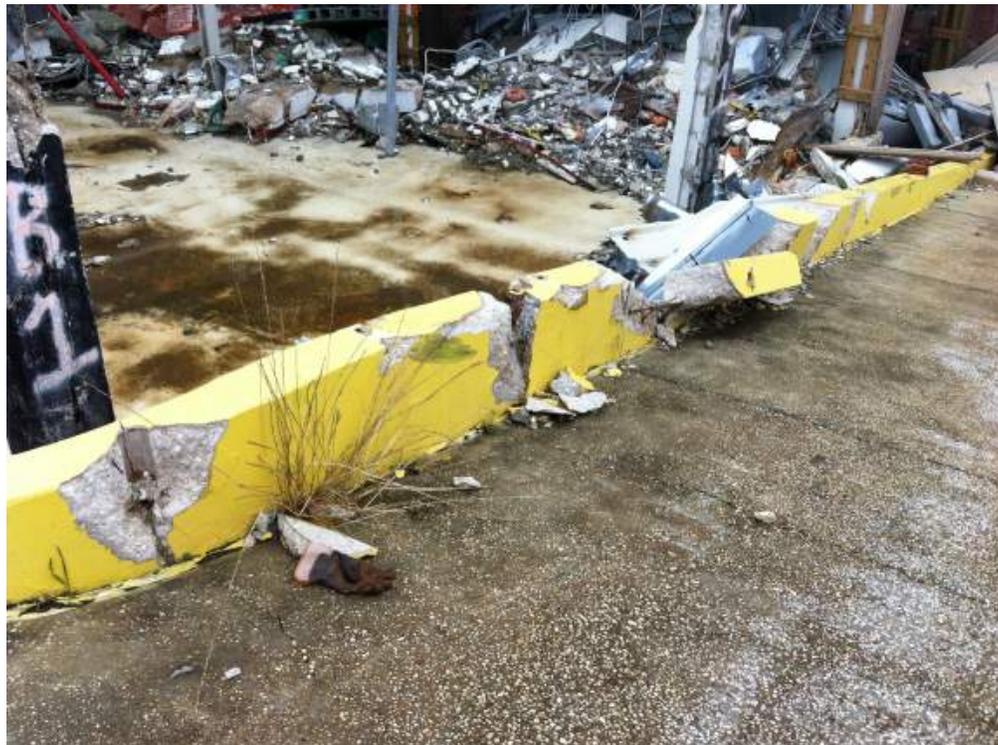
Photo 2: Damaged Retaining Wall- Looking Southwest

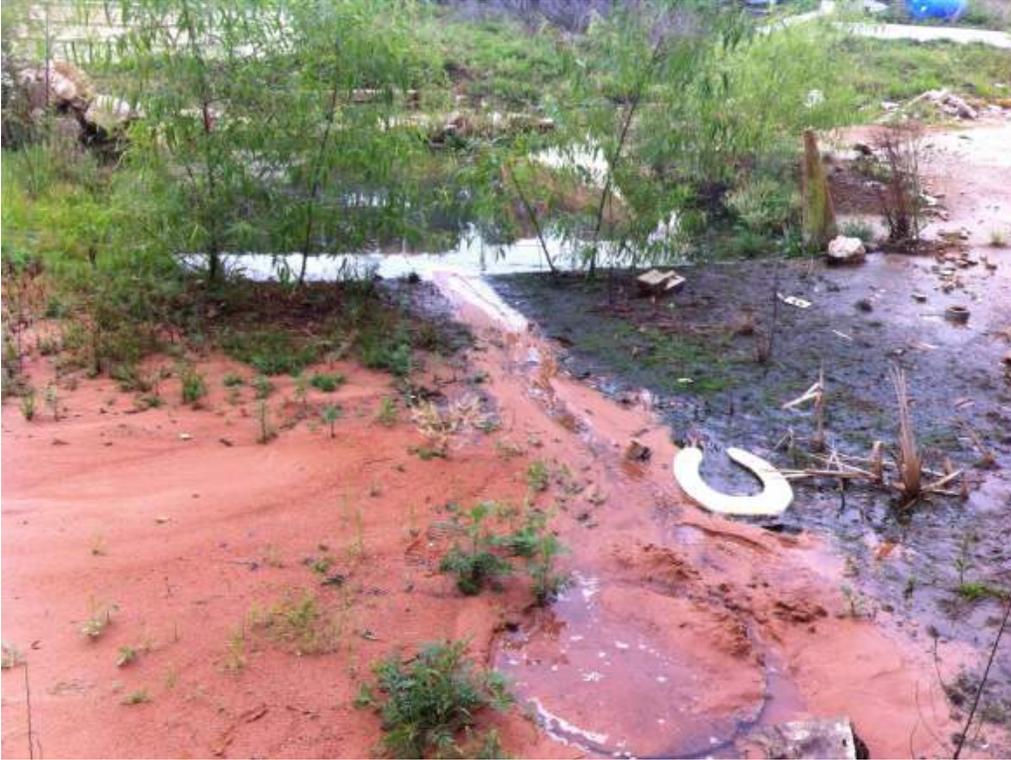
Photo 3: Parking Area Adjacent to Sally Port and Mechanical Room Sediment- Looking North

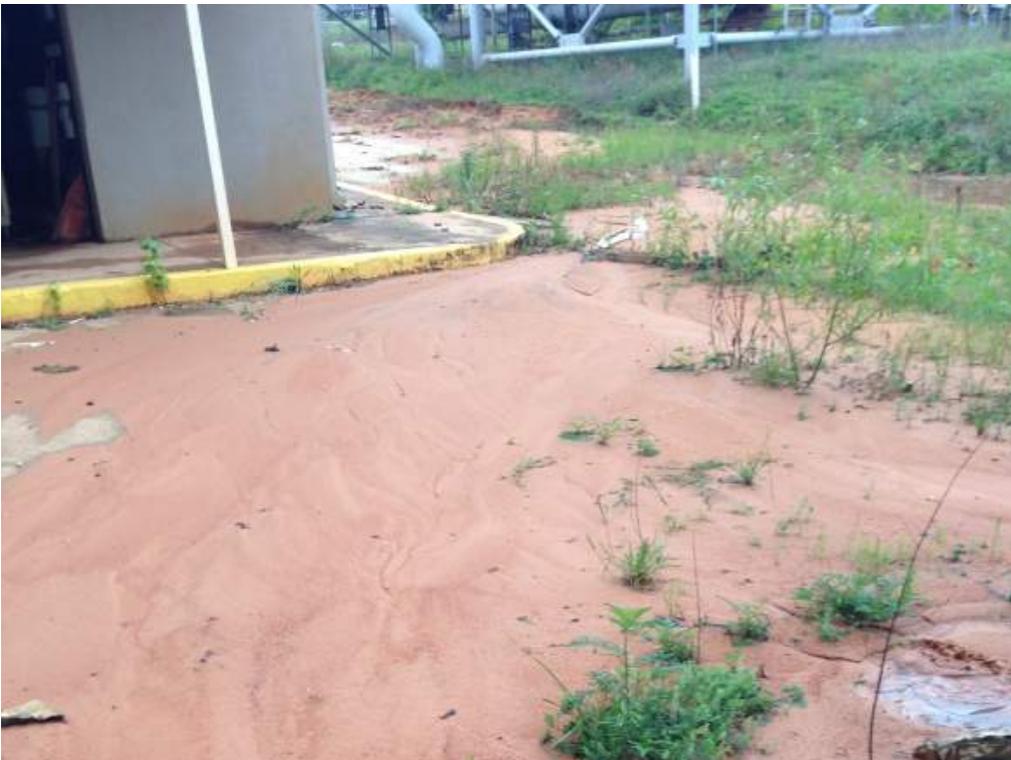
Photo 4: Parking Area Adjacent to Sally Port and Mechanical Room Sediment-Looking Northwest

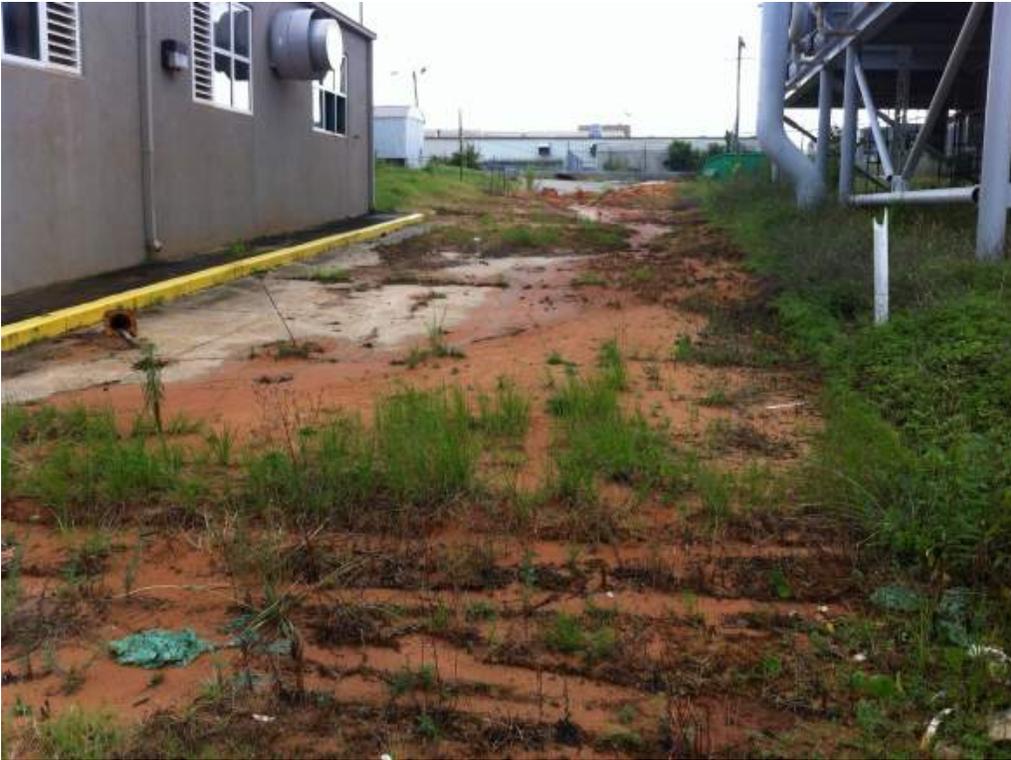
Photo 5: Northwest Ramp Sediment- Looking West

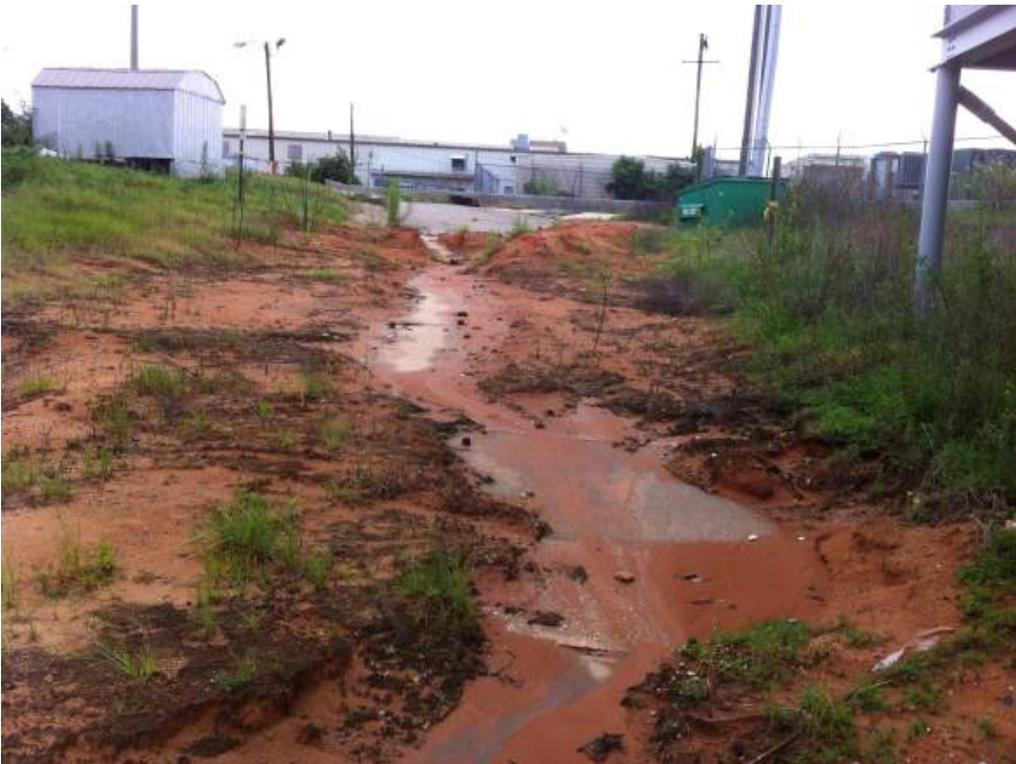
Photo 6: Northwest Ramp Sediment- Looking West

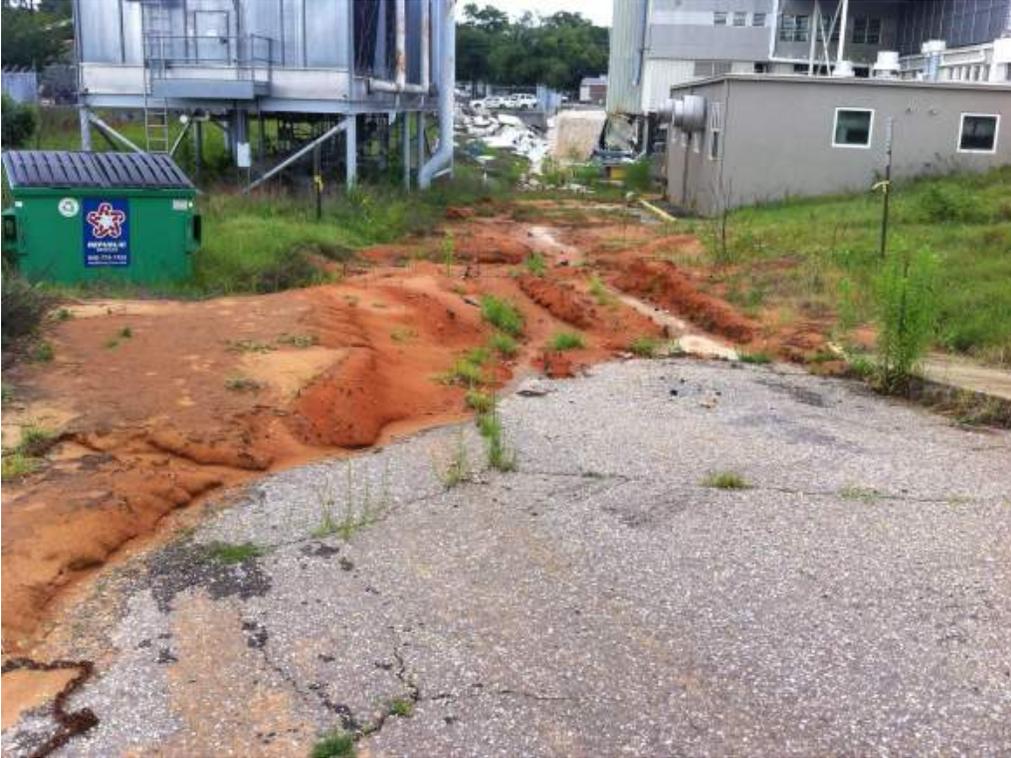
Photo 7: Northwest Ramp Sediment- Looking East

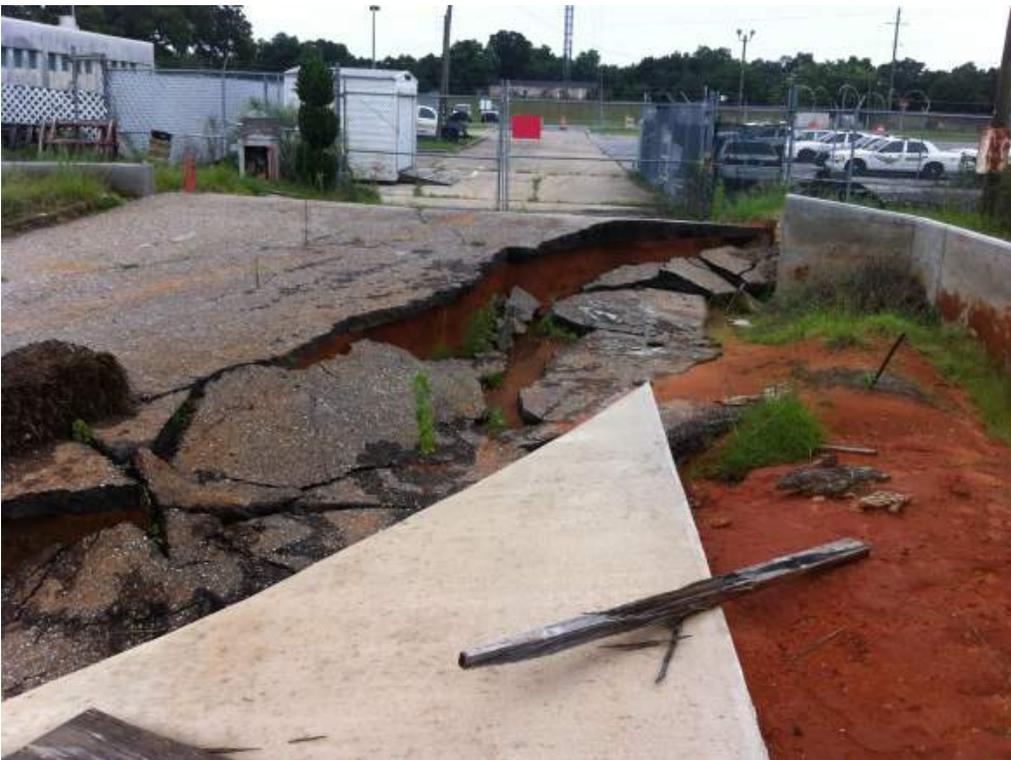
Photo 8: Northwest Access Road Erosion- Looking South

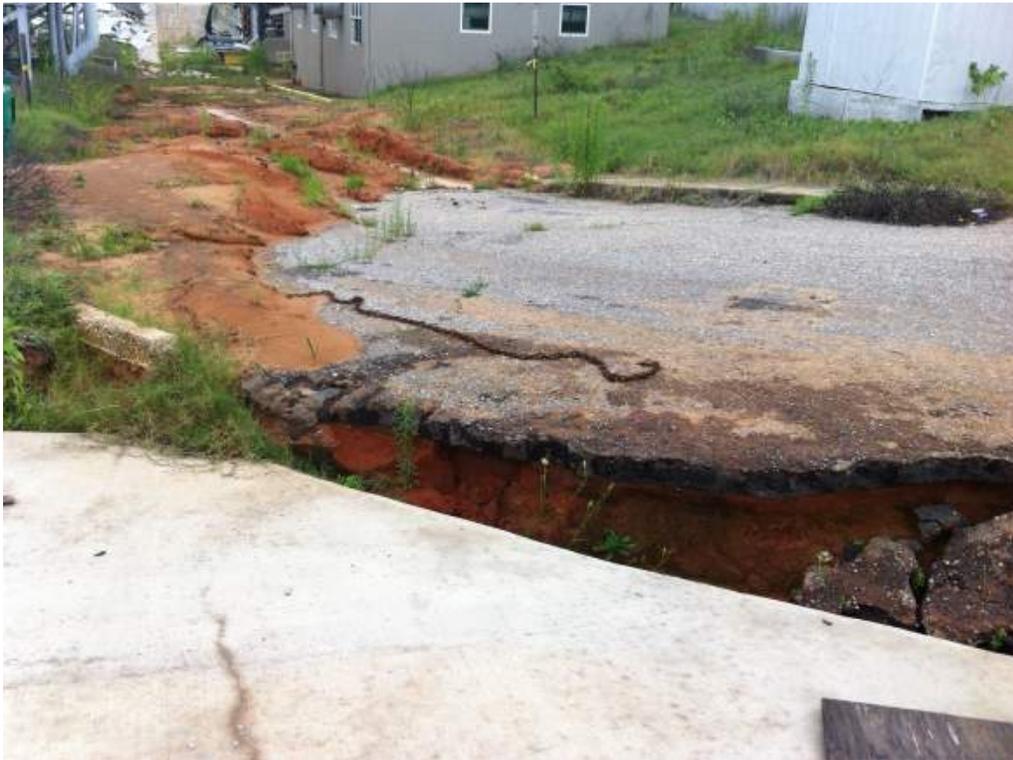
Photo 9: Northwest Access Road Erosion-Looking Southeast

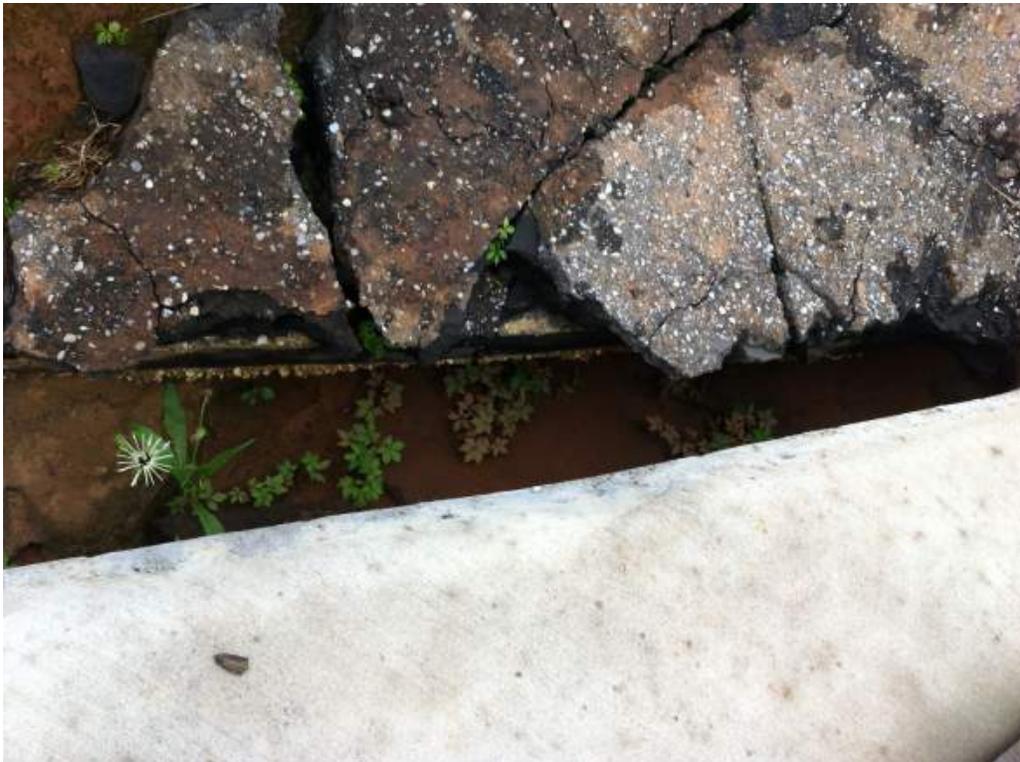
Photo 10: Northwest Access Road Erosion- Looking Southeast

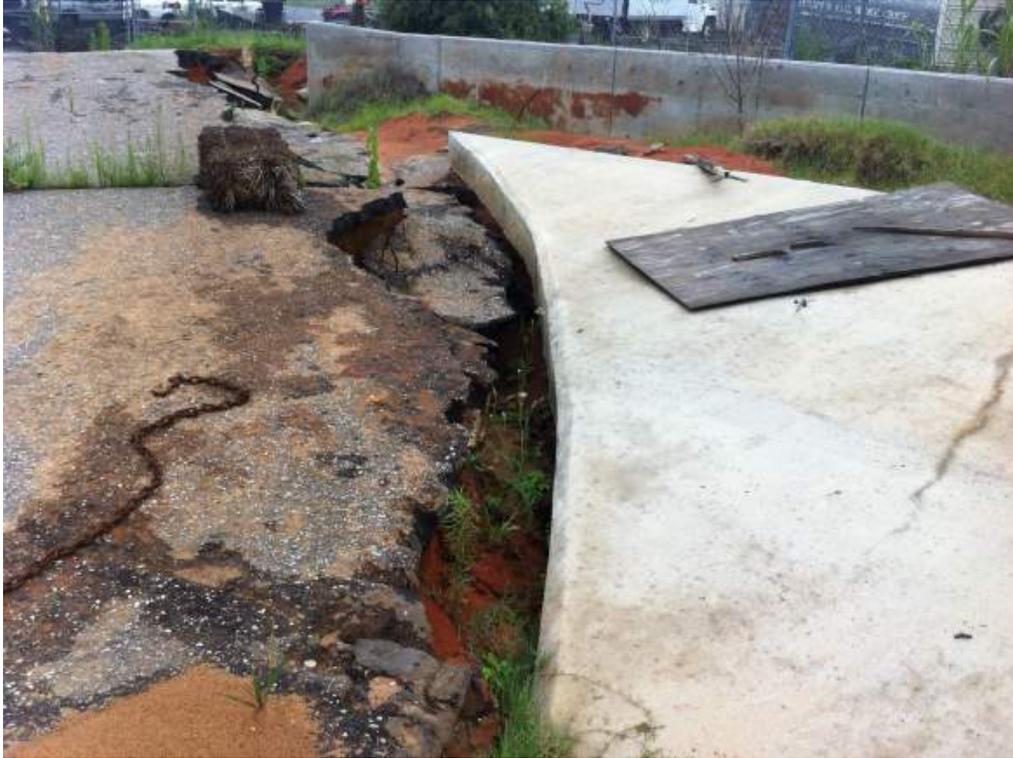
Photo 11: Northwest Concrete Landing Undermining- Looking Southwest

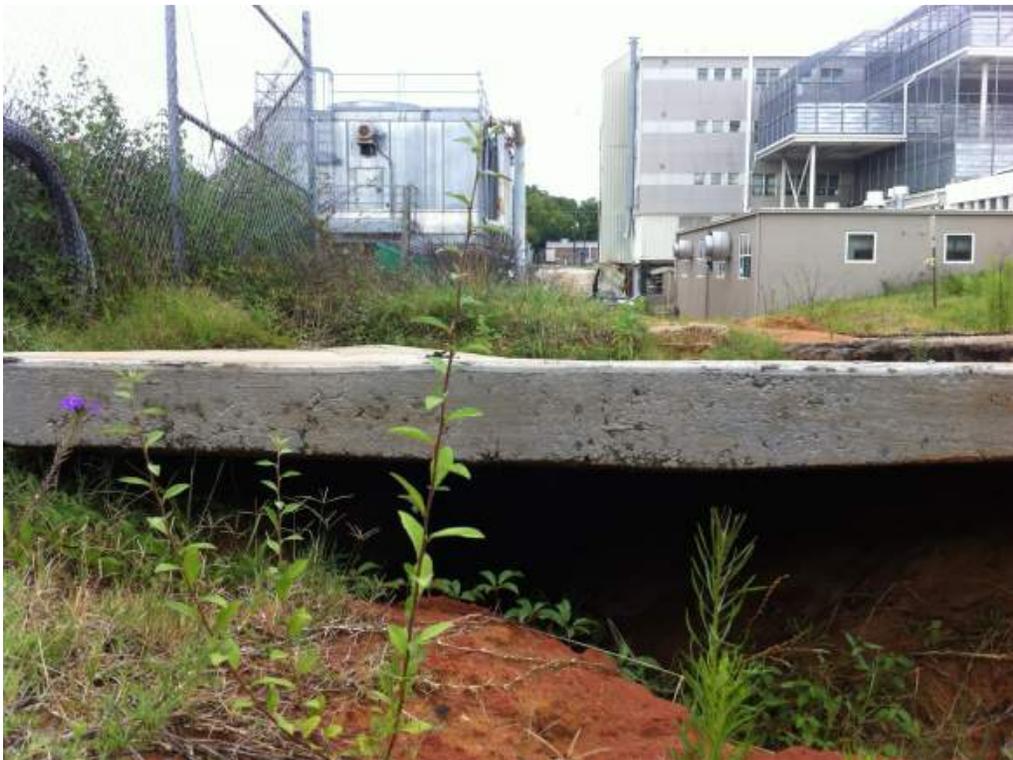
Photo 12: Northwest Concrete Slab Undermining- Looking East

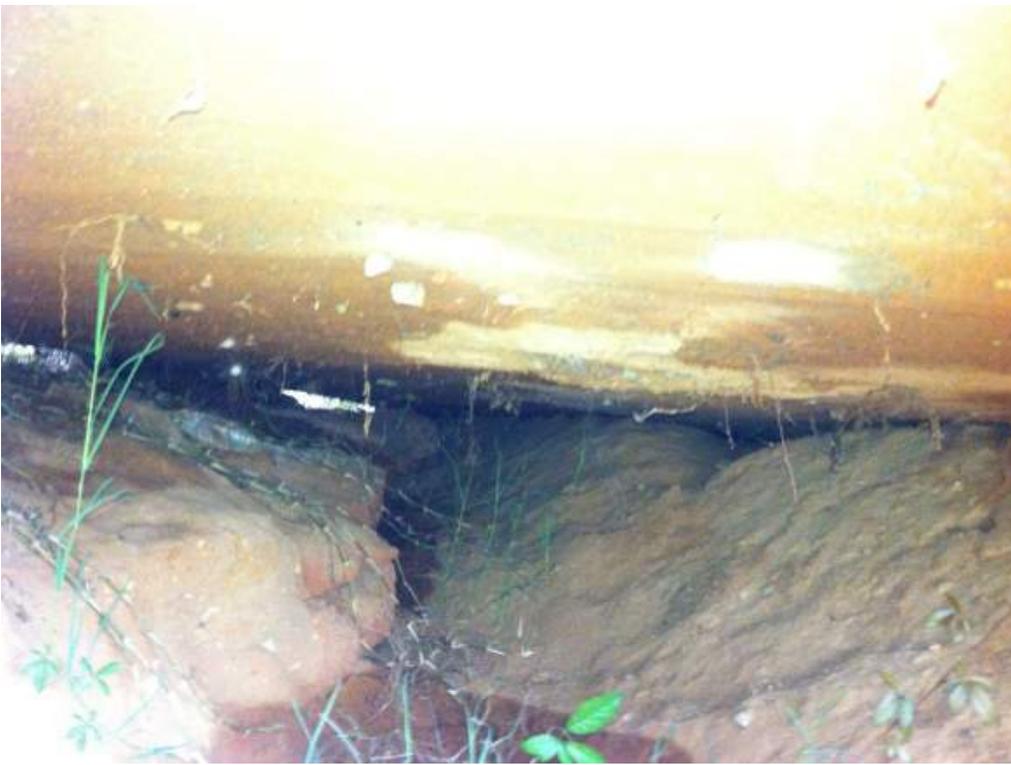
Photo 13: Northwest Concrete Slab Complete Undermining- Looking East

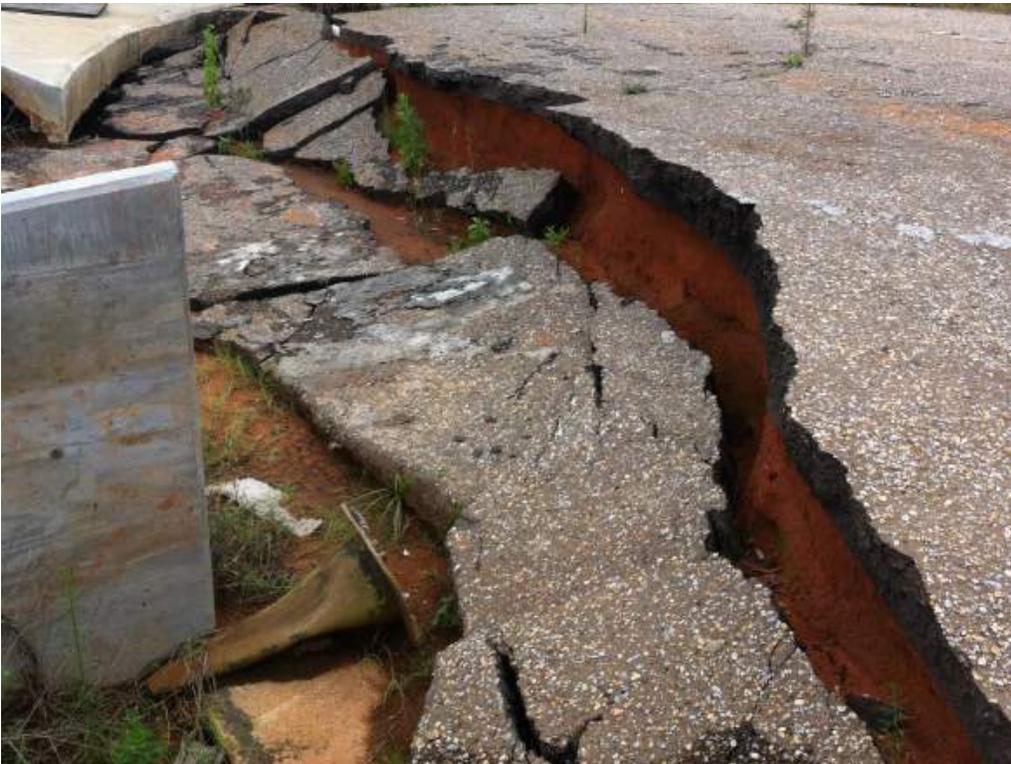
Photo 14: Northwest Access Road Erosion- Looking Northwest

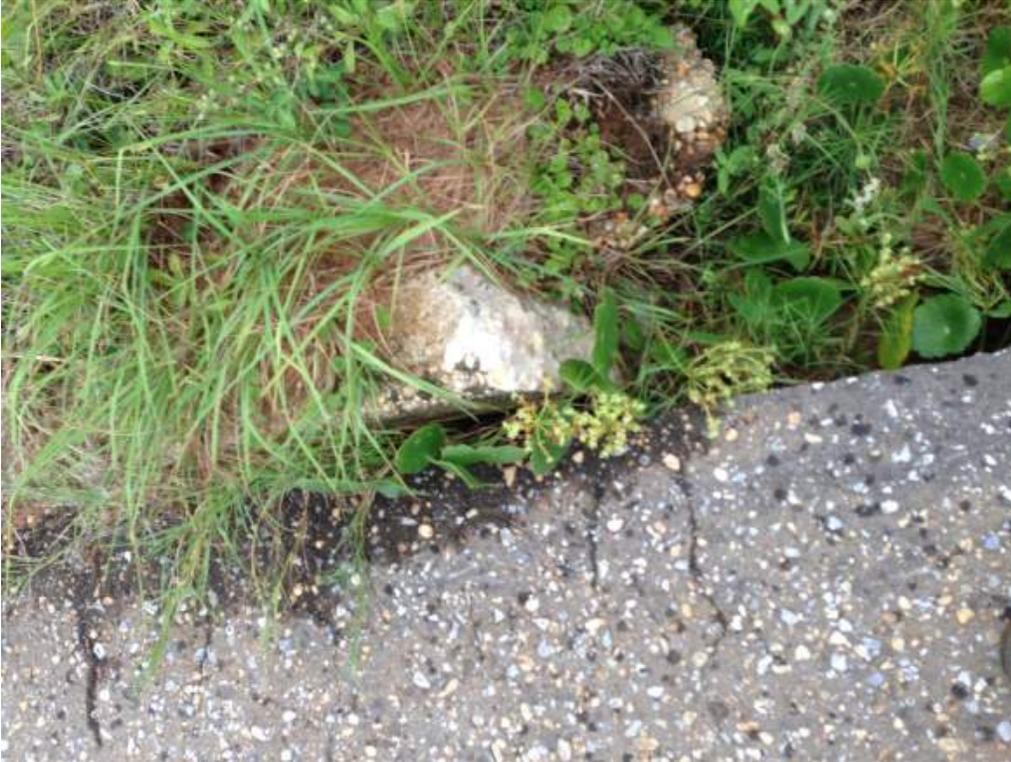
Photo 15: Curb at East Edge of Northwest Access Road Ditching- Looking East

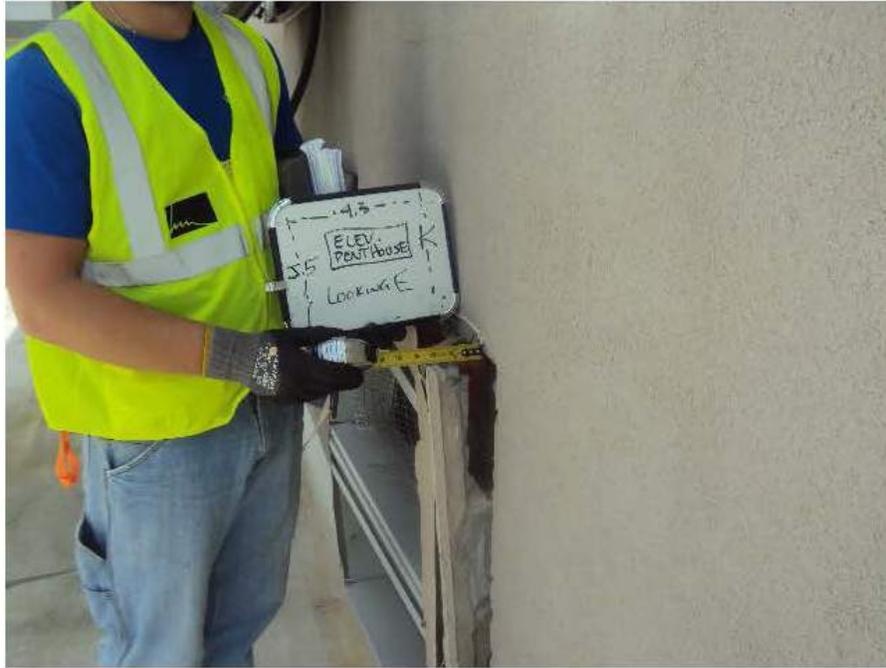
Photo 1: Elevator Penthouse –Along col line 4.3 between col lines J.5 and K – Looking East - Damaged exhaust vent and wall section at the elevator shaft

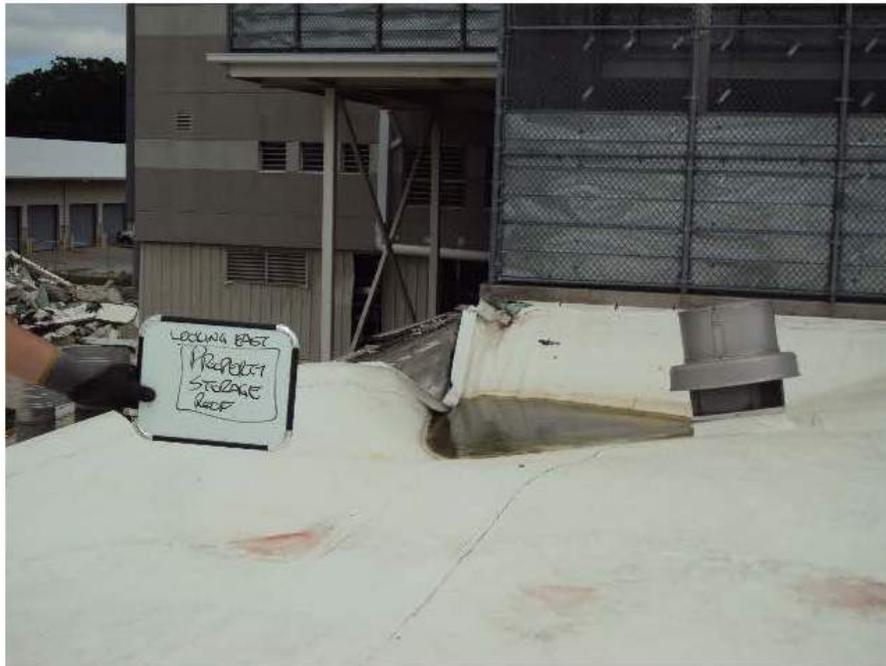
Photo 2: 1st Floor Roof –Between col lines D and E & 7 and 8 – Looking East - Collapsed portion of roof

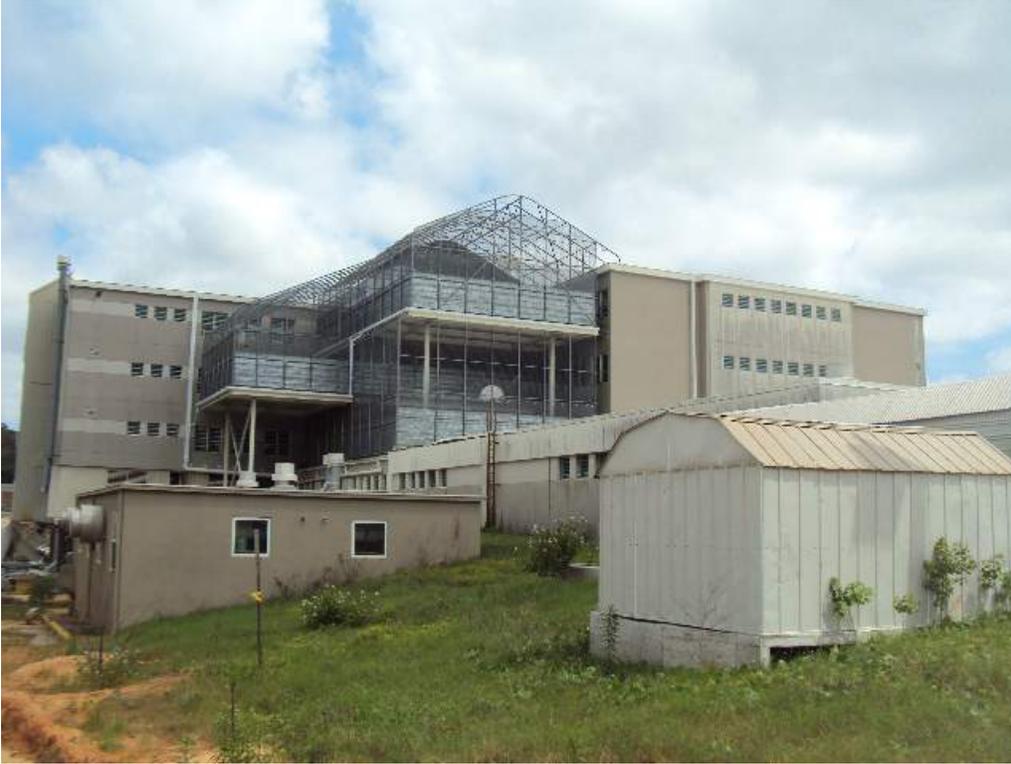
Photo 3: North Elevation – Looking East

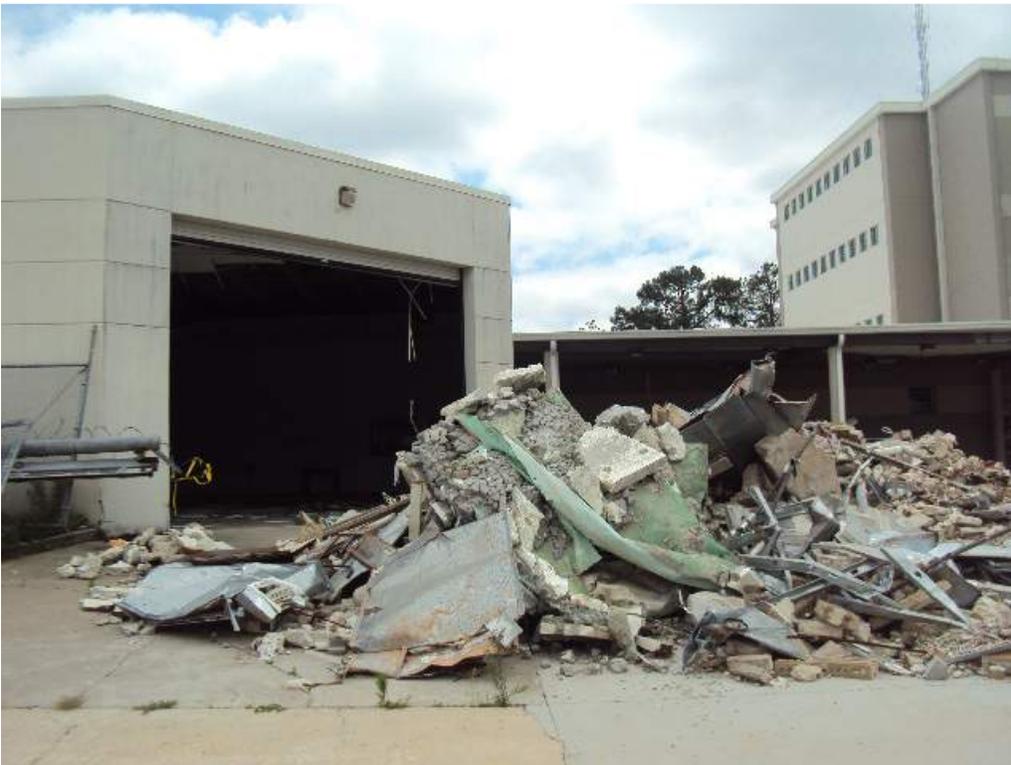
Photo 4: North Elevation Eastern End of Facility– Looking South

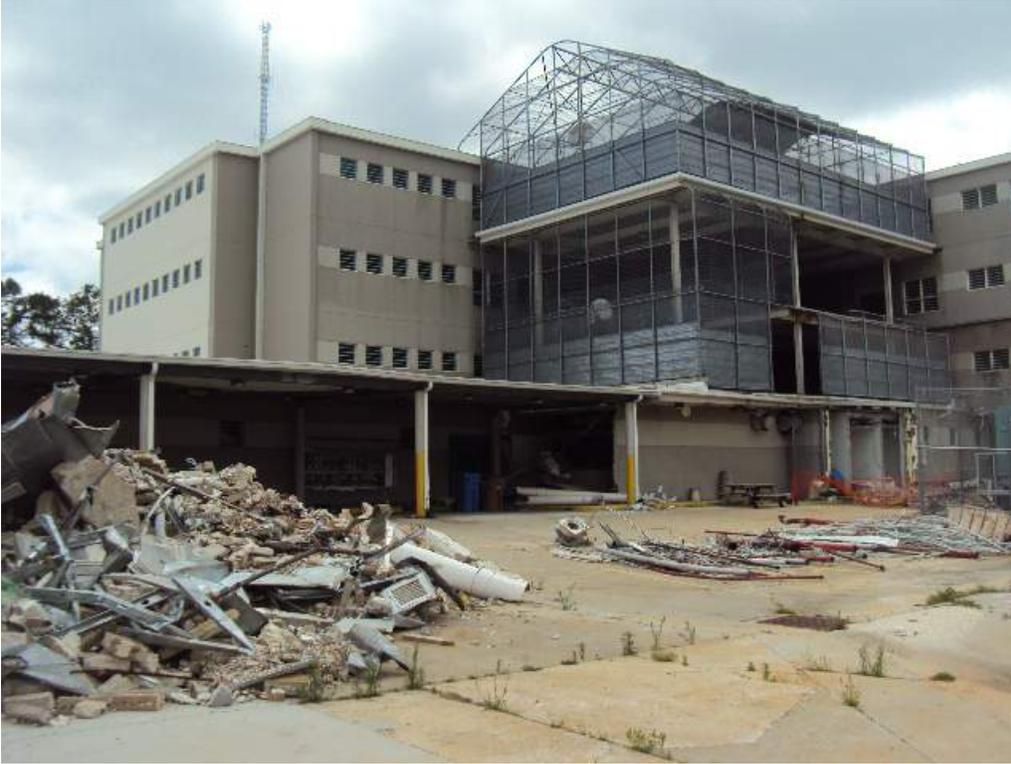
Photo 5: North Elevation – Looking South-Southwest

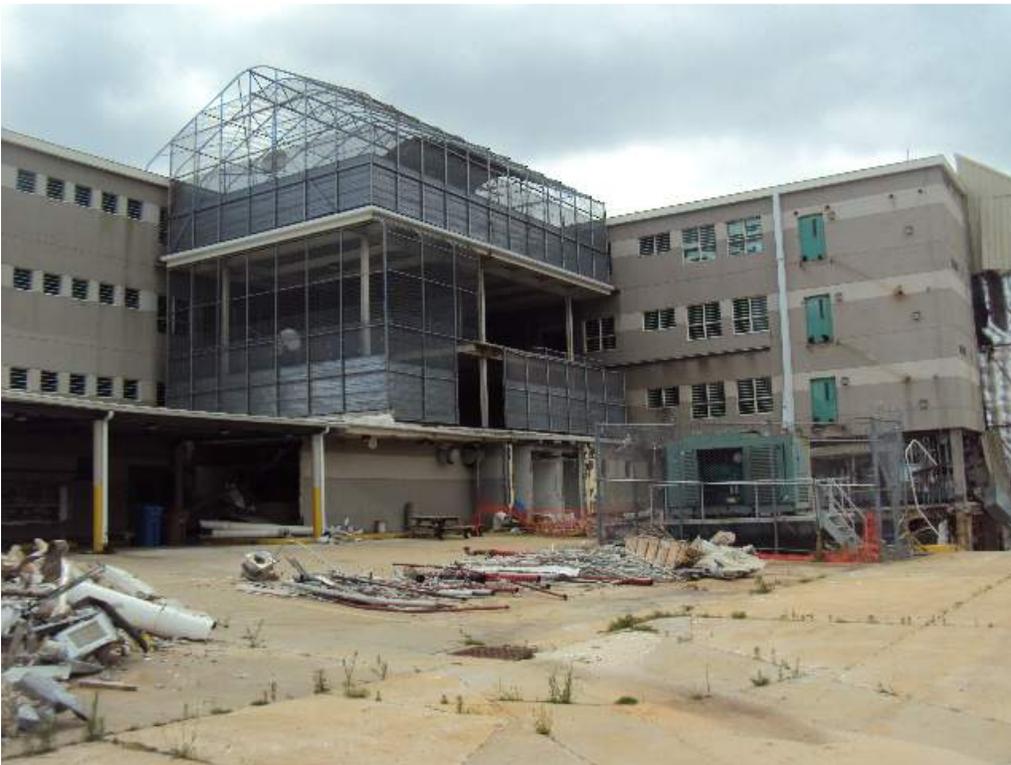
Photo 6: North Elevation – Looking Southwest-South

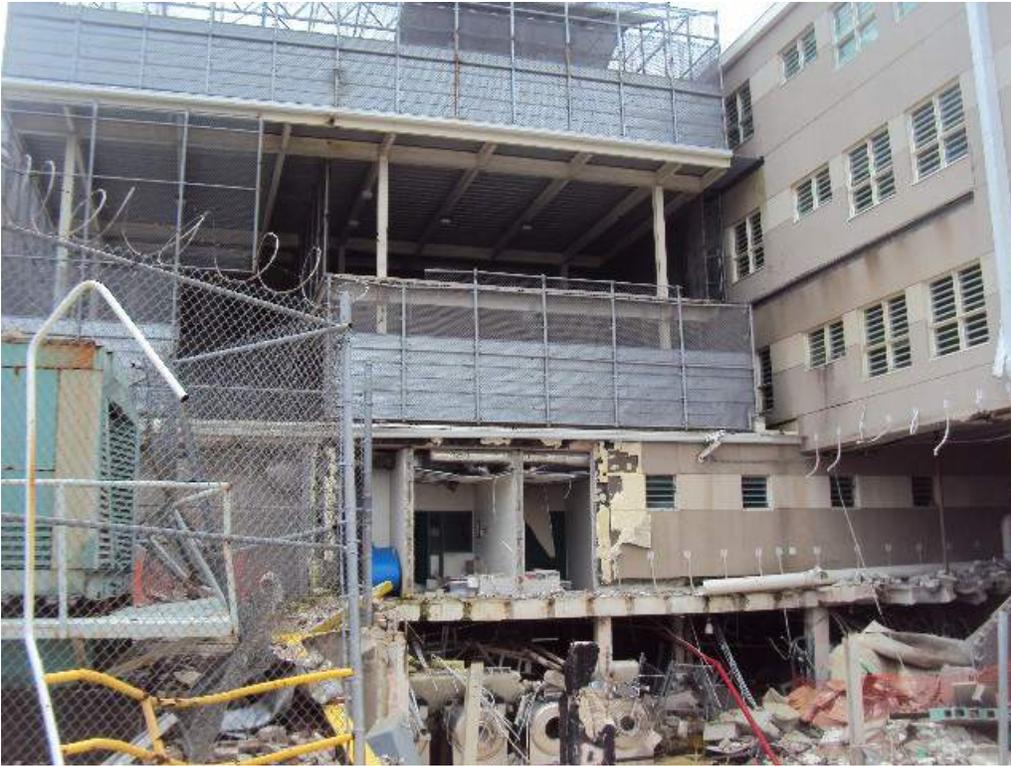
Photo 7: North Elevation – Looking South

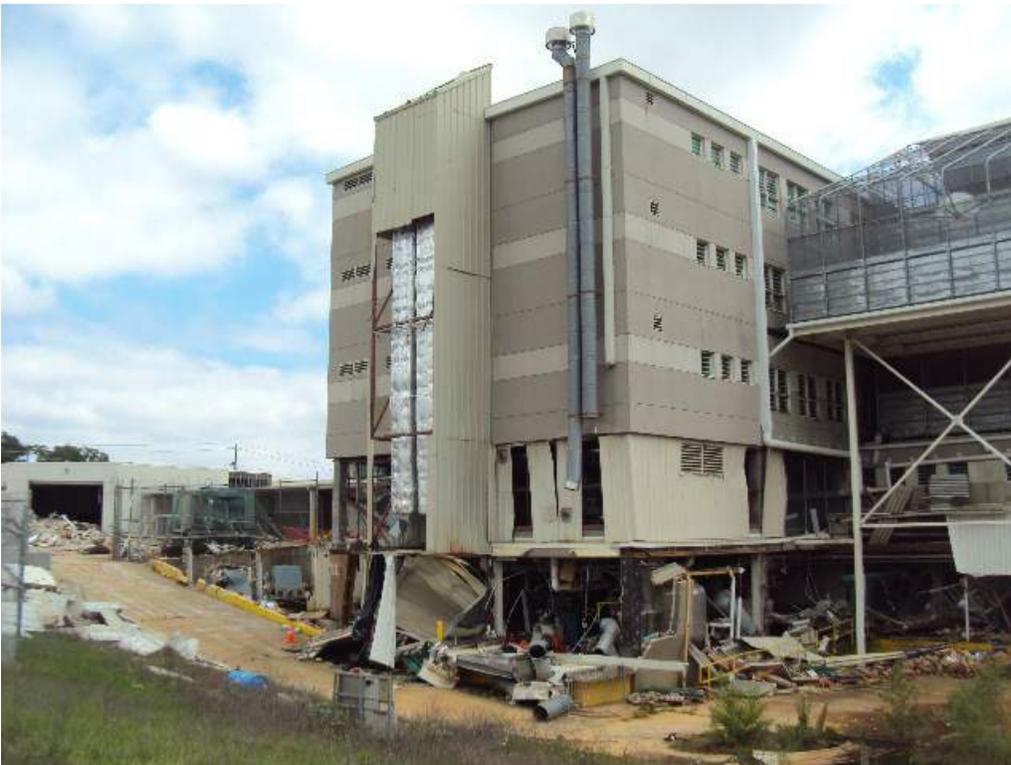
Photo 8: North Elevation – Looking Southeast-South

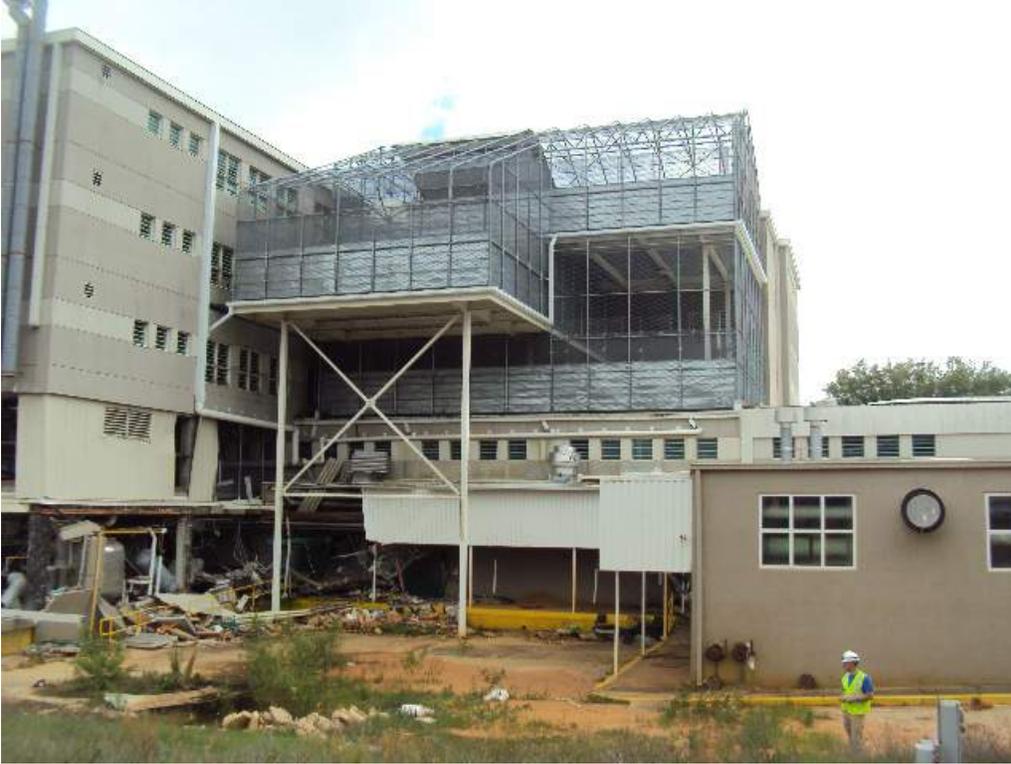
Photo 9: North Elevation Western end of Facility - Looking South

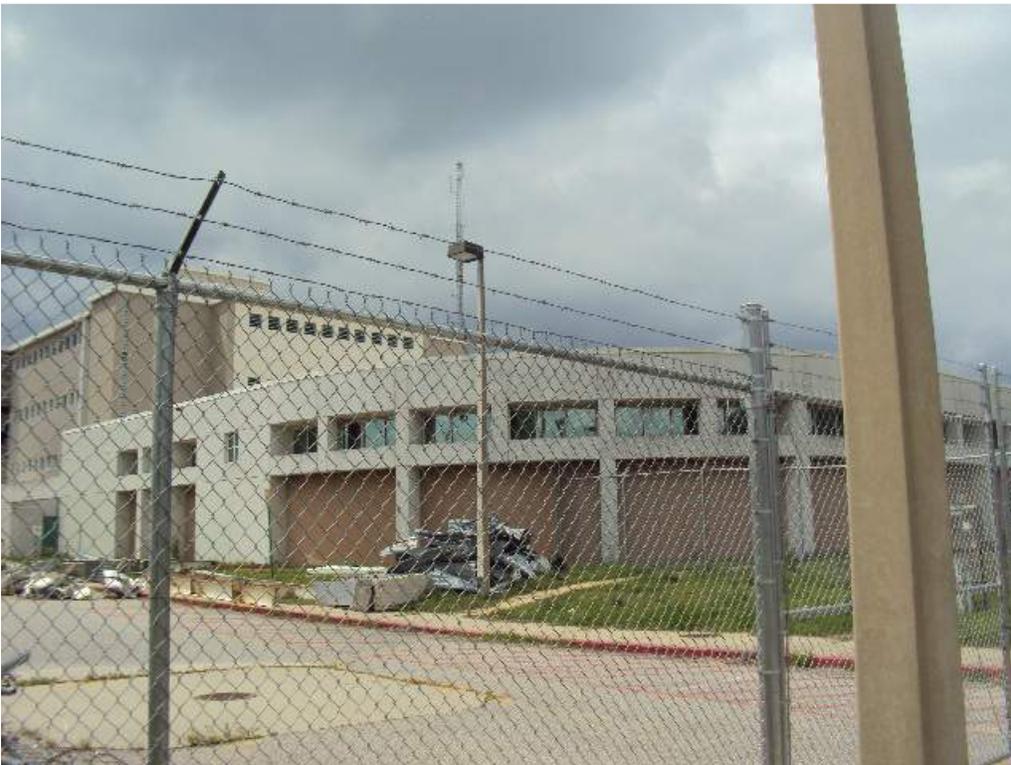
Photo 10: South Elevation - Looking Northwest-West

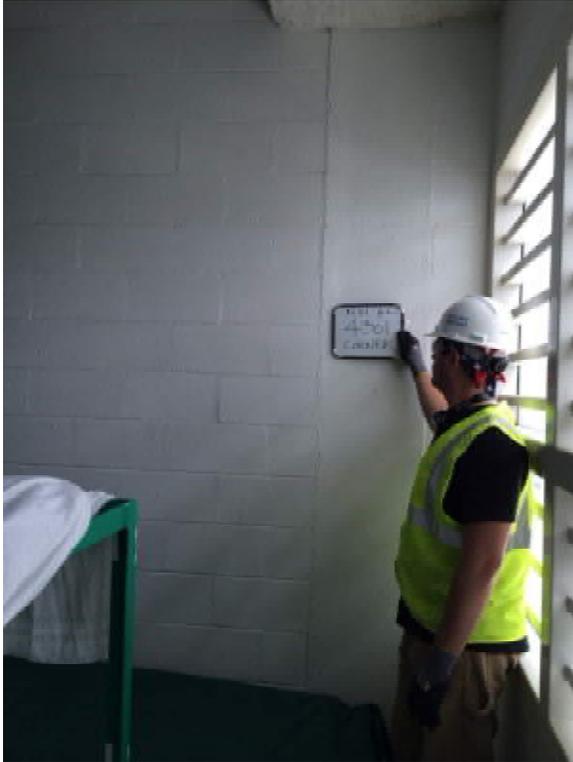
Photo 13: 4th Floor – Room 4301 – Col line 6/E2 – Looking West - Vertical crack between the concrete column and CMU wall

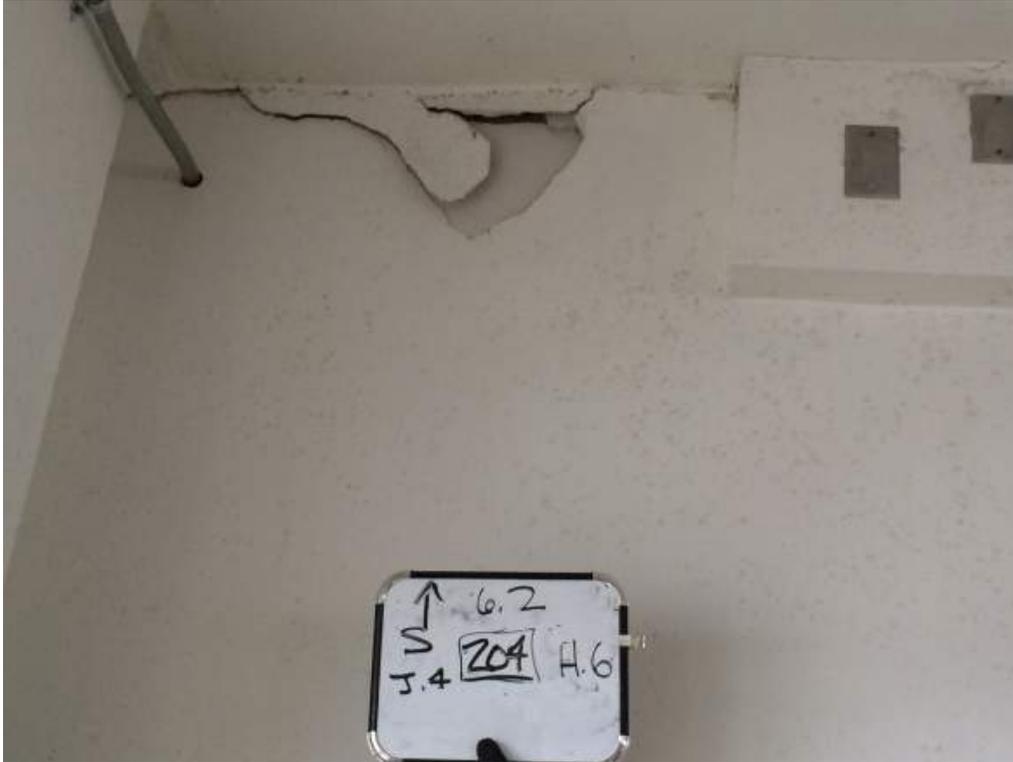
Photo 15: 4th Floor – Room 204 – Along col Line 6.2 between H.6 & J.4-Looking South – Horizontal crack @ top of CMU wall

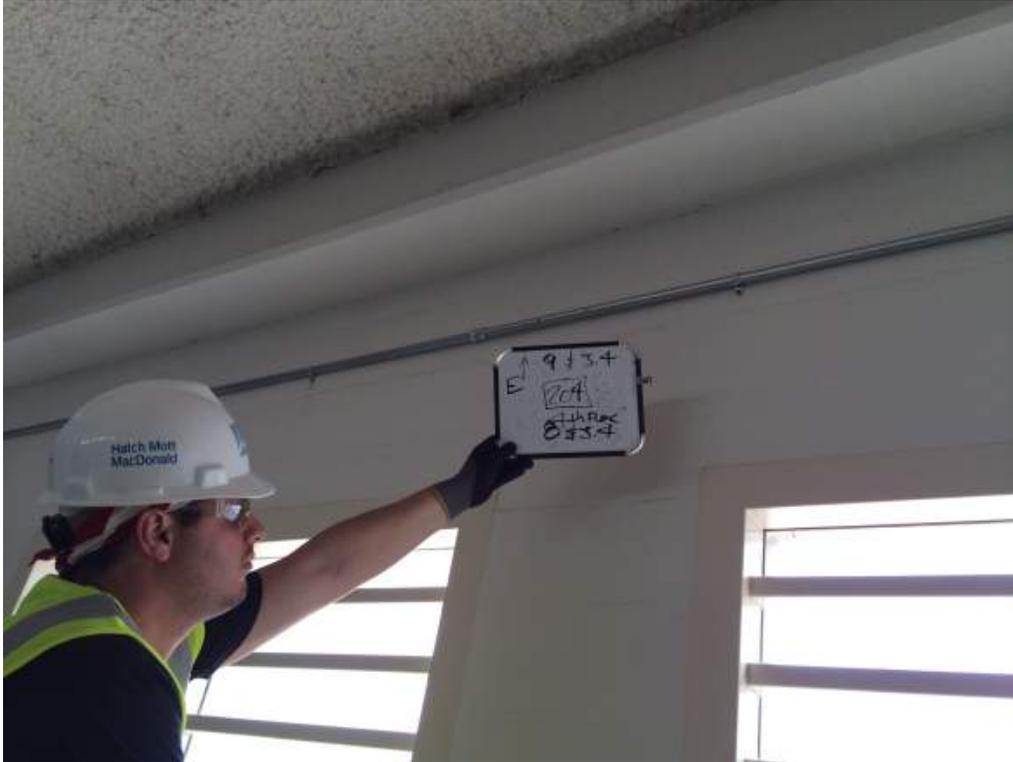
Photo 19: 4th Floor – Room 204 –Along col Line J.4 Between 8 and 9 –Looking East– Horizontal crack @ top of CMU wall

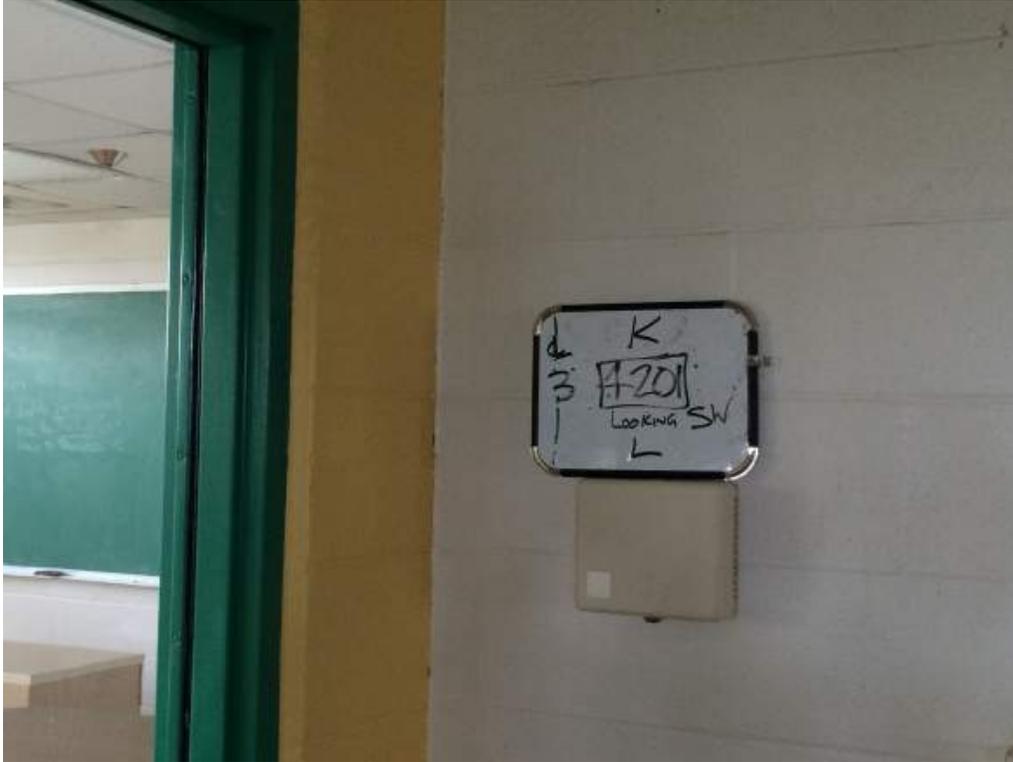
Photo 21: 4th Floor – Room 4201 – Along col line 3 between K and L – Looking West – Vertical crack at CMU wall corner

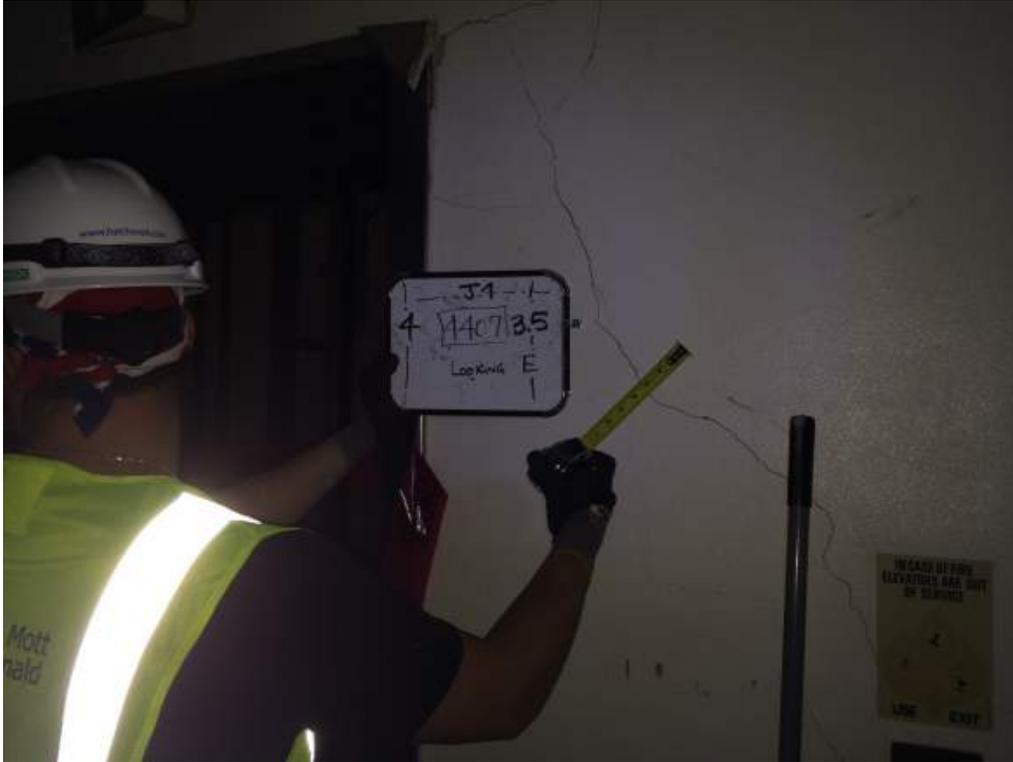
Photo 23: 4th Floor- Room 4407-Along col line J.4 between 3.5 and 4 – Looking East – Map cracking in elevator CMU wall
