Existing Condition Assessment Report

DEMOLITION OF CENTRAL BOOKING FACILITY

Escambia County Central Booking and Detention Facility
Condition Assessment Report - June 11, 2015

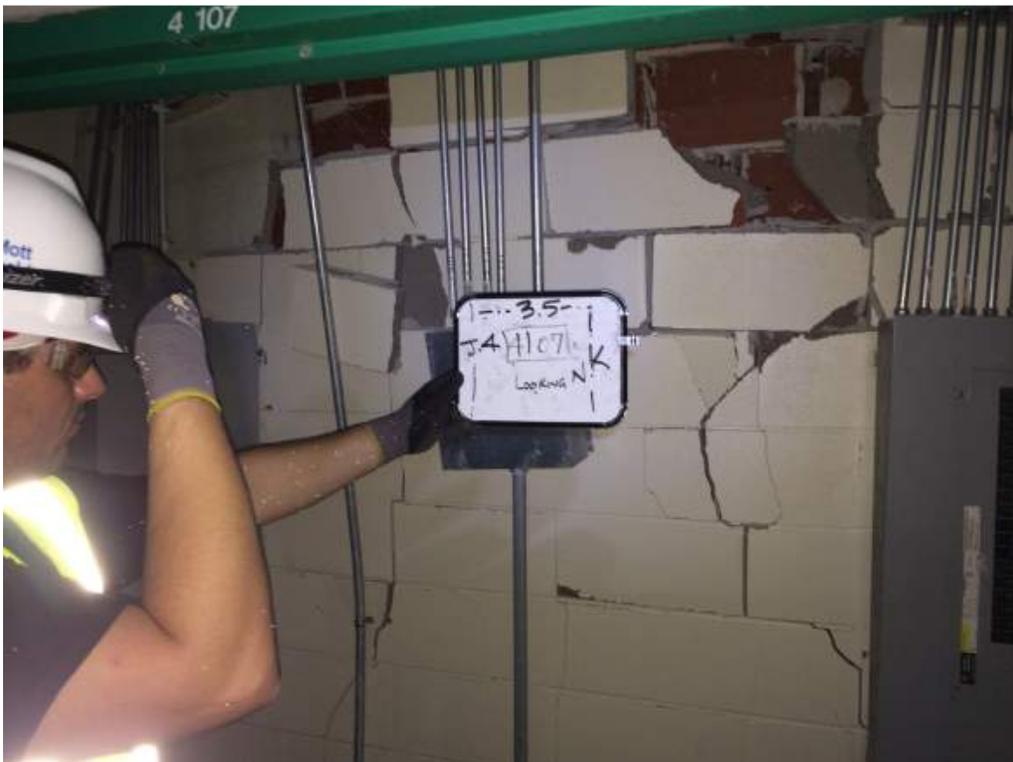
Photo 24: 4th Floor – Room 4107 – Along col line 3.5 between J.4 and K – Looking North – Collapsed elevator CMU wall

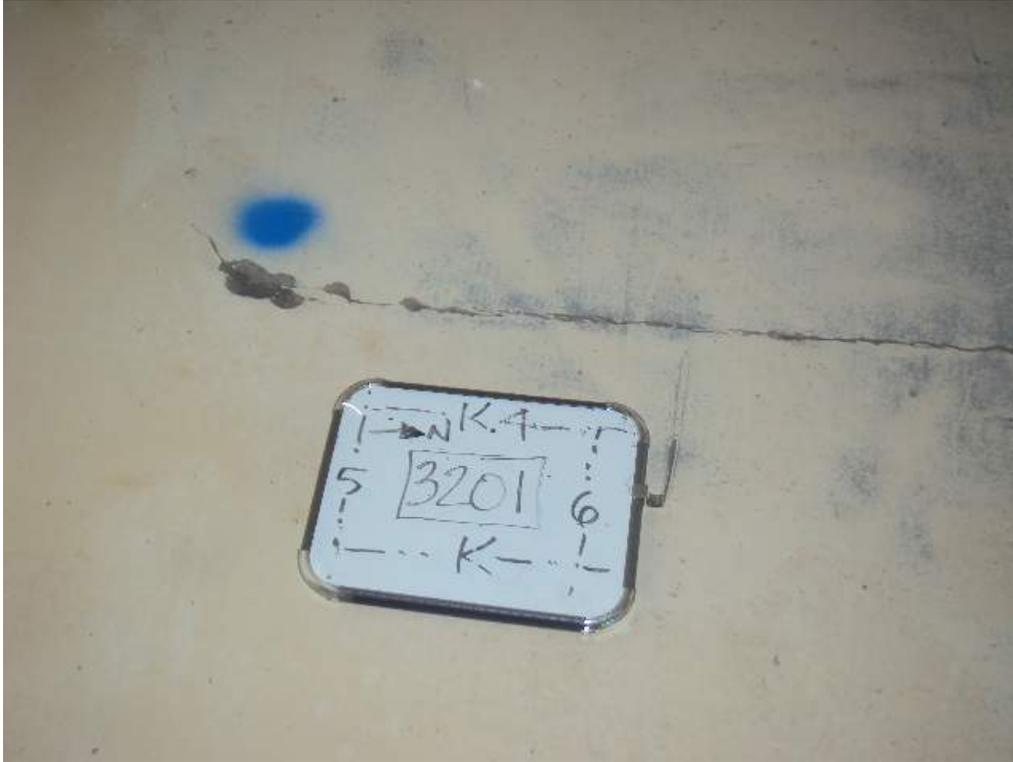
Photo 27: 3rd Floor- Room 3201 – Between col lines K and K.4 & 5 and 6- Crack in the floor slab

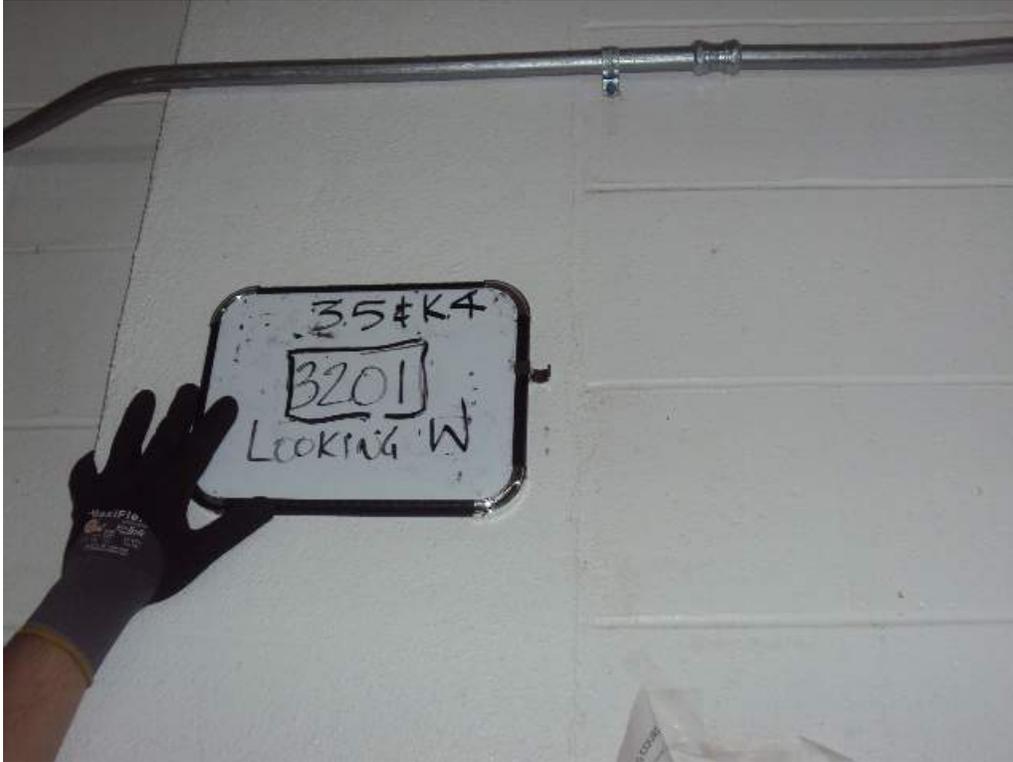
Photo 29: 3rd Floor – Room 3201-Col line 3.5 & K.4 – Looking West – Vertical crack between concrete column and CMU wall

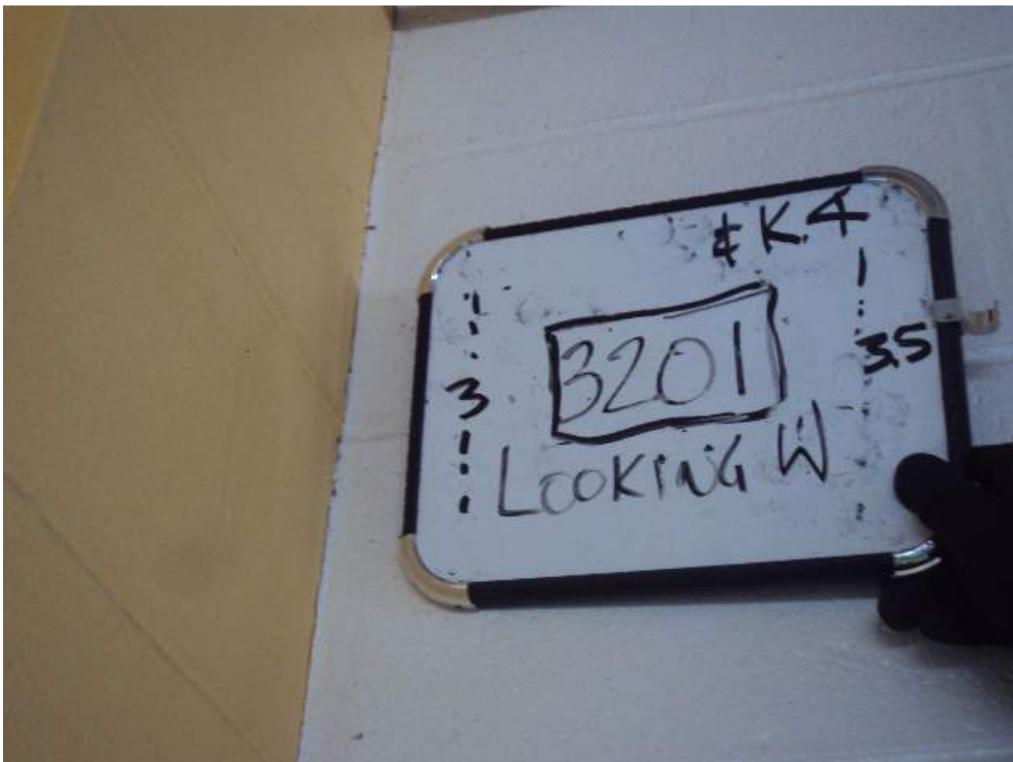
Photo 30: 3rd Floor – Room 3201 – Along col line K.4 between 3 and 3.5 – Looking West – Vertical crack at CMU wall corner

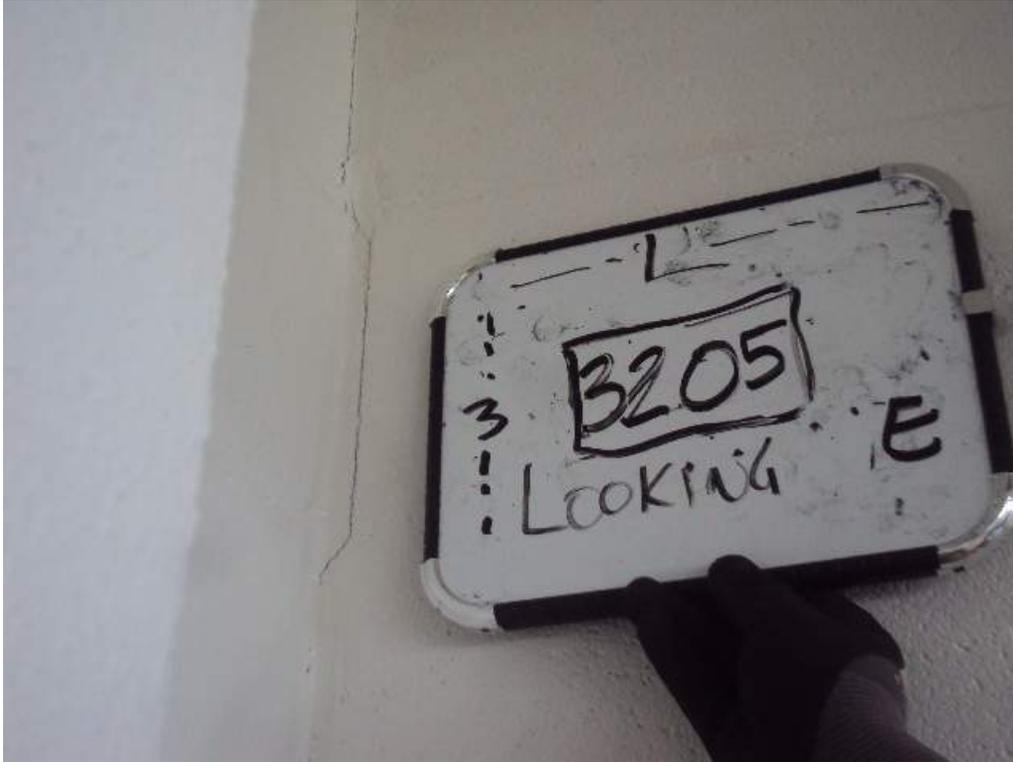
Photo 31: 3rd Floor – Room 3205 – Along col line 3 and L – Looking East – Vertical crack between the concrete column to CMU wall

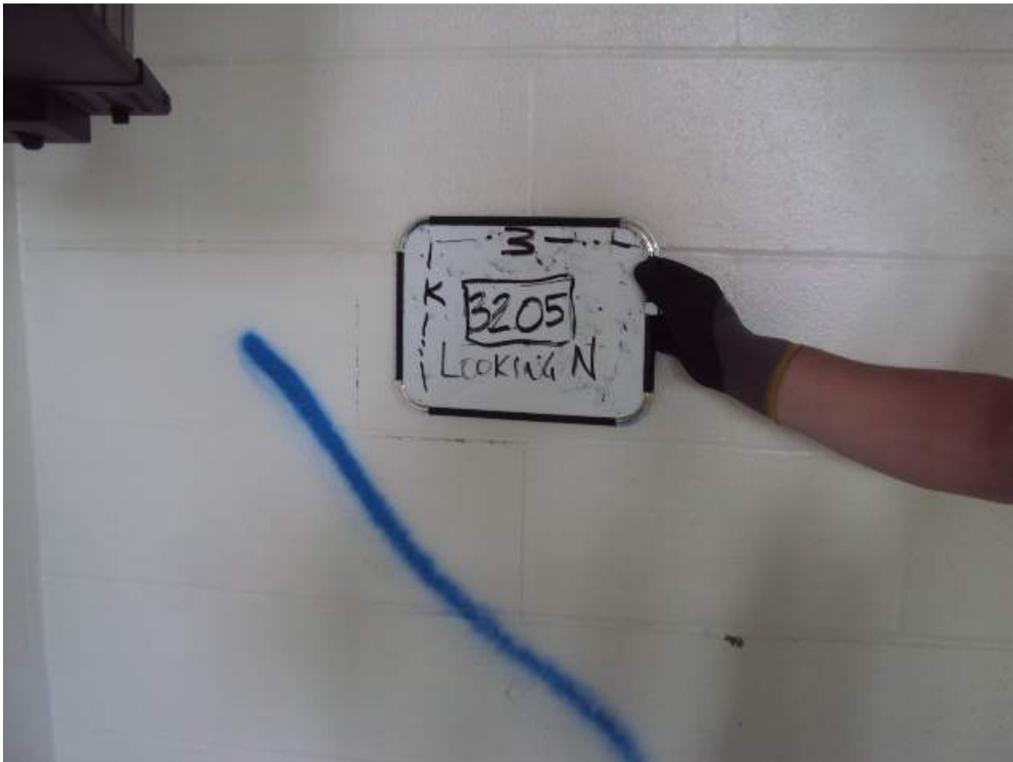
Photo 32: 3rd Floor – Room 3205 – Along col line 3 and K – Looking North – Stair step crack in CMU wall

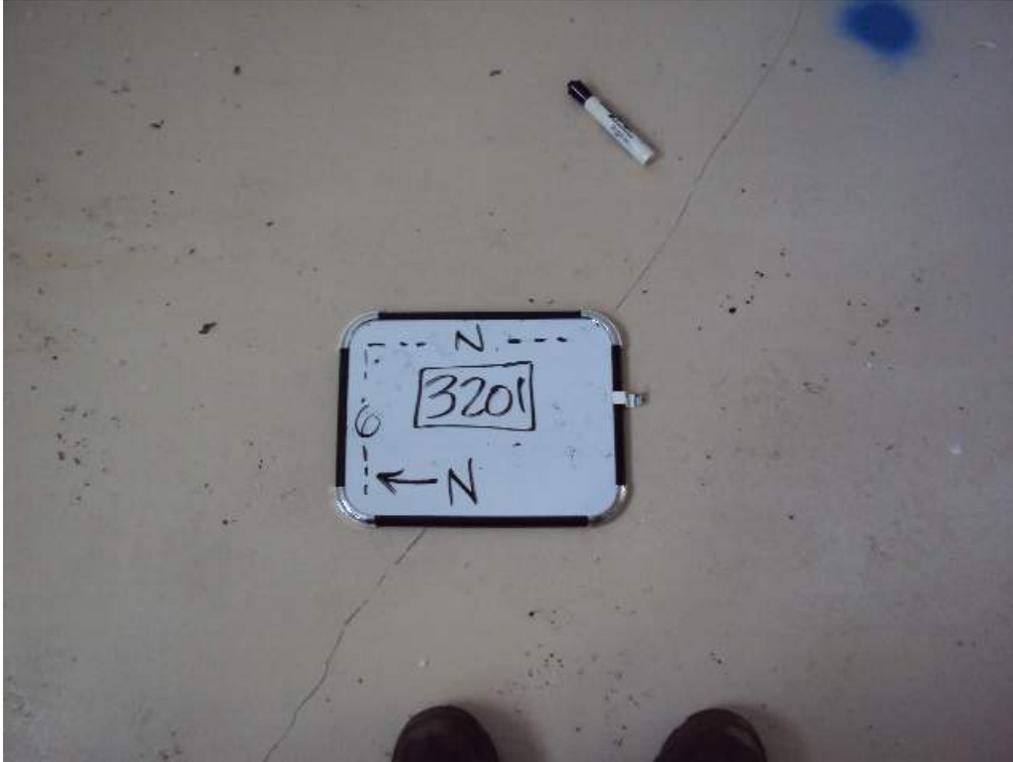
Photo 33: 3rd Floor – Room 3201 – Adjacent to col lines N and 6 – Crack in the floor slab

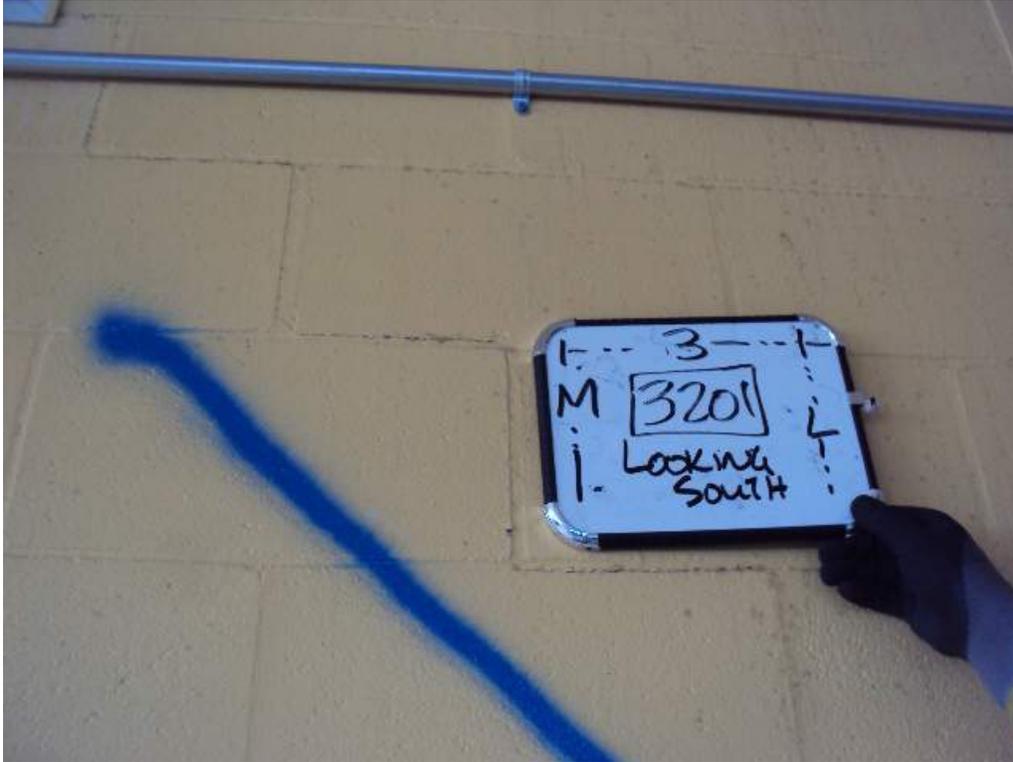
Photo 35: 3rd Floor – Room 3201 – Along col line 3 between L and M – Looking South – Stair step crack in CMU wall

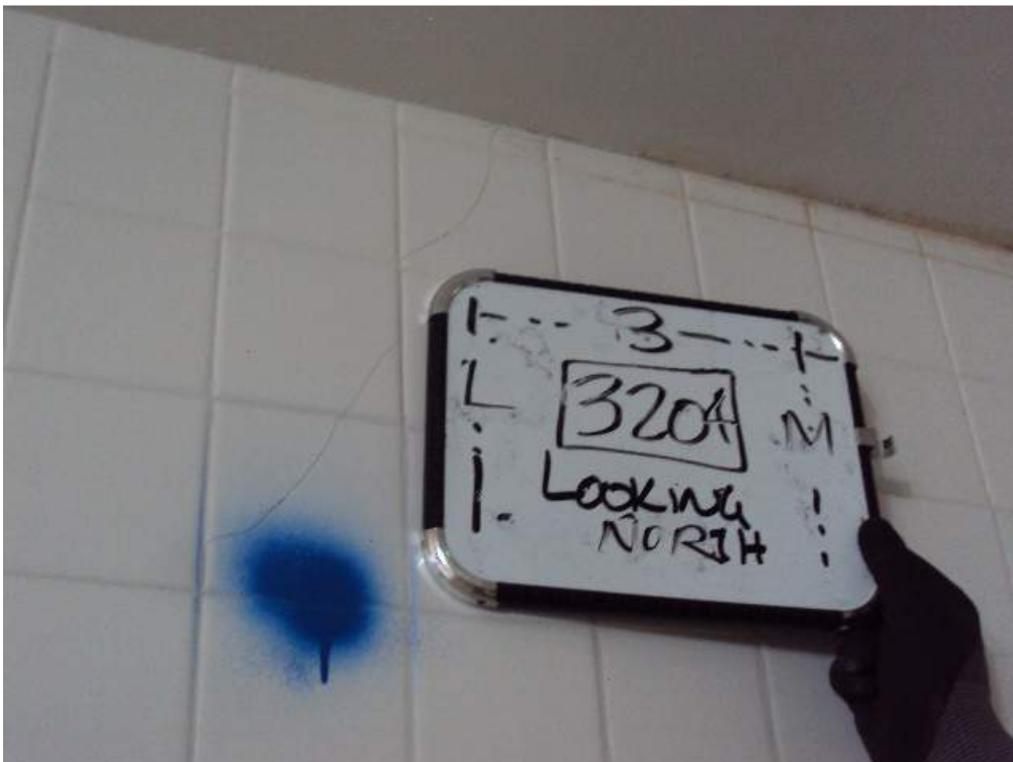
Photo 36: 3rd Floor – Room 3204 – Along col line 3 between L and M – Looking North – Stair step crack in tile in restroom walls

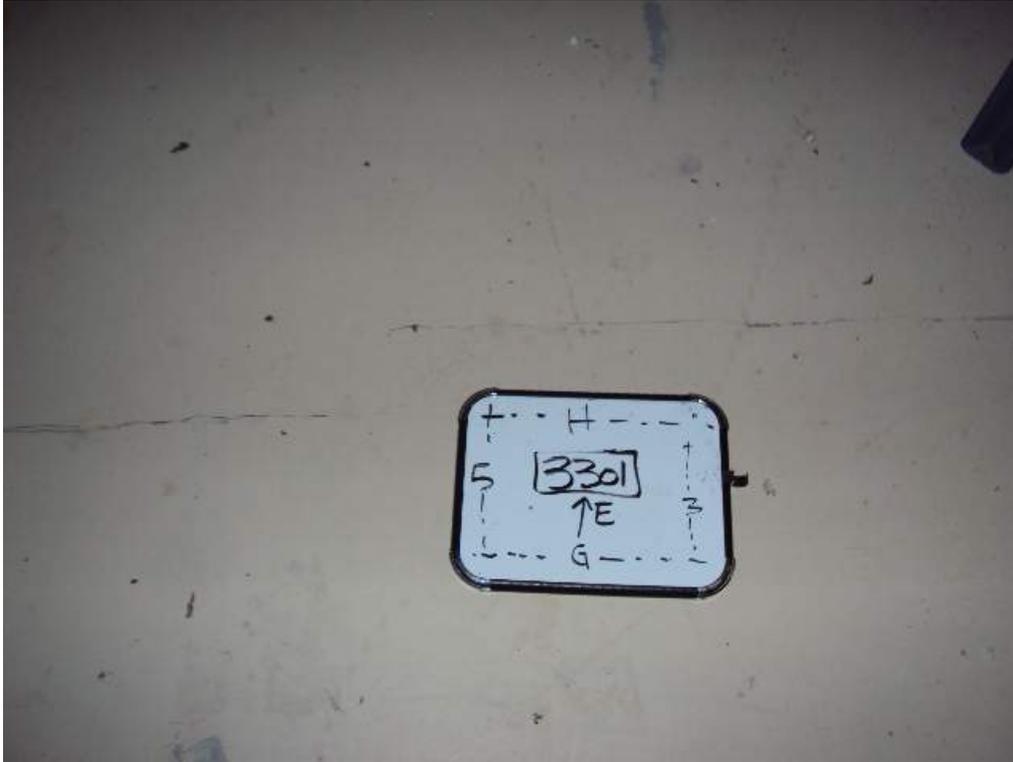
Photo 41: 3rd Floor – Room 3301 – Between col lines G & H and 3 & 5 –Cracks in floor slab

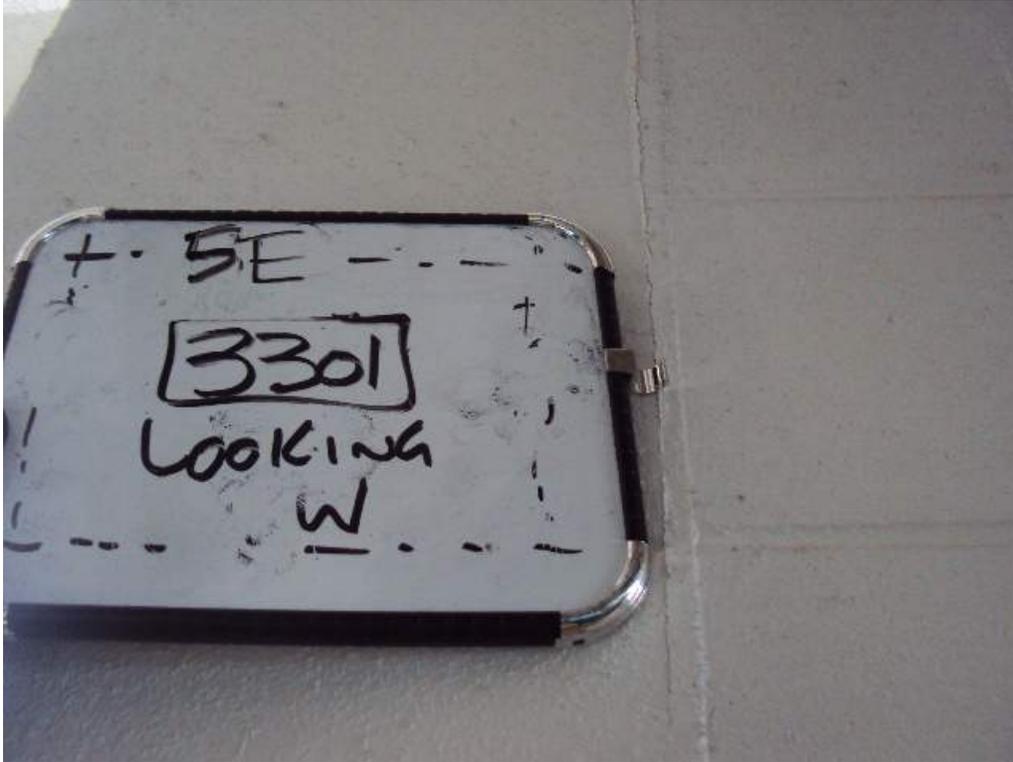
Photo 43: 3rd Floor – Room 3301 – At col line 5E – Looking West – Crack between concrete column and CMU wall

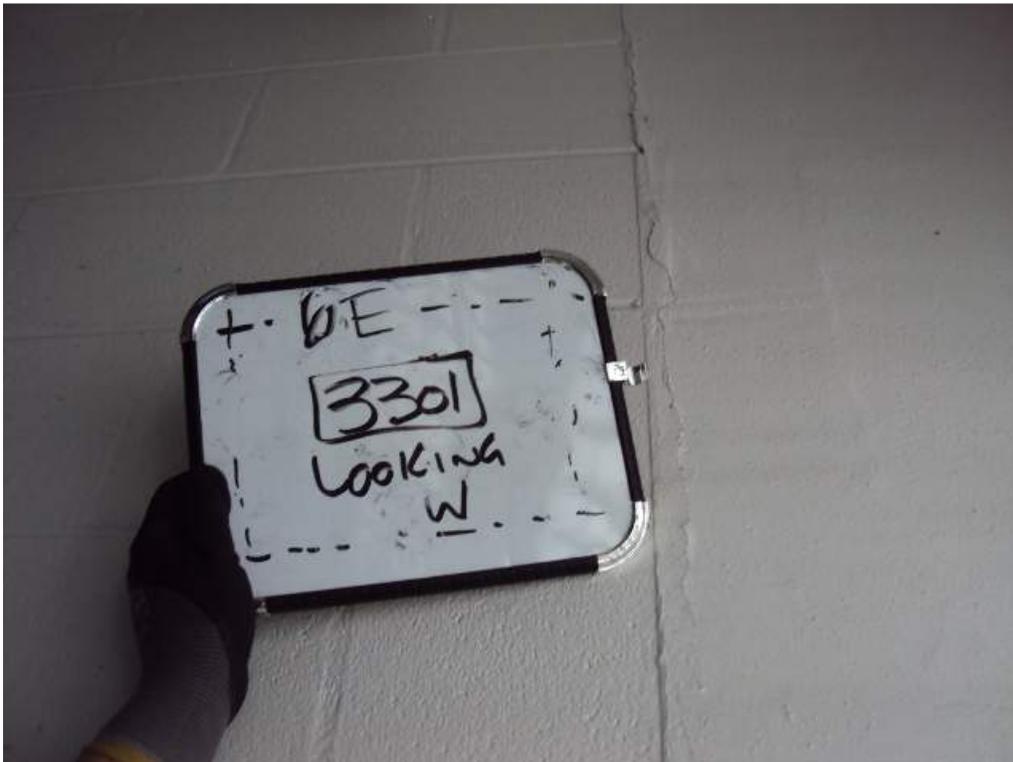
Photo 44: 3rd Floor – Room 3301 – At col line 6E – Looking West – Crack between concrete column and CMU wall

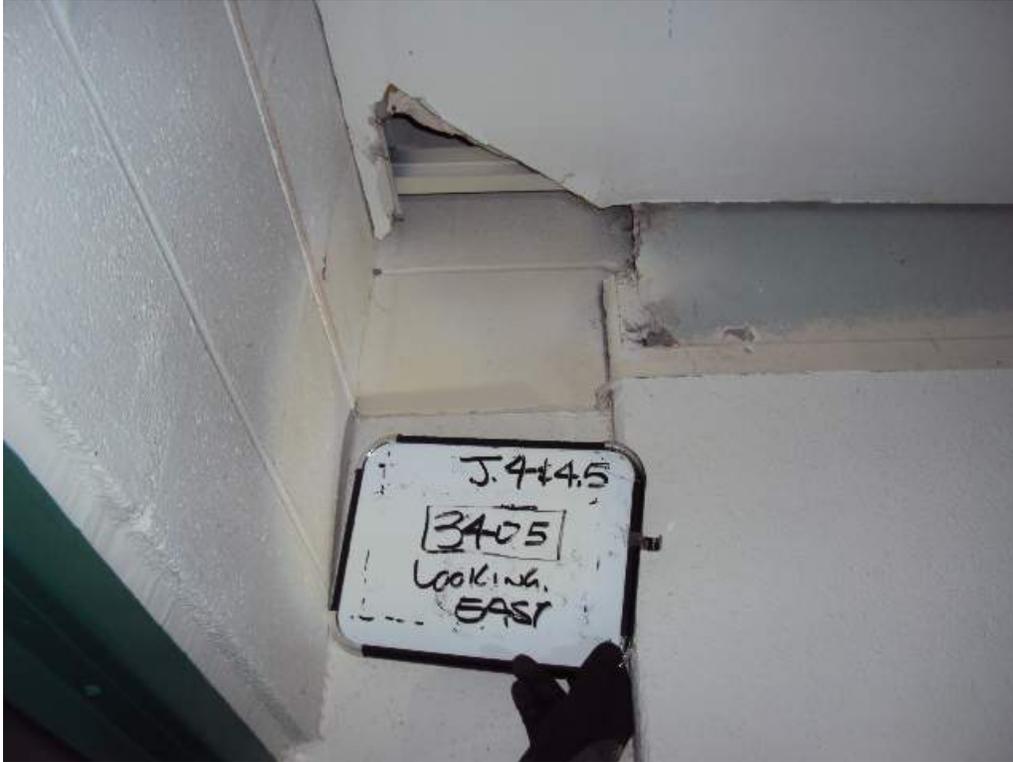
Photo 45: 3rd Floor – Room 3405 – At col line J.4 and 4.5 – Looking East – Crack at CMU wall corner & between concrete col and CMU wall

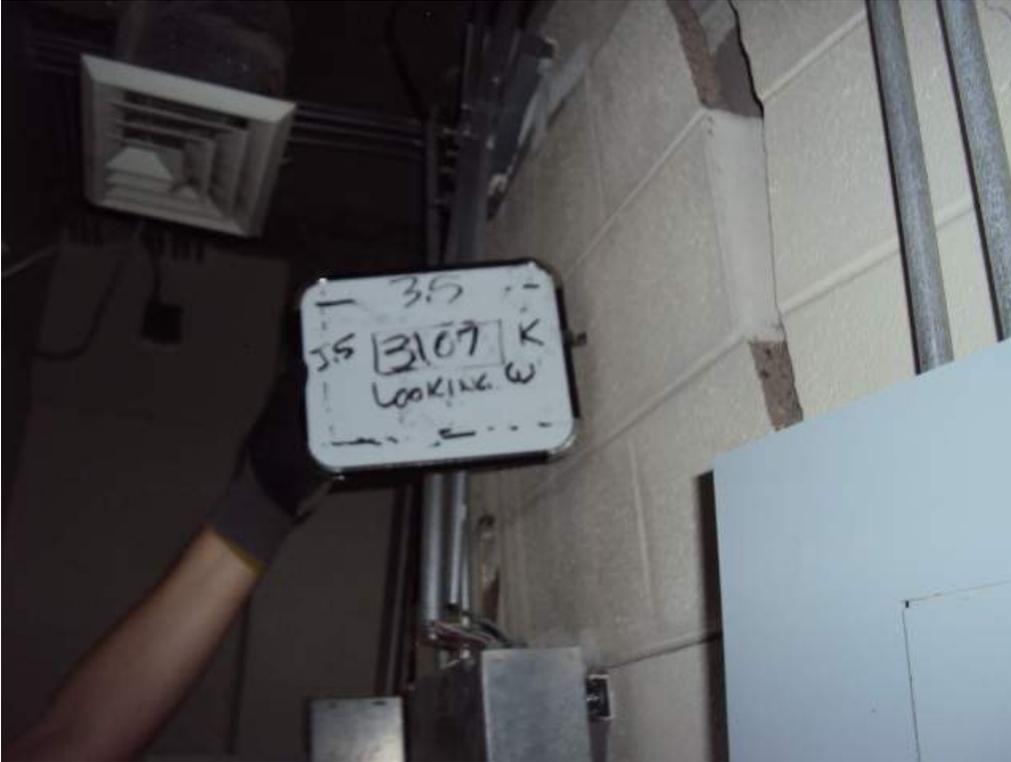
Photo 51: 3rd Floor – Room 3107 –Along col line 3.5 between col lines J.5 and K – Looking West - Collapsed elevator CMU wall

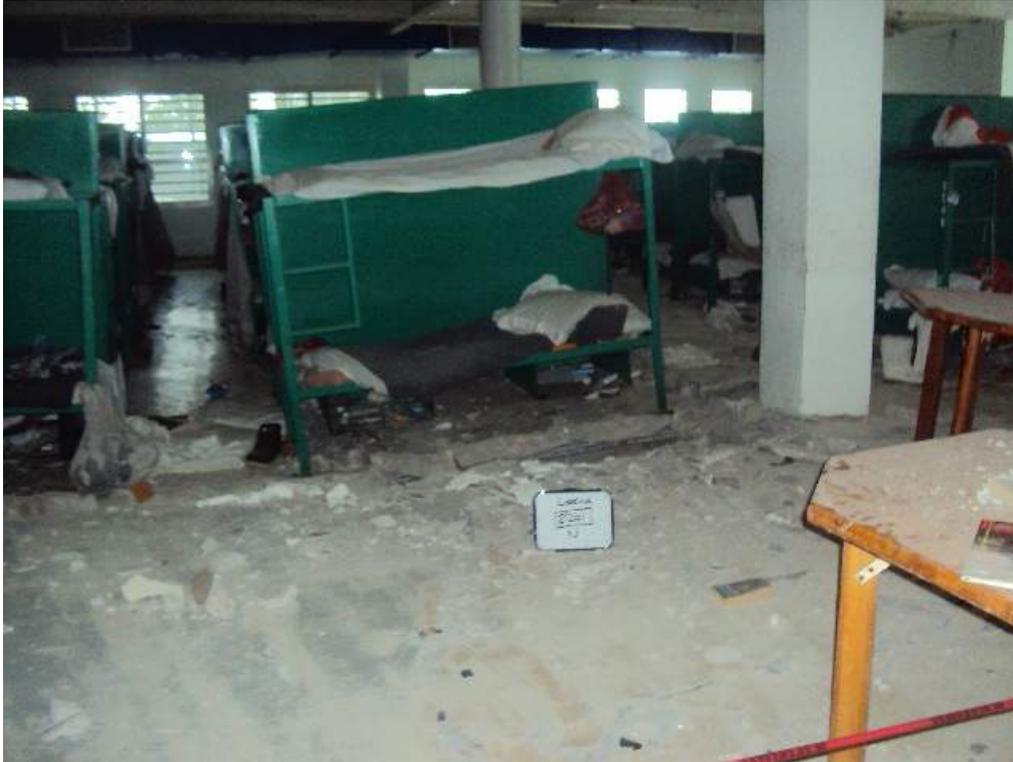
Photo 52: 2nd Floor – Room 2201-East Dormitory –Along col line 4 between column lines L and M – Looking North - Buckled, collapsed and sheared floor slab

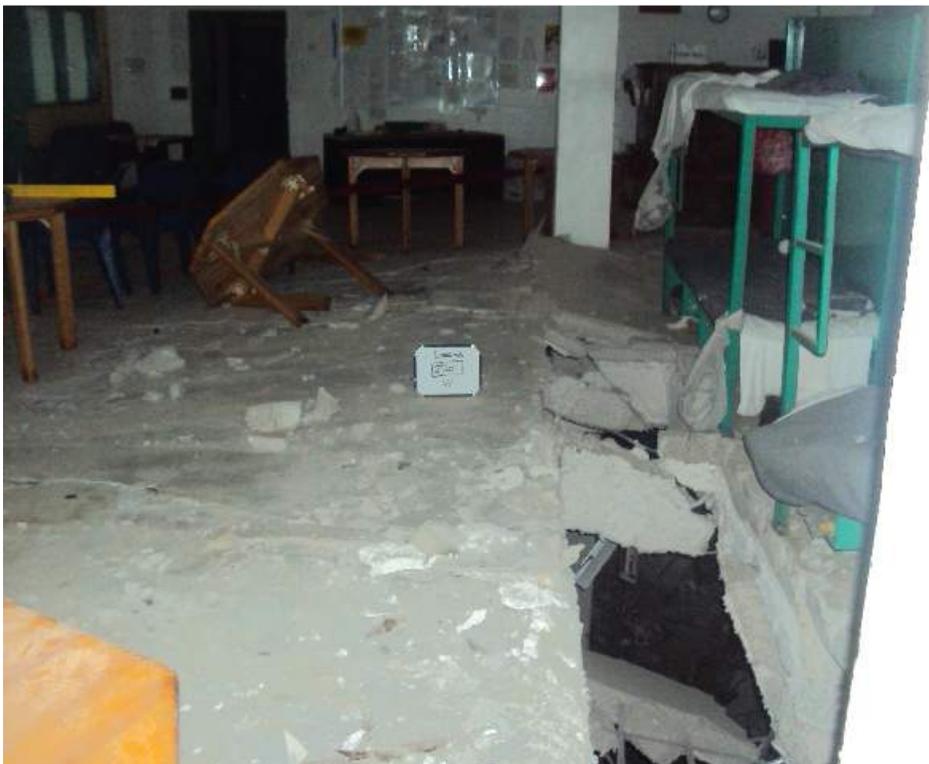
Photo 53: 2nd Floor – Room 2201-East Dormitory –Along col line 4 between column lines L and M – Looking West - Buckled, collapsed and sheared floor slab

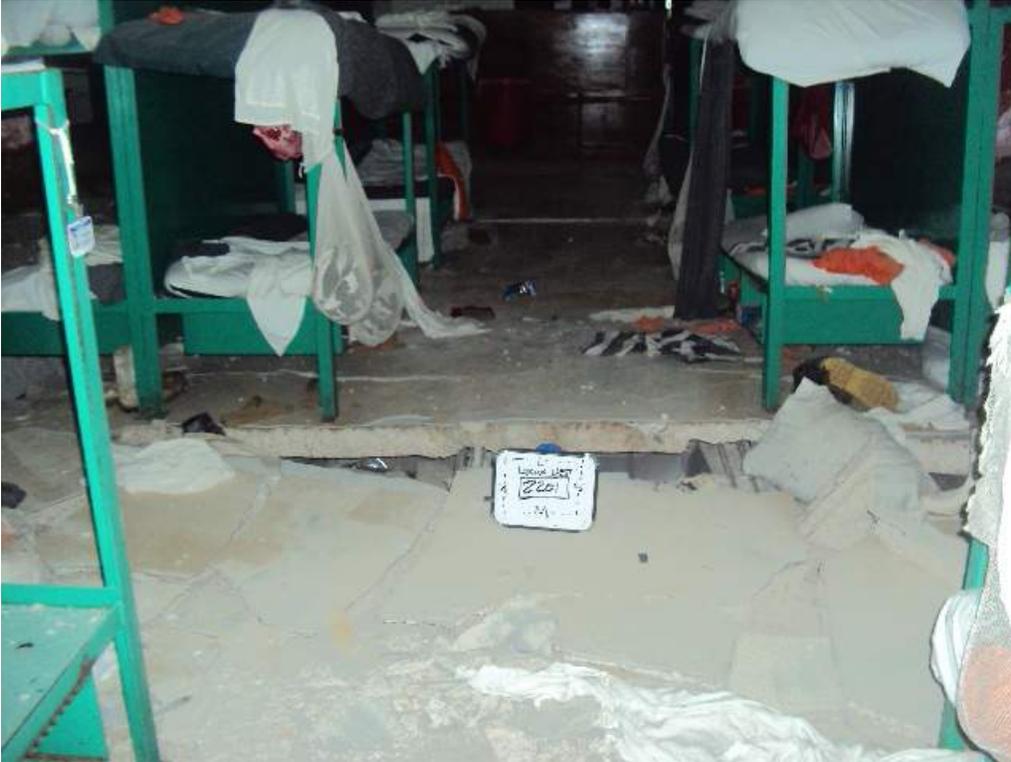
Photo 54: 2nd Floor – Room 2201-East Dormitory –Between column lines 4 and 5 & L and M - Looking West - Buckled, collapsed and sheared floor slab

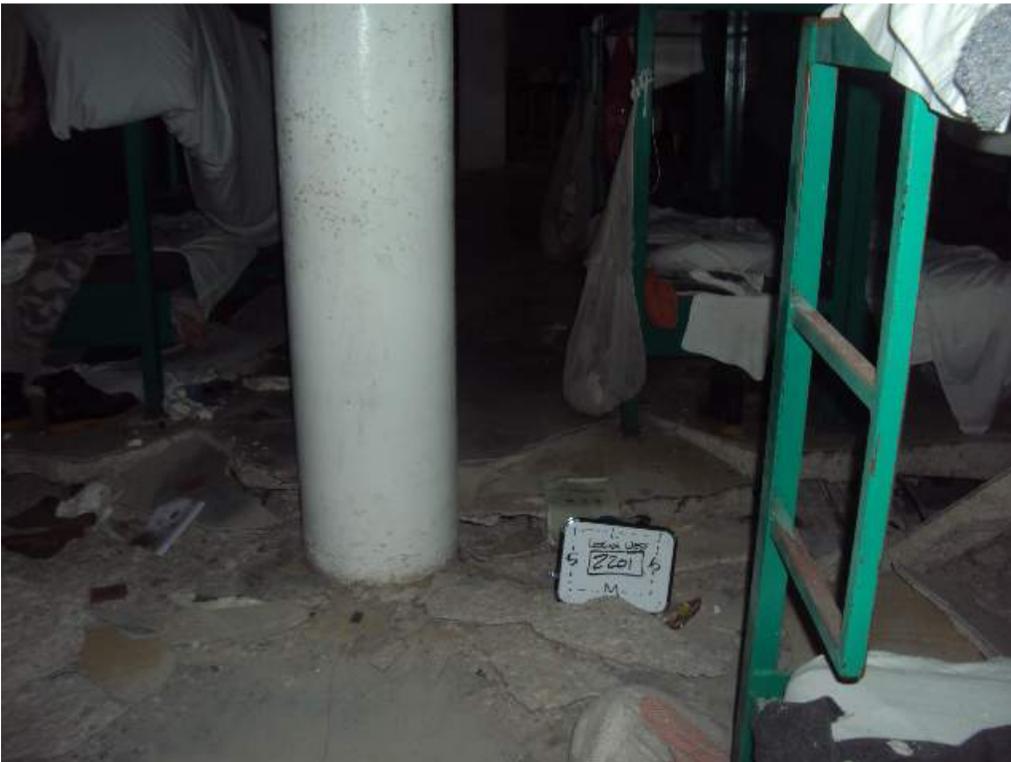
Photo 55: 2nd Floor – Room 2201-East Dormitory –Between column lines 4 and 5 & L and M - Looking West - Buckled, collapsed and sheared floor slab

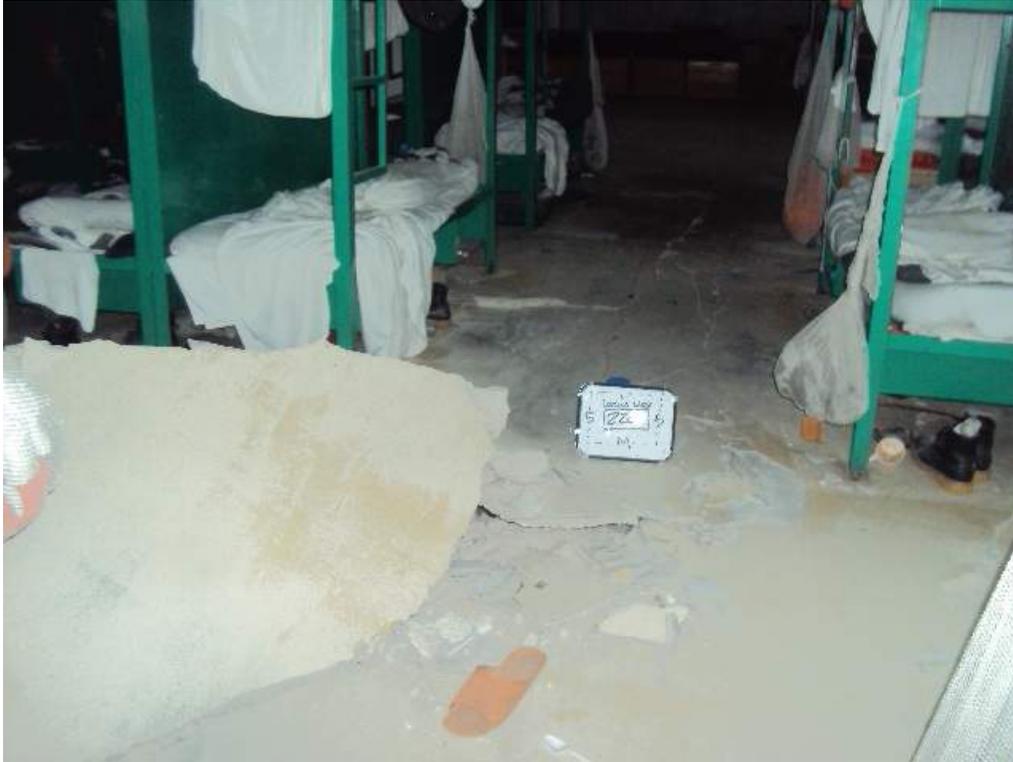
Photo 56: 2nd Floor – Room 2201-East Dormitory –Between column lines 5 and 6 & L and M - Looking West - Buckled, collapsed and sheared floor slab

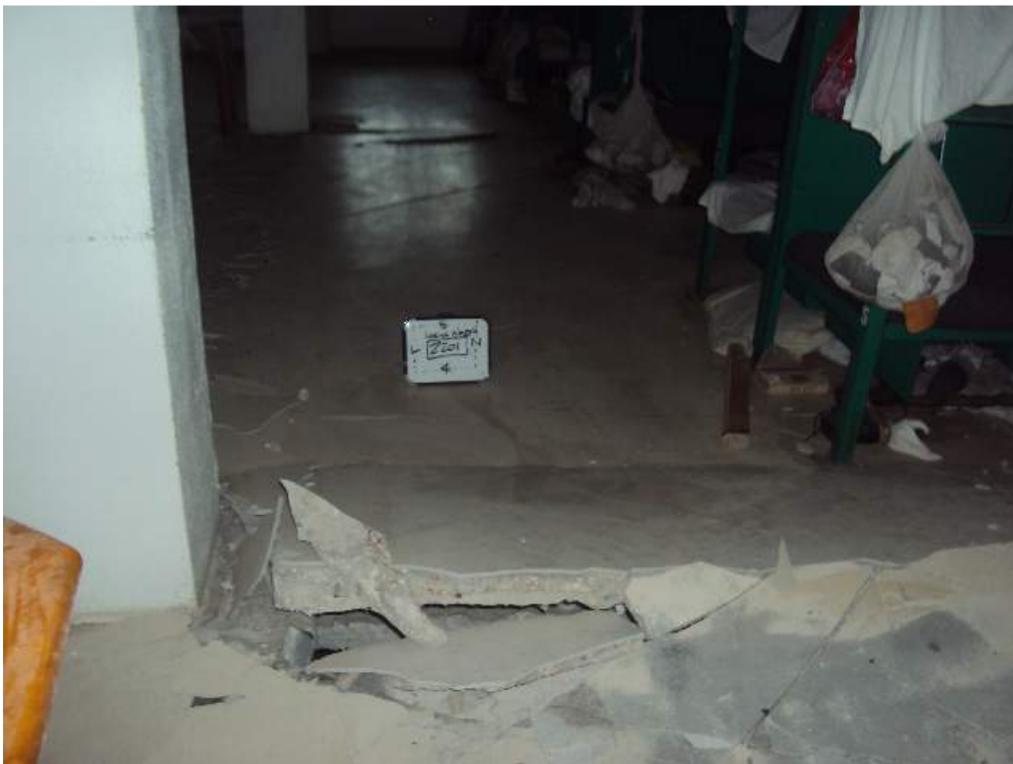
Photo 57: 2nd Floor – Room 2201-East Dormitory –Between column lines 4 and 5 & L and M - Looking North - Buckled, collapsed and sheared floor slab

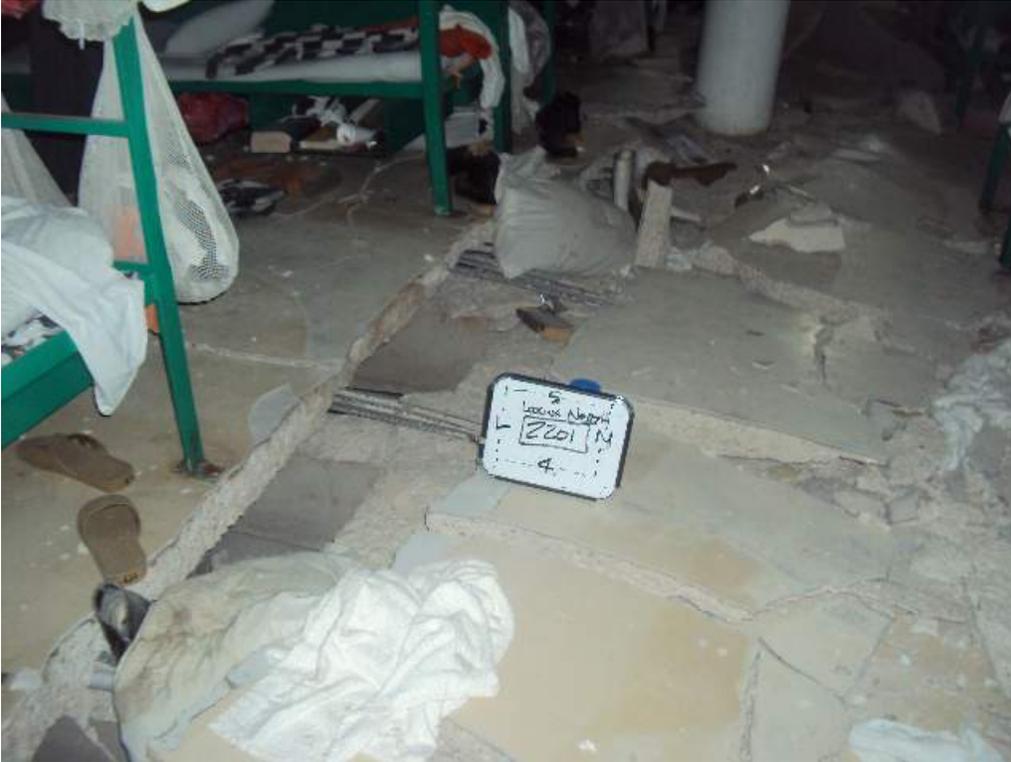
Photo 58: 2nd Floor – Room 2201-East Dormitory –Between column lines 4 and 5 & L and M - Looking North - Buckled, collapsed and sheared floor slab

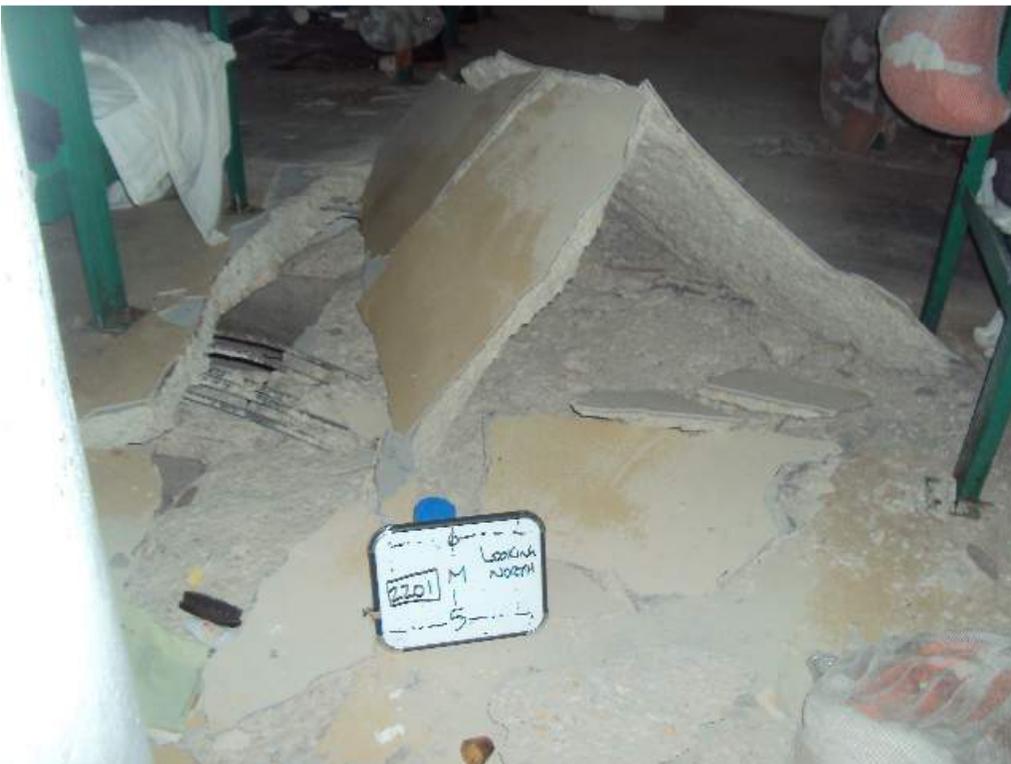
Photo 59: 2nd Floor – Room 2201-East Dormitory –Along column line M between col lines 5 and 6 - Looking North - Buckled, collapsed and sheared floor slab

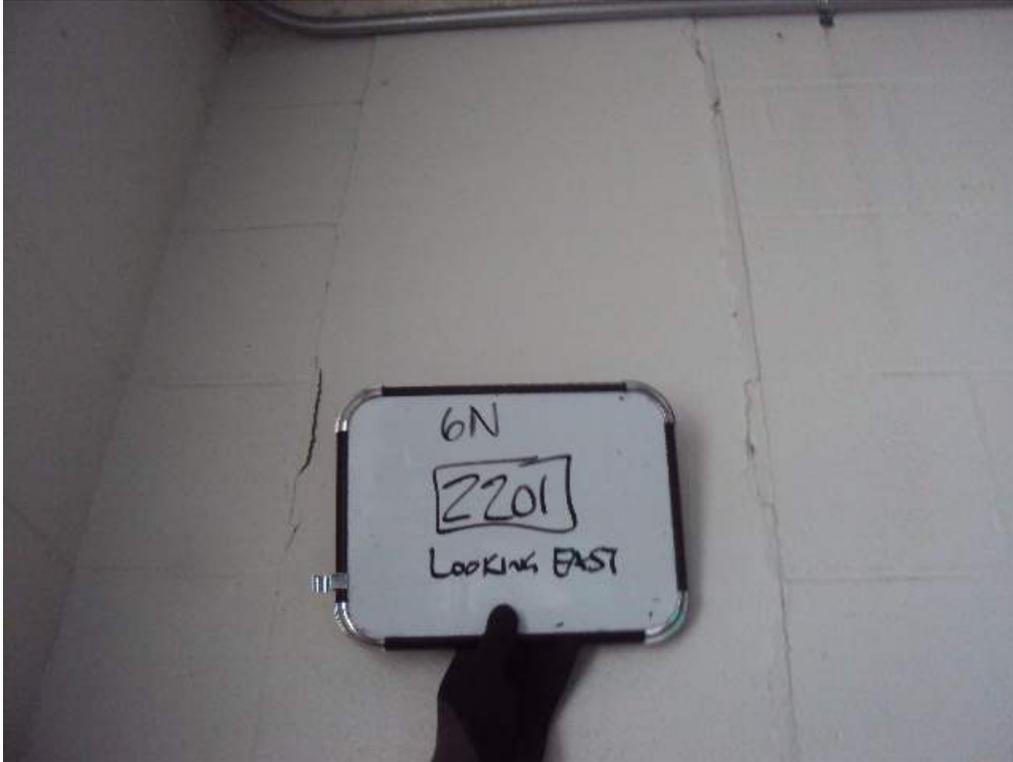
Photo 60: 2nd Floor – Room 2201-East Dormitory –At col line 6N - Looking East – Vertical cracks between concrete column and CMU walls

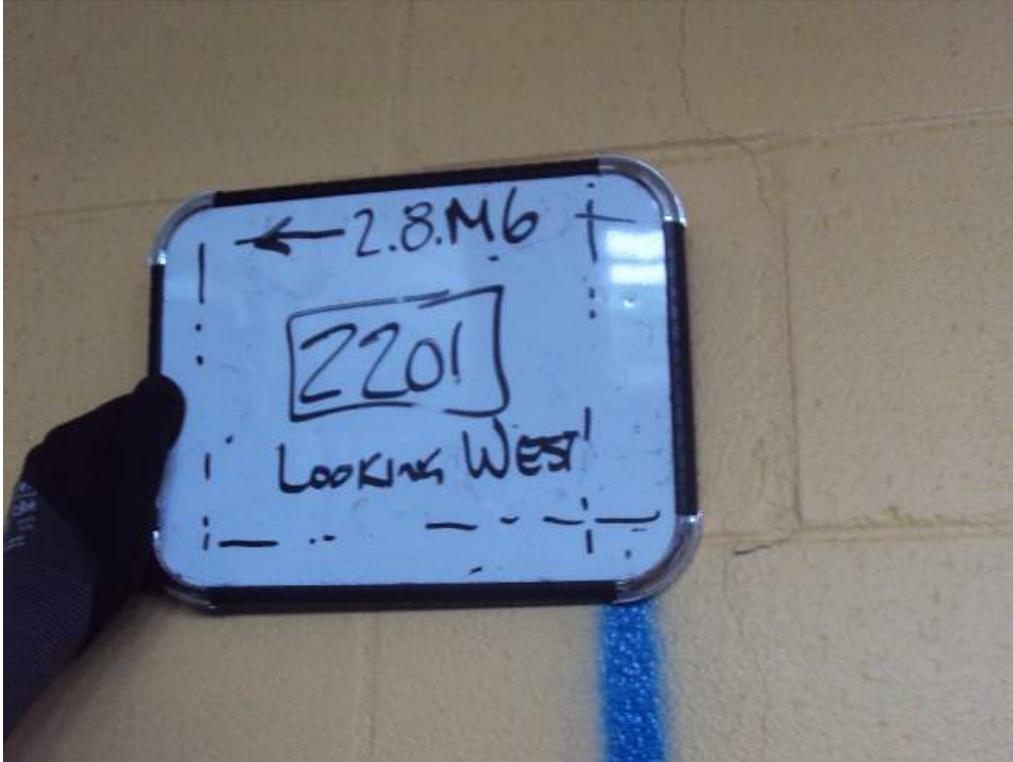
Photo 62: 2nd Floor – Room 2201-East Dormitory –Adjacent to col lines 2.8 & M6 - Looking West – Stair step/vertical cracks in CMU walls

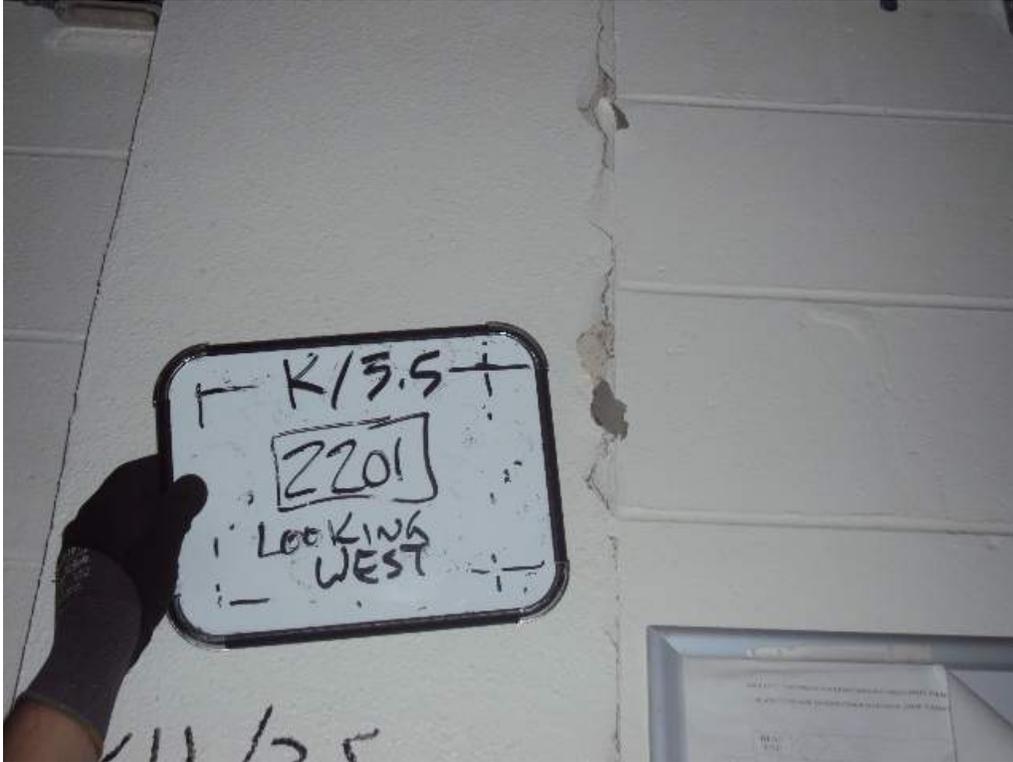
Photo 64: 2nd Floor – Room 2201 – East Dormitory – At column line 3.5&K- Looking West-Vertical cracks between a concrete column and CMU wall

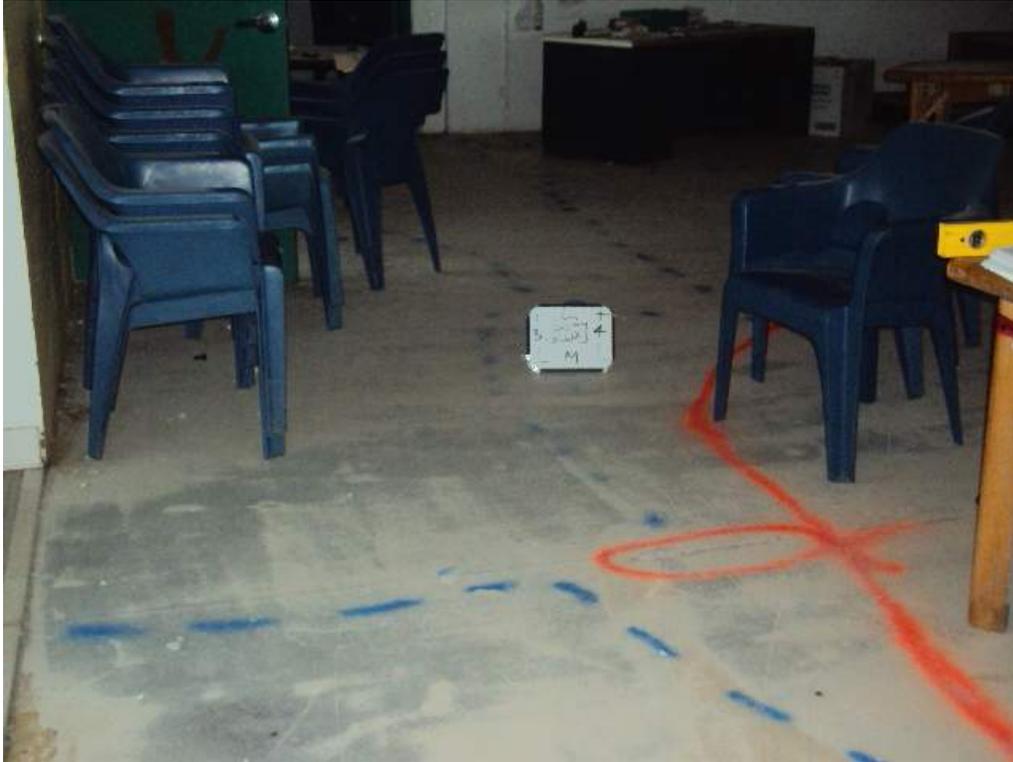
Photo 66: 2nd Floor – Room 2201 – East Dormitory – Between col lines L and M & 4 and 5-Looking West - Cracks in floor slab

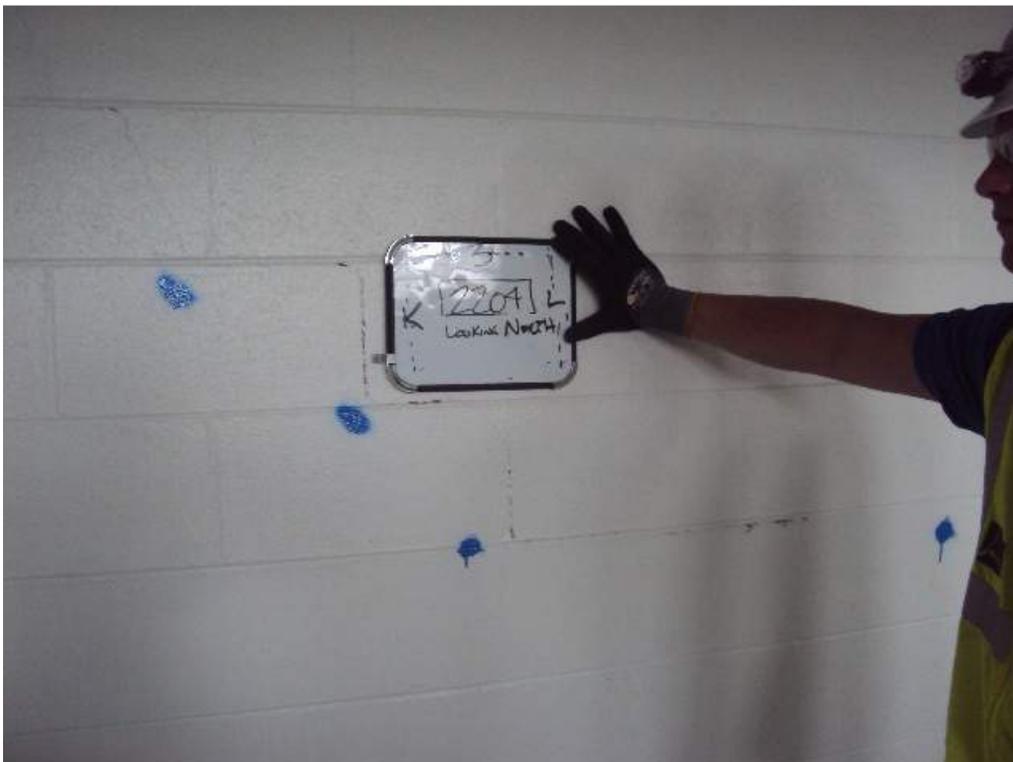
Photo 69: 2nd Floor – Room 2204 – Along col line 3 between col lines L and M-Looking North –Stair step crack in CMU wall

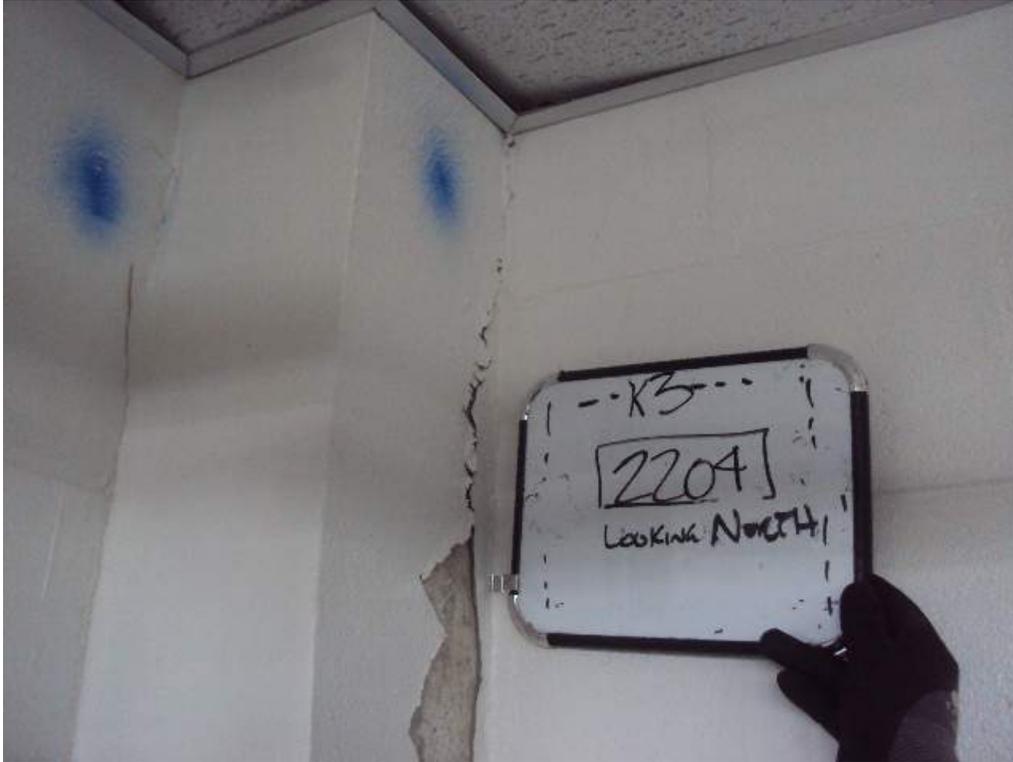
Photo 70: 2nd Floor – Room 2204 – At col line 3K-Looking North –Vertical crack between concrete col and CMU wall
