Existing Condition Assessment Report

DEMOLITION OF CENTRAL BOOKING FACILITY

Escambia County Central Booking and Detention Facility
Condition Assessment Report - June 11, 2015

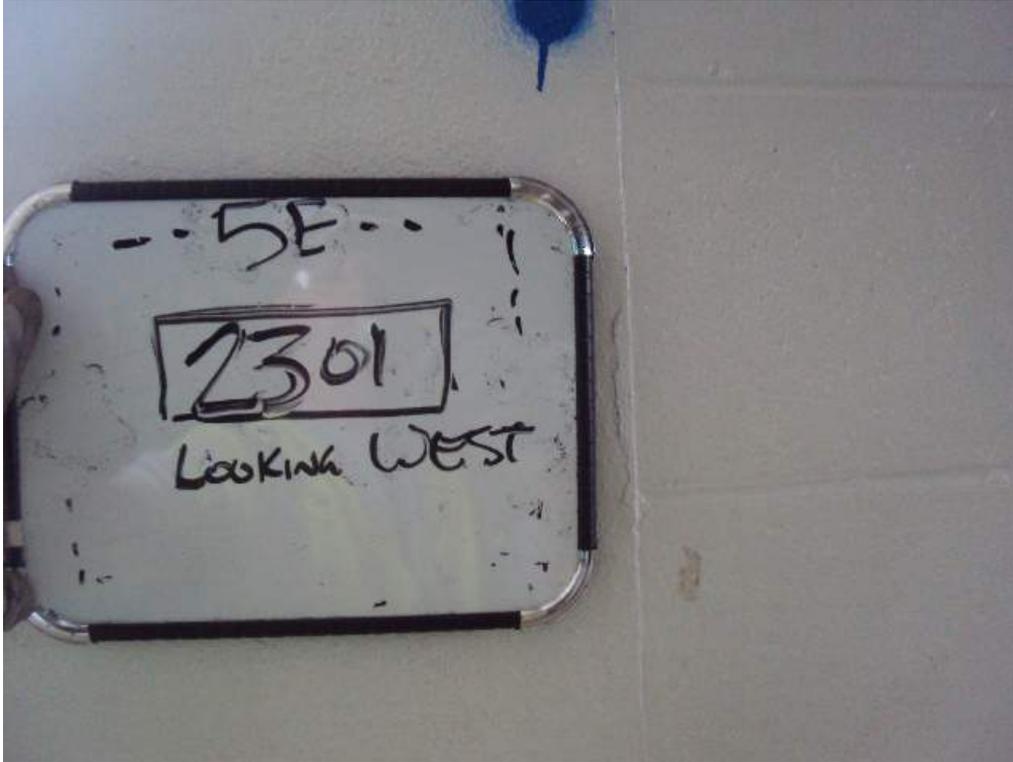
Photo 72: 2nd Floor – Room 2301 – At col line 5E-Looking West –Vertical crack between concrete col and CMU wall

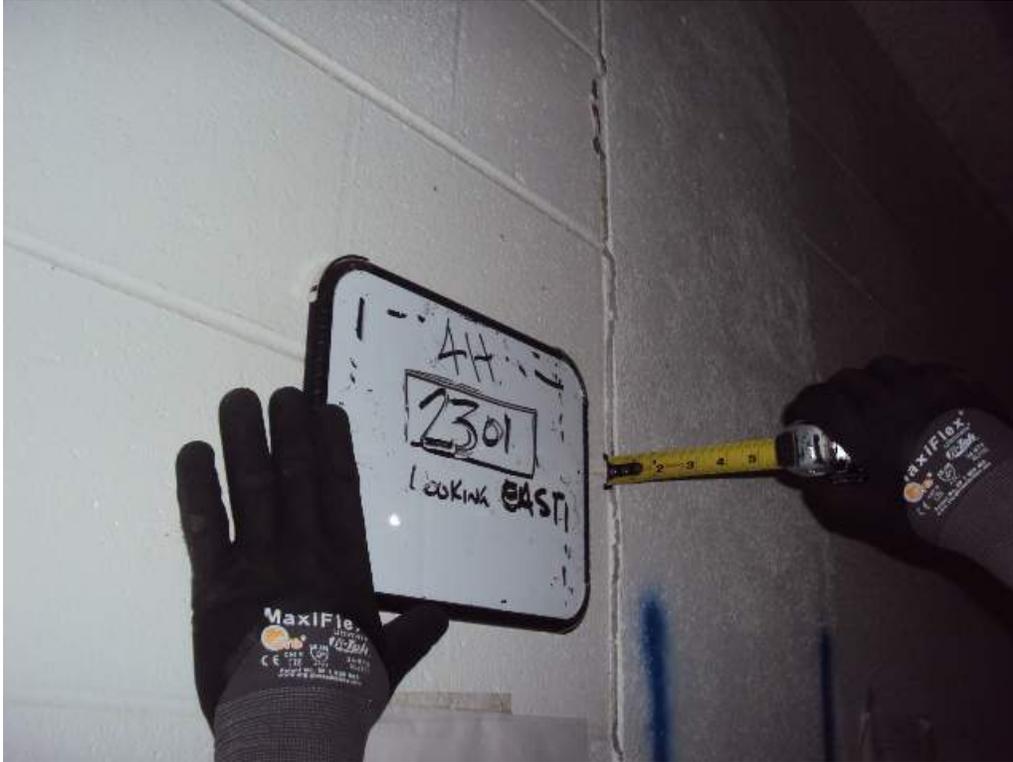
Photo 74: 2nd Floor – Room 2301 – At col line 4H-Looking East –Vertical crack between conc col and CMU wall and CMU wall displacement

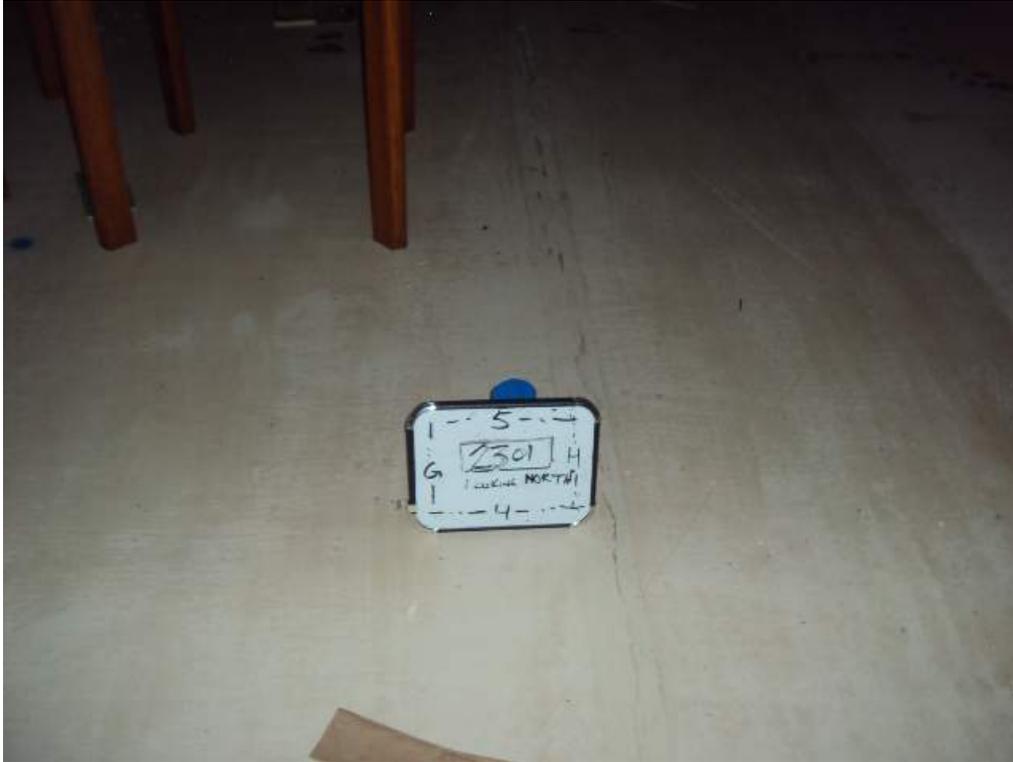
Photo 76: 2nd Floor – Room 2301 – Between col lines 4 and 5 & G and H-Looking North –Crack in the floor slab

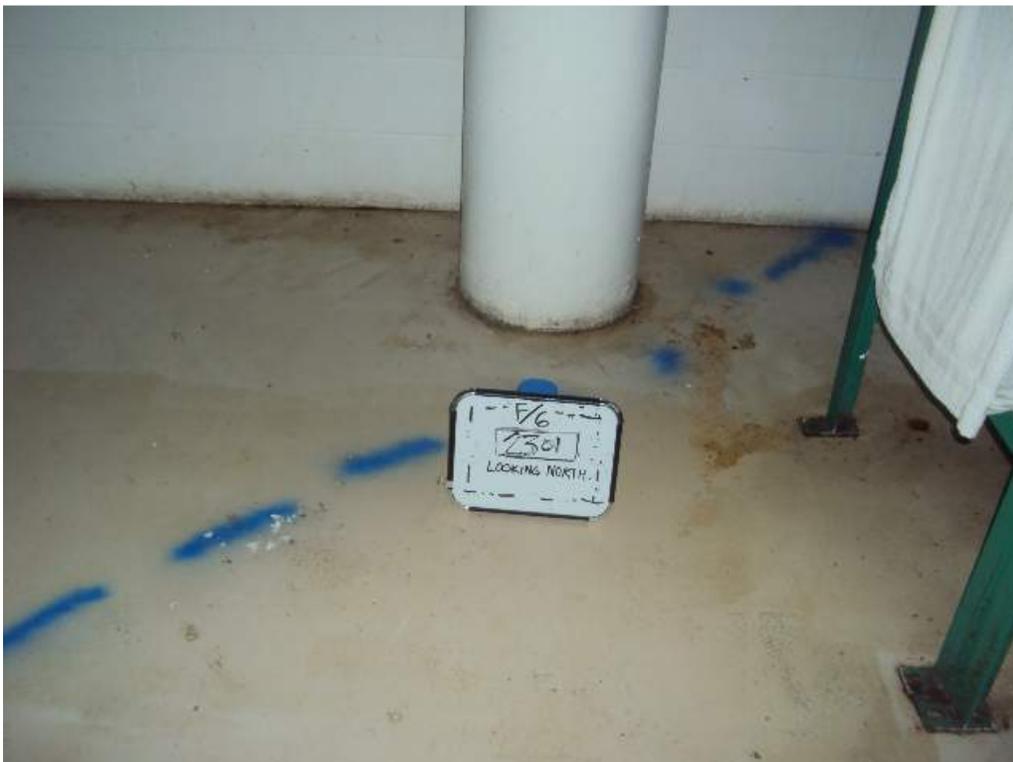
Photo 77: 2nd Floor – Room 2301 – At col line F6-Looking North –Crack in the floor slab

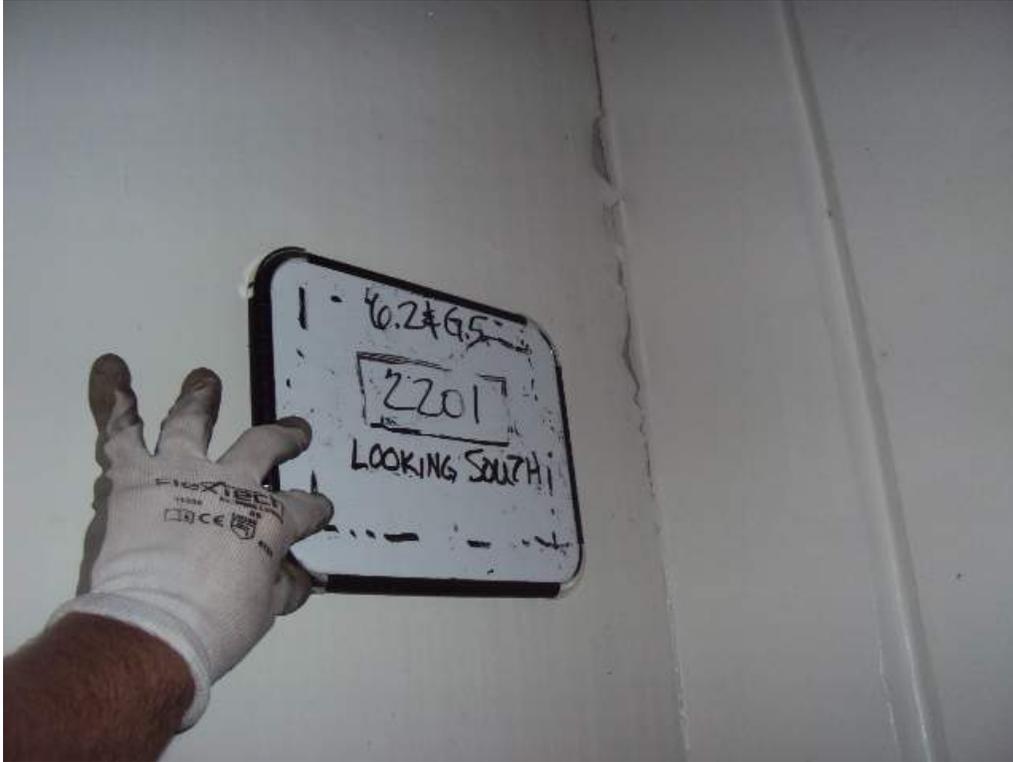
Photo 78: 2nd Floor – Room 2201 North Dormitory – At col line 6.5 & G.5 – Looking South – Vertical crack at the CMU wall intersection

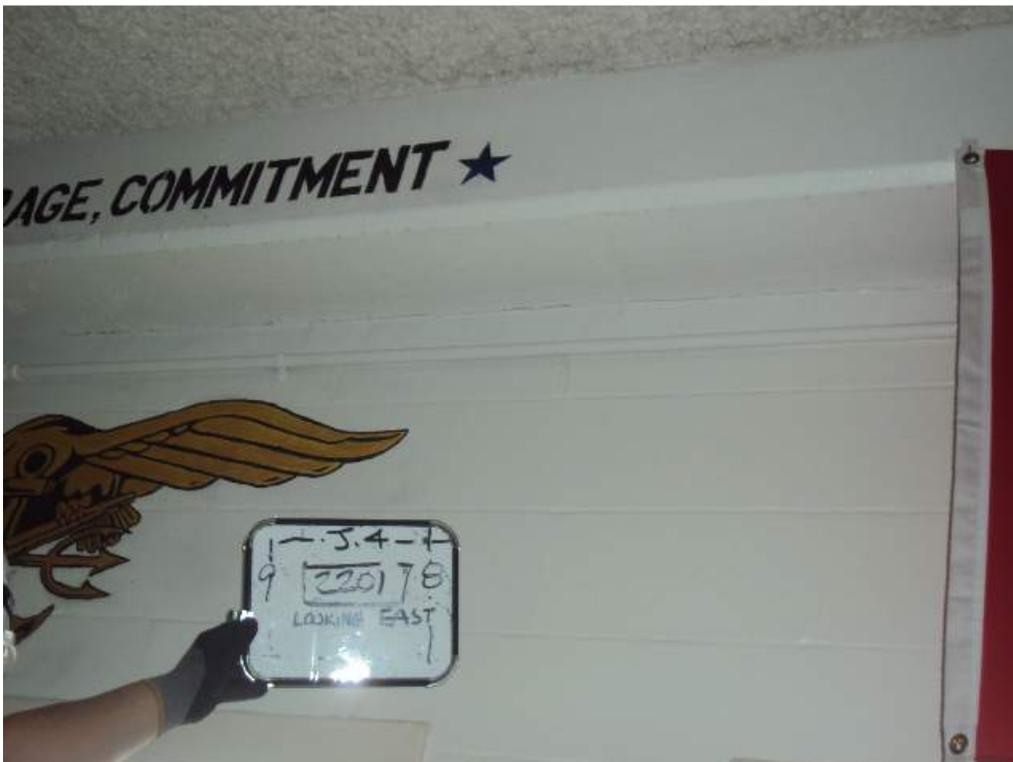
Photo 79: 2nd Floor – Room 2201 North Dormitory – Along col line J.4 between col lines 8 and 9 – Looking East – Horizontal crack @ top of wall between the concrete beam and CMU wall

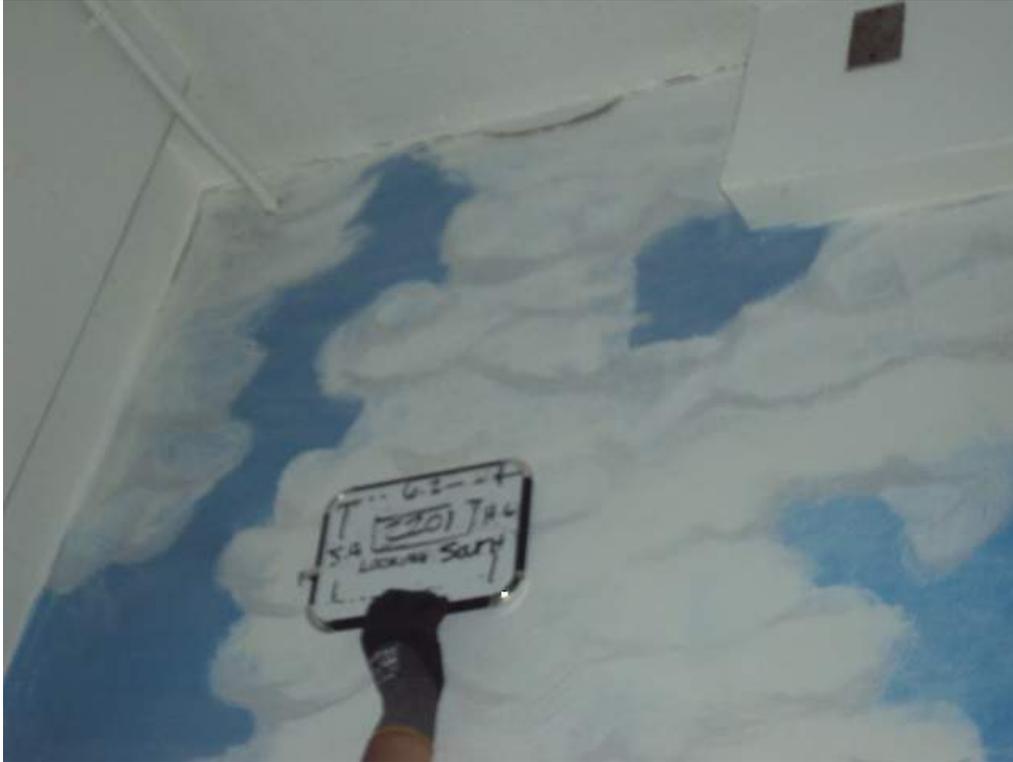
Photo 80: 2nd Floor – Room 2201 North Dormitory – Along col line 6.2 between col lines J.4 and H.6 – Looking South –Horizontal crack @ top of CMU wall

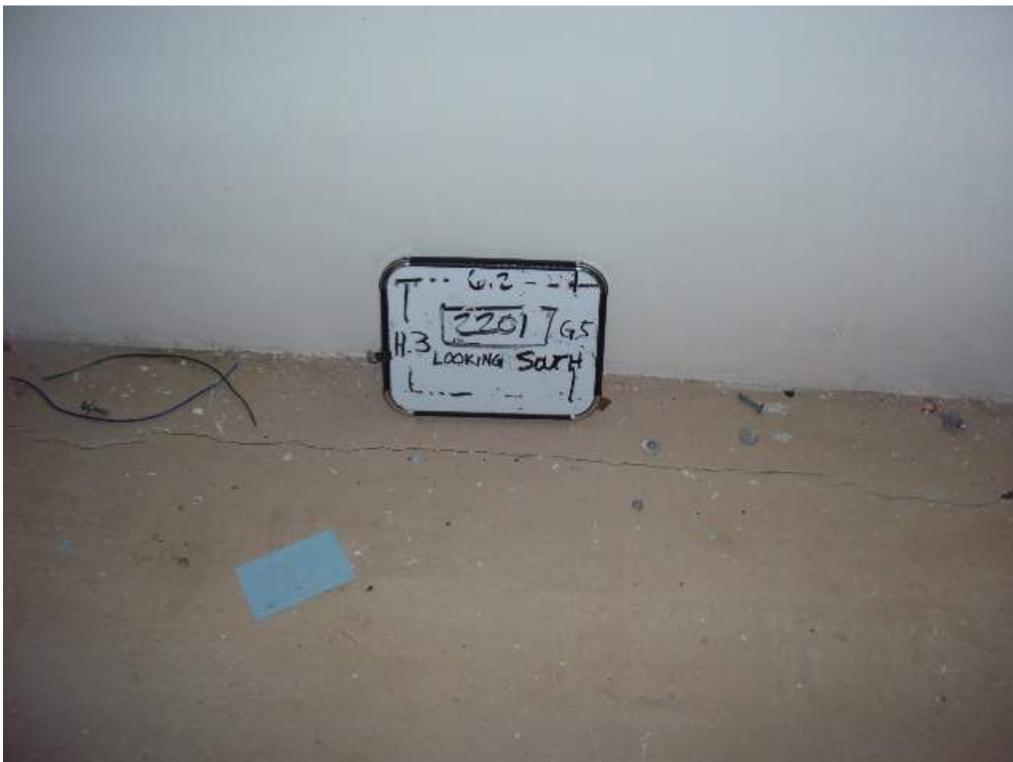
Photo 81: 2nd Floor – Room 2201 North Dormitory – Along col line 6.2 between col lines G.5 and H.3 – Looking South –Crack in the floor slab

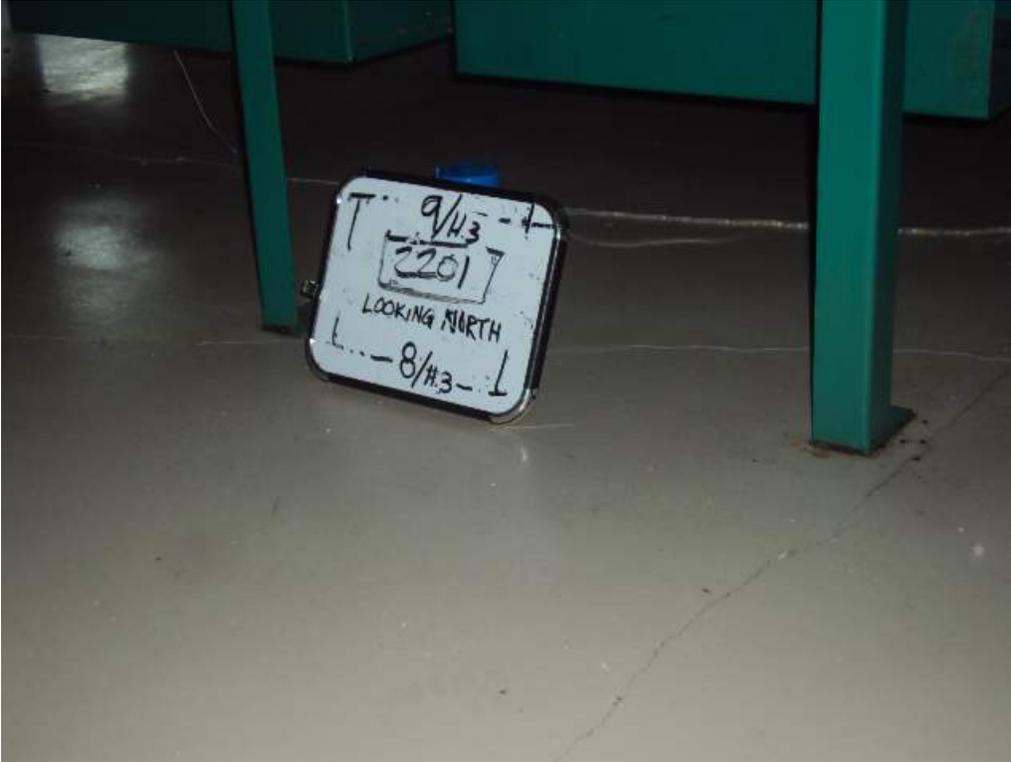
Photo 82: 2nd Floor – Room 2201 North Dormitory – Along col line H.3 between col lines 8 and 9 – Looking North –Crack in the floor slab

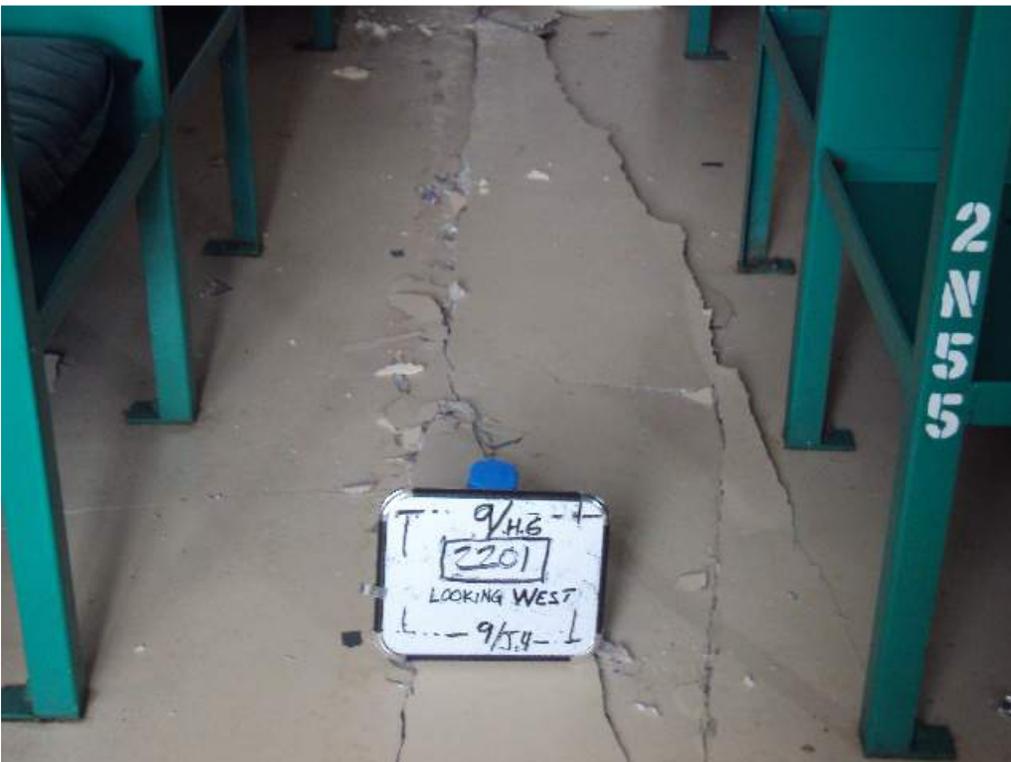
Photo 83: 2nd Floor – Room 2201 North Dormitory – Along col line 9 between col lines H.6 and J.4 – Looking West –Buckled, Cracked and Shear floor slabs

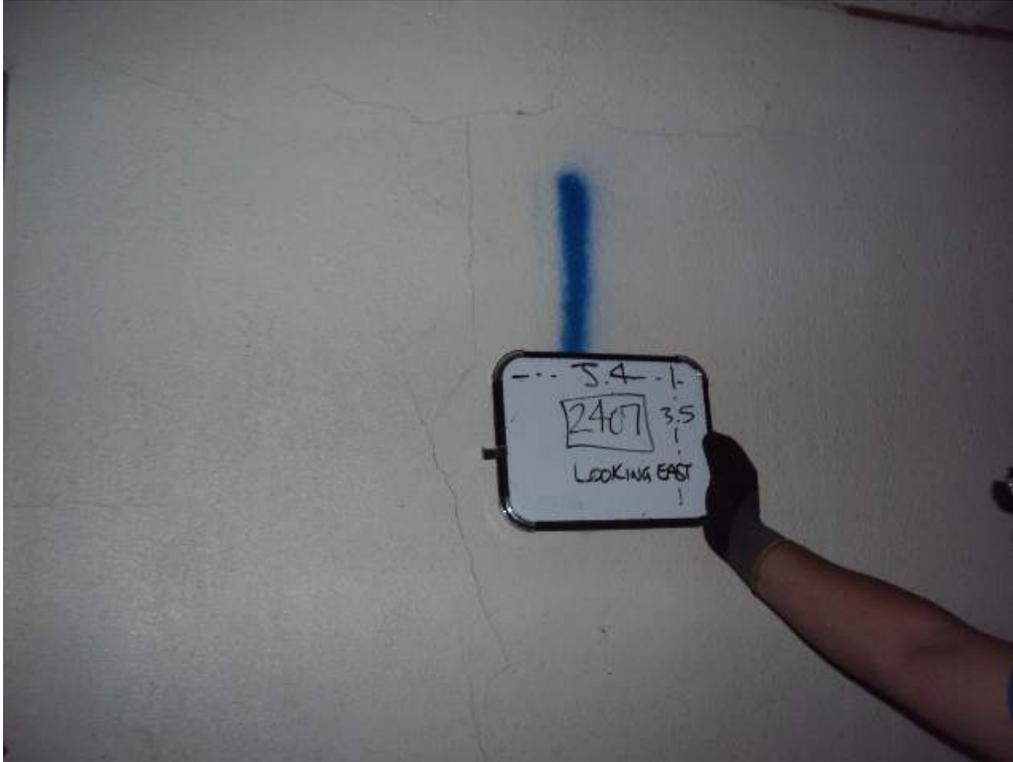
Photo 88: 2nd Floor – Room 2407– At col lines J.4 and 3.5 – Looking East –Map cracking in the elevator CMU wall

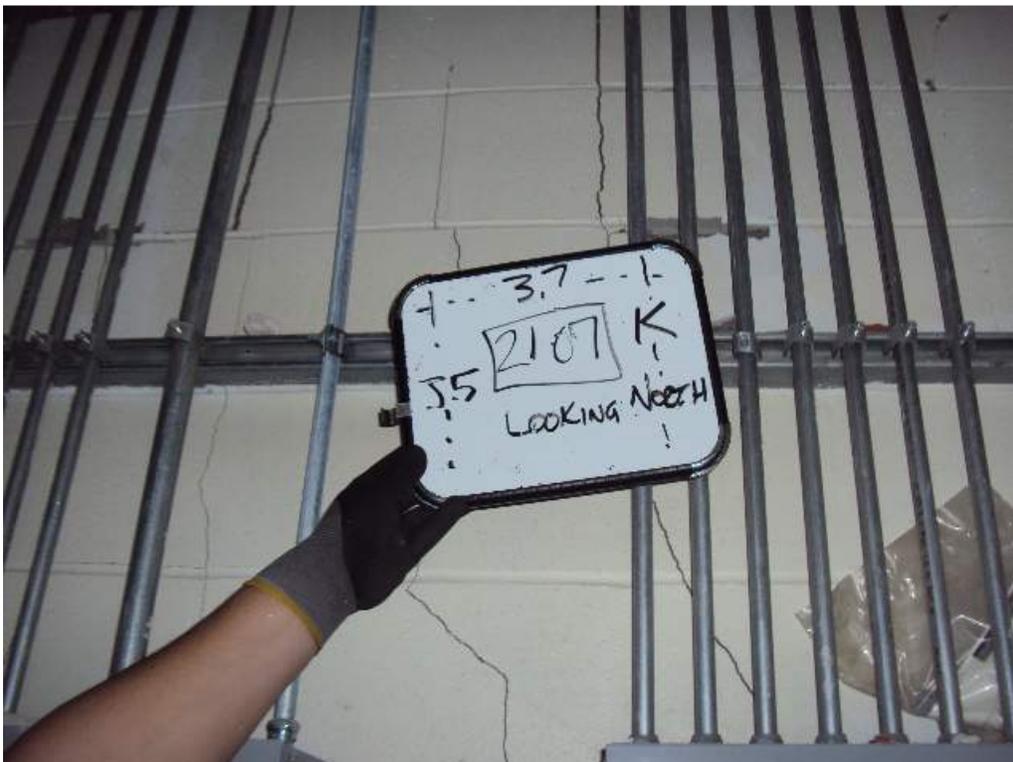
Photo 89: 2nd Floor – Room 2107– Adjacent to col line 3.7 between col lines J.5 and K – Looking North – Collapsed elevator CMU wall

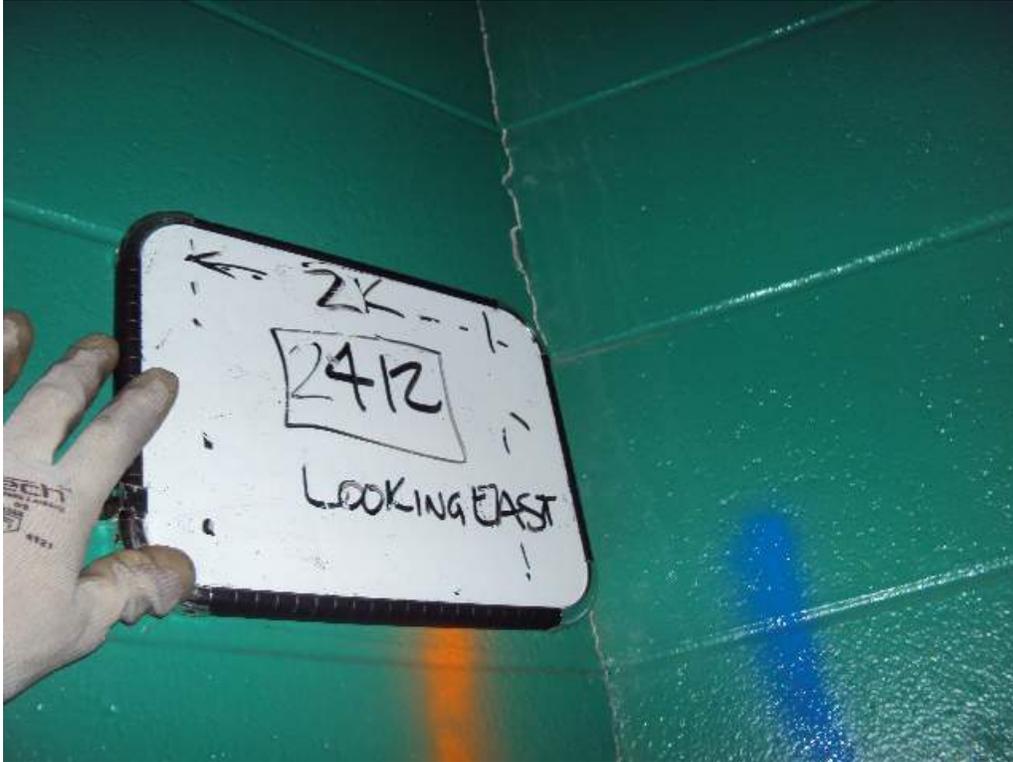
Photo 90: 2nd Floor – Room 2412– Adjacent to col line 2K – Looking East –Vertical crack at CMU wall intersection

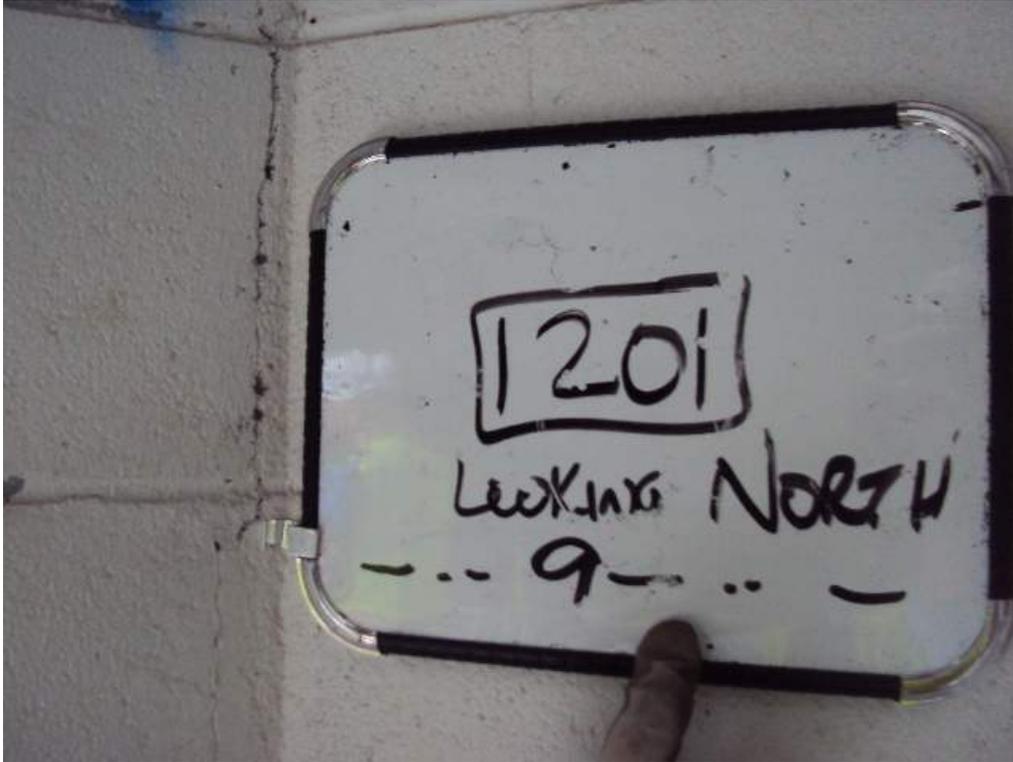
Photo 92: 1st Floor – Room 1201– Adjacent to col line 9S– Looking North –Vertical cracks at CMU wall corner

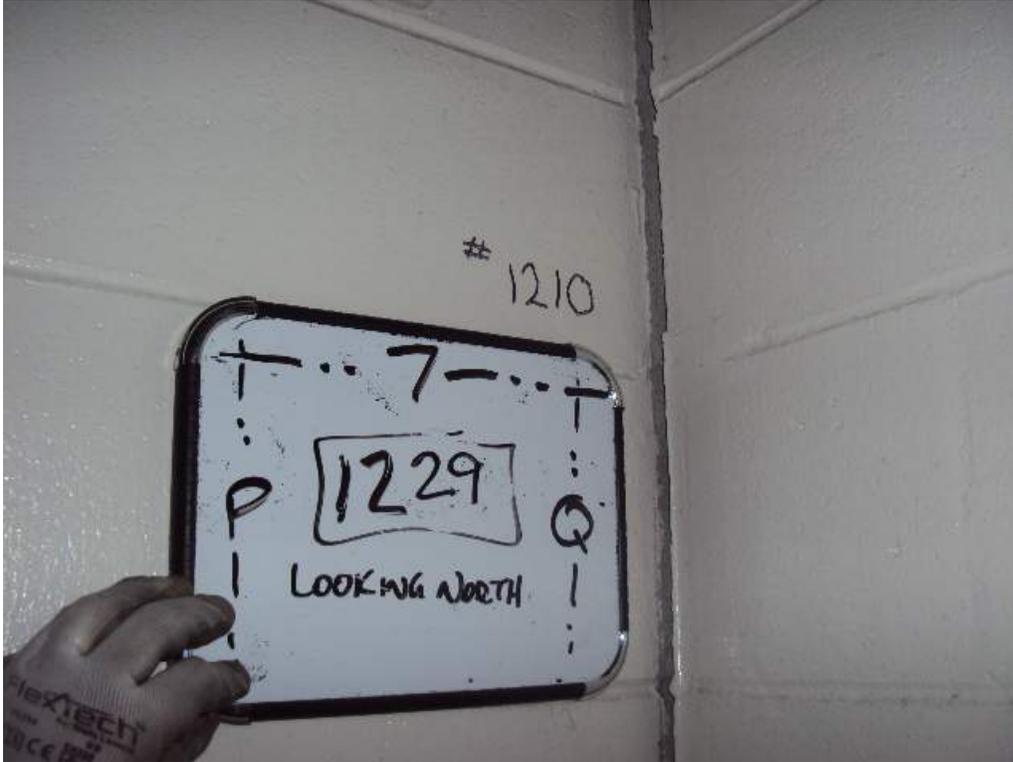
Photo 94: 1st Floor – Room 1229– Along col line 7 between col lines P and Q– Looking North–Vertical cracks at CMU wall corner with CMU wall displacement

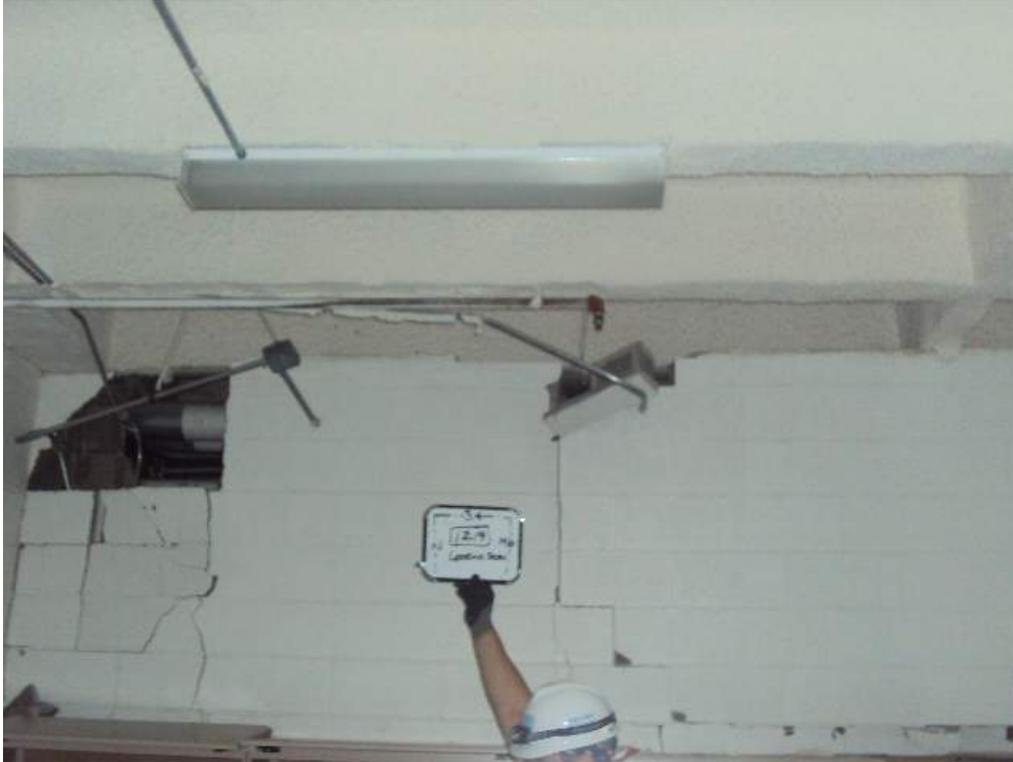
Photo 96: 1st Floor – Room 1219– Along col line 3.4 between col lines M.6 and N– Looking South- Partially collapsed CMU wall

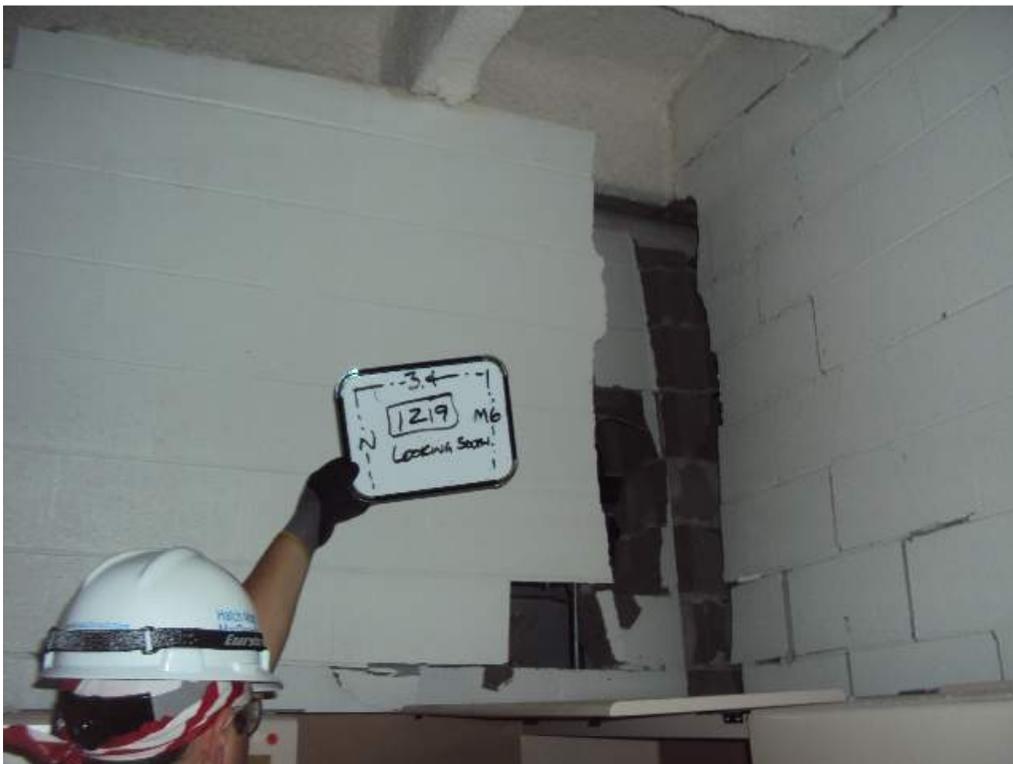
Photo 97: 1st Floor – Room 1219– Along col line 3.4 between col lines M.6 and N– Looking South- Partially collapsed CMU wall

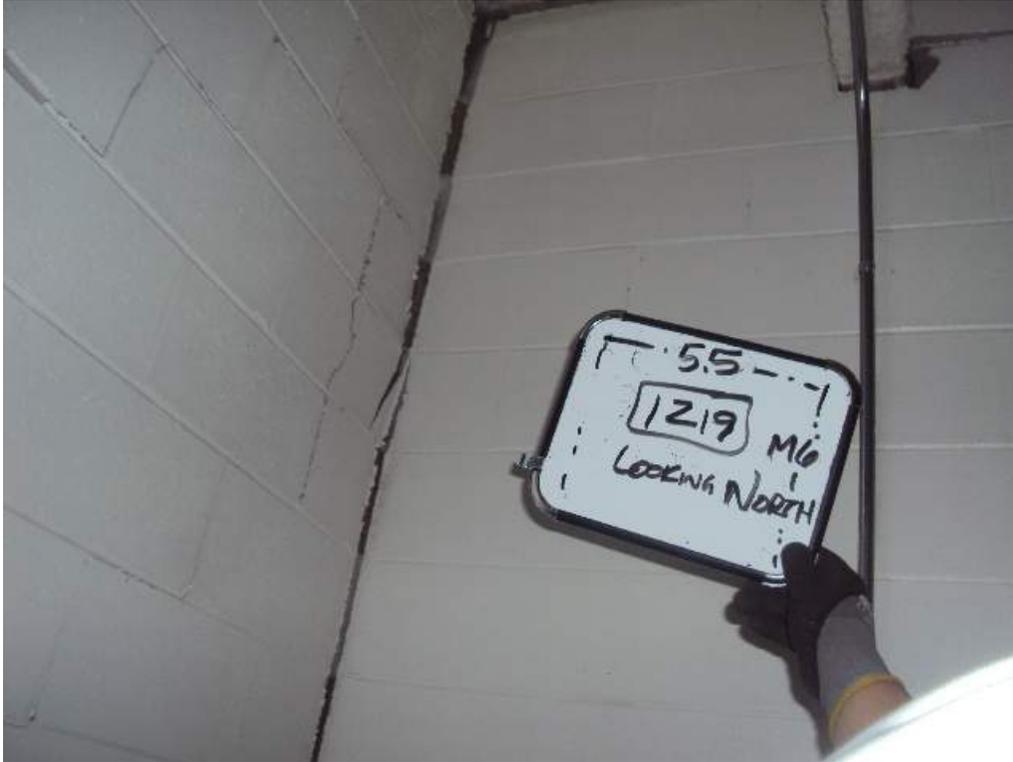
Photo 98: 1st Floor – Room 1219– Along col line 5.5 adjacent to M6– Looking North-Partially collapsed CMU wall

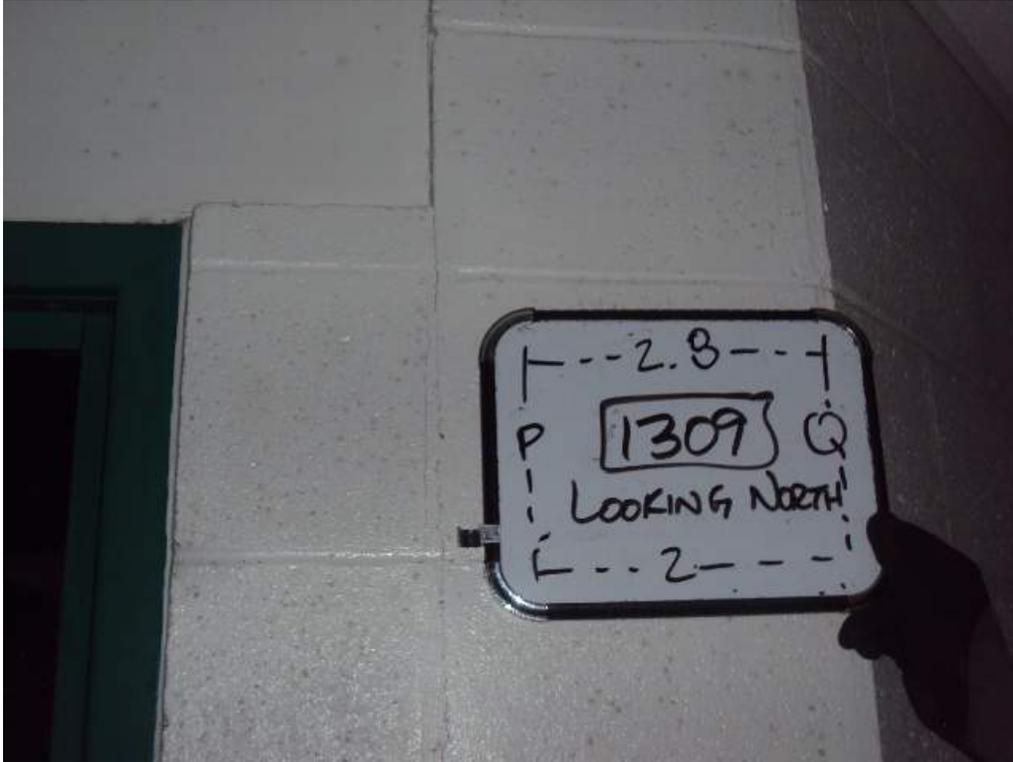
Photo 100: 1st Floor – Room 1309– Between col lines 2 and 2.8 & P and Q – Looking North – Stair step crack and vertical crack in CMU wall

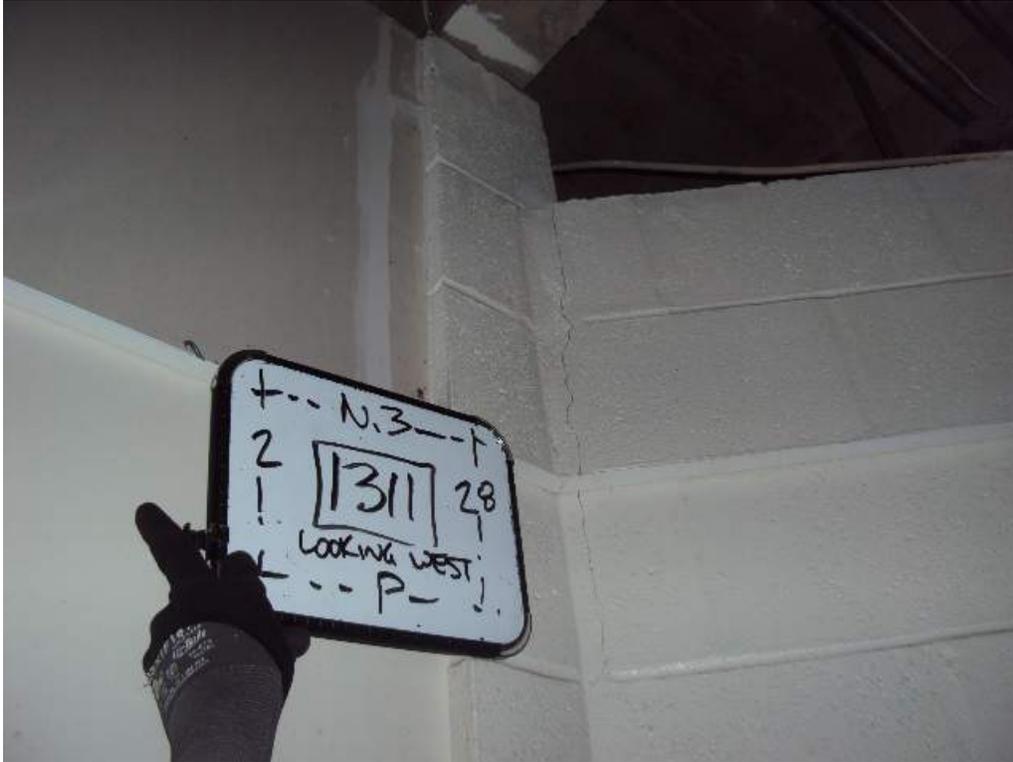
Photo 102: 1st Floor – Room 1311– Between col lines N.3 and P & 2 and 2.8 – Looking West – Vertical crack in CMU column and wall

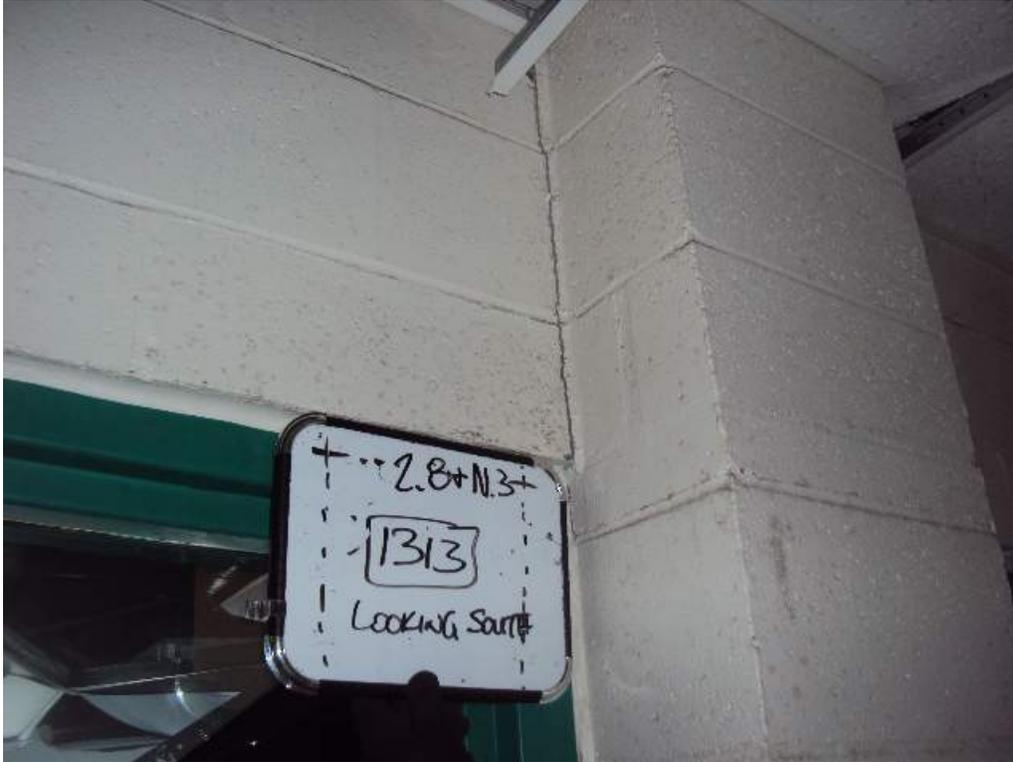
Photo 104: 1st Floor – Room 1313– At col line 2.8 and N.3 – Looking South – Vertical crack in CMU wall

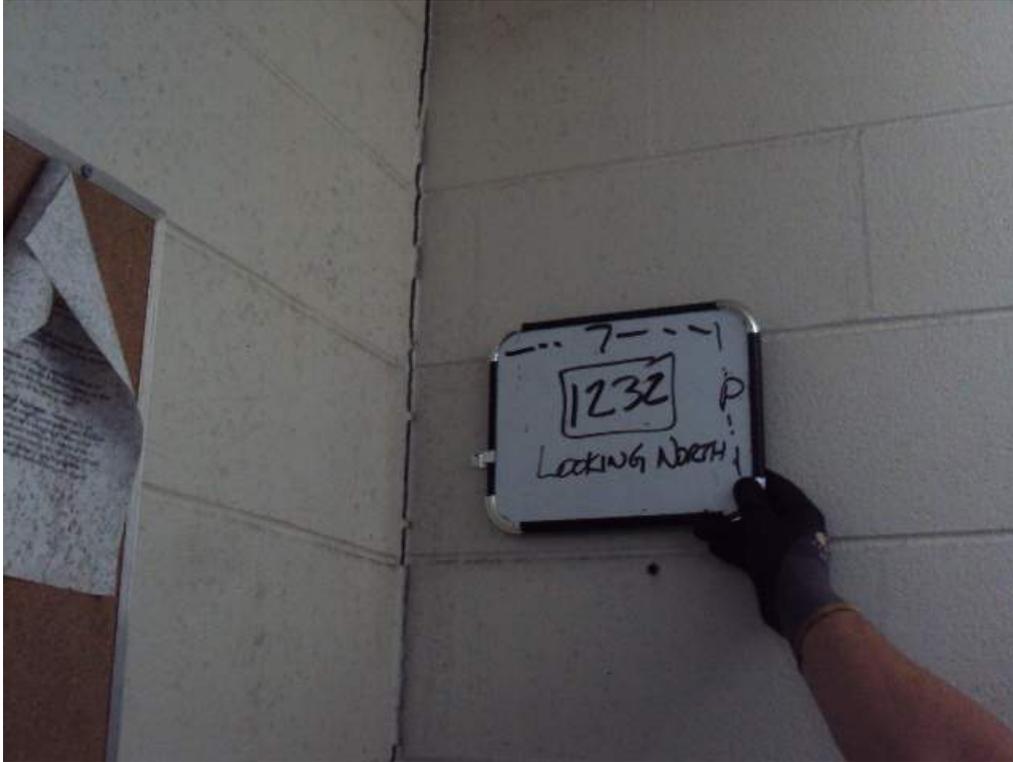
Photo 106: 1st Floor – Room 1232– Along col line 7 adjacent to P – Looking North – Vertical crack at corner of CMU wall

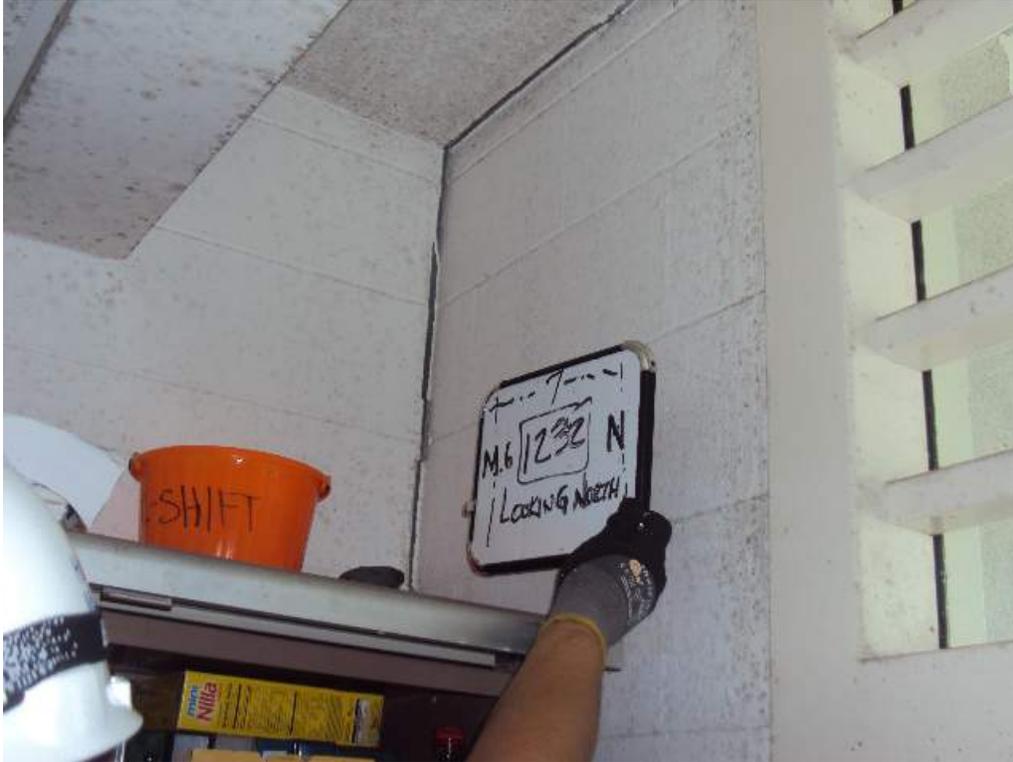
Photo 108: 1st Floor – Room 1232– Along col line 7 between col lines M.6 and N – Looking North – Vertical and horizontal cracks in CMU walls with CMU wall displacement

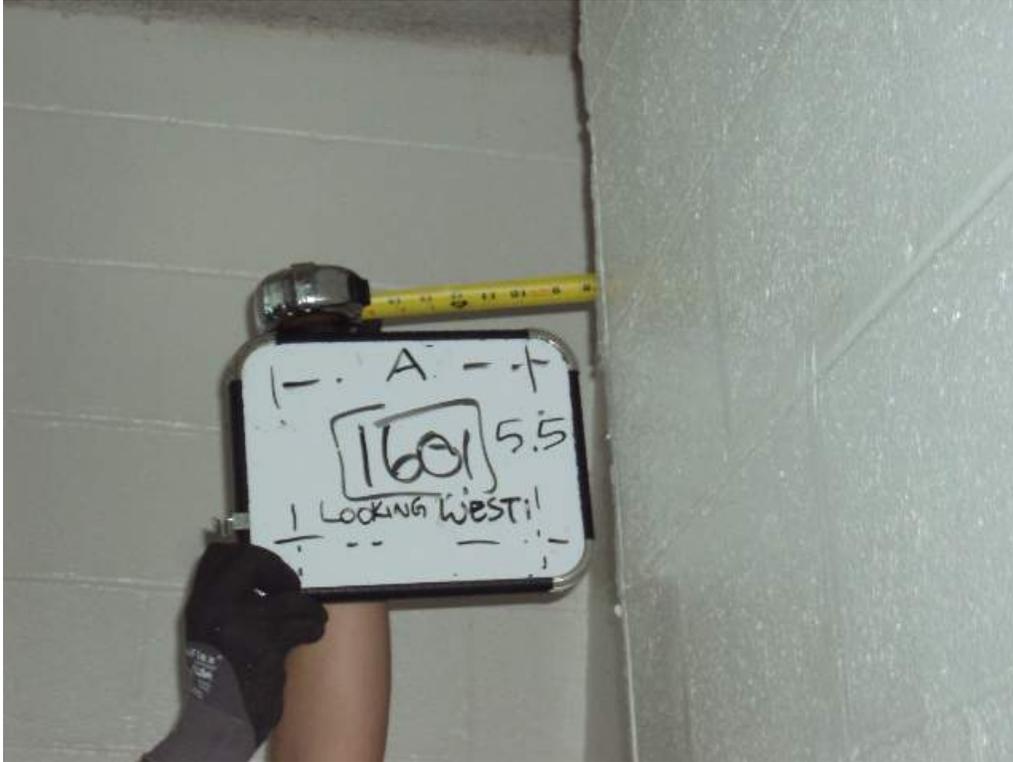
Photo 110: 1st Floor – Room 1601– Along col line 5.5 and A – Looking West – Sheared, displaced and partially collapsed CMU wall

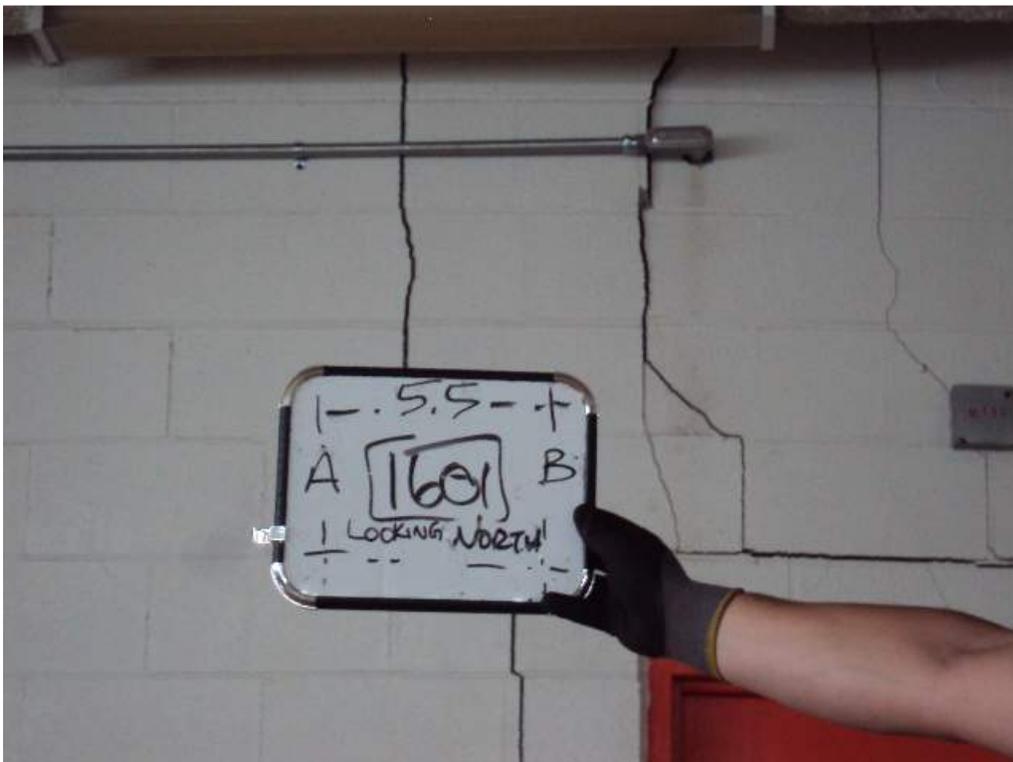
Photo 111: 1st Floor – Room 1601– Along col line 5.5 and between A and B – Looking North – Sheared, displaced and partially collapsed CMU wall

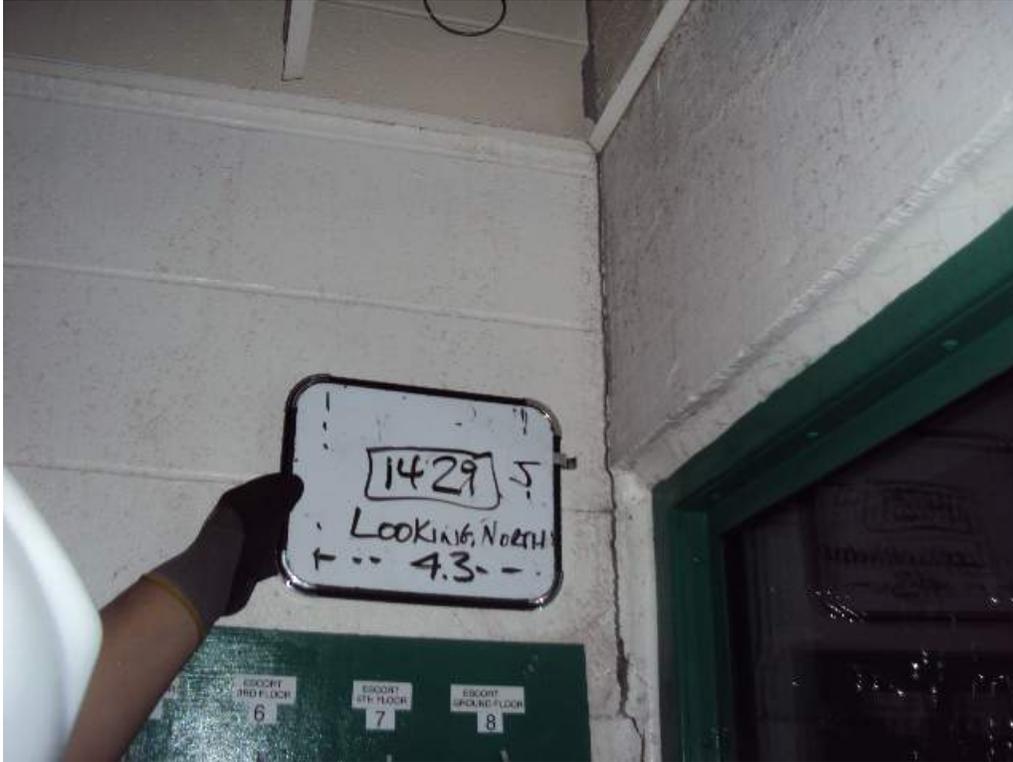
Photo 114: 1st Floor – Room 1429– At col line J and 4.3 – Looking North – Vertical crack at corner of CMU wall

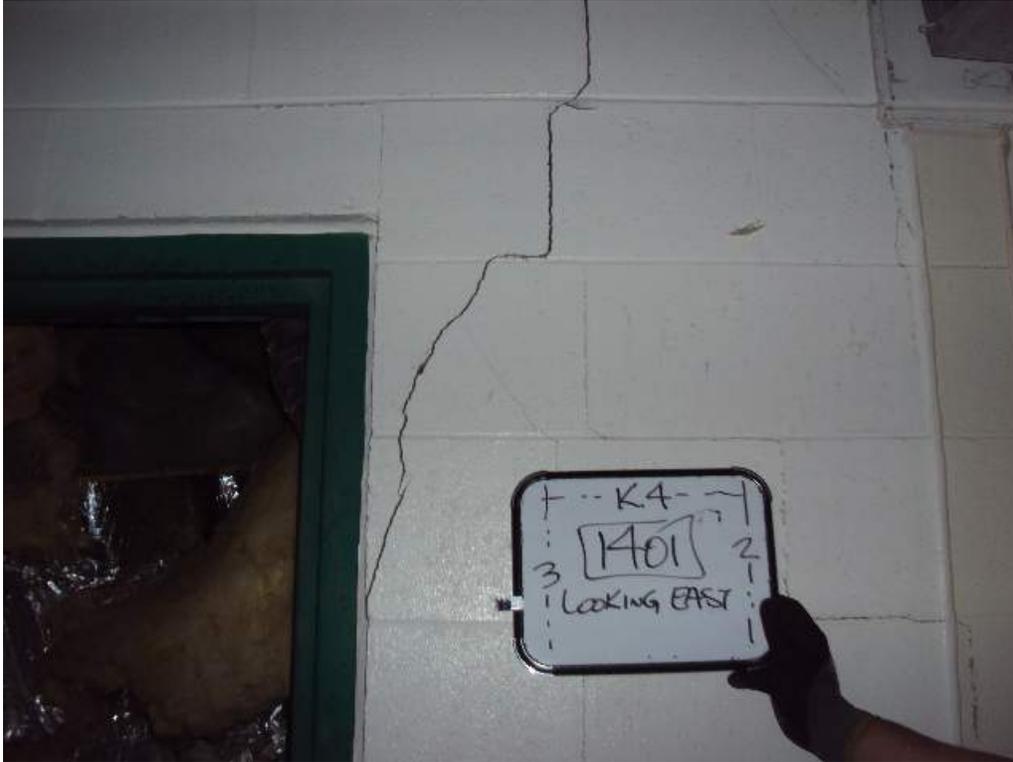
Photo 116: 1st Floor – Room 1401– Along col line K4 between col lines 2 and 3 – Looking East– Stair step crack in CMU wall

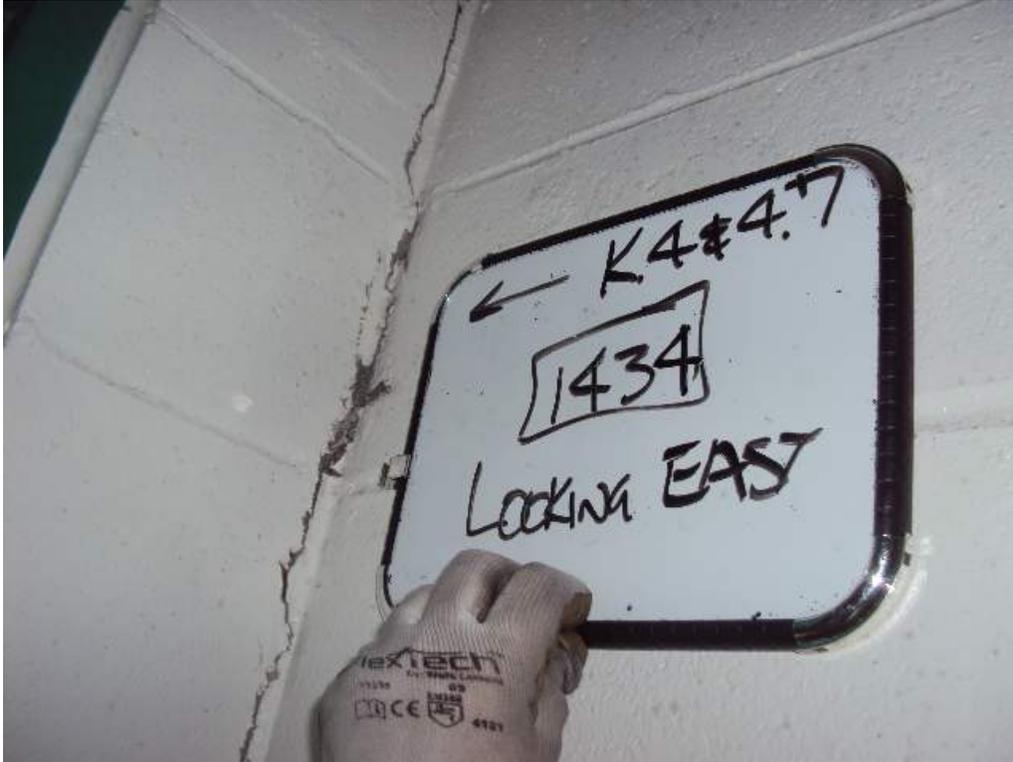
Photo 118: 1st Floor – Room 1434– Adjacent to col line K4 and 4.7 – Looking East– Vertical crack at CMU wall corner
