Existing Condition Assessment Report

DEMOLITION OF CENTRAL BOOKING FACILITY

Escambia County Central Booking and Detention Facility
Condition Assessment Report - June 11, 2015

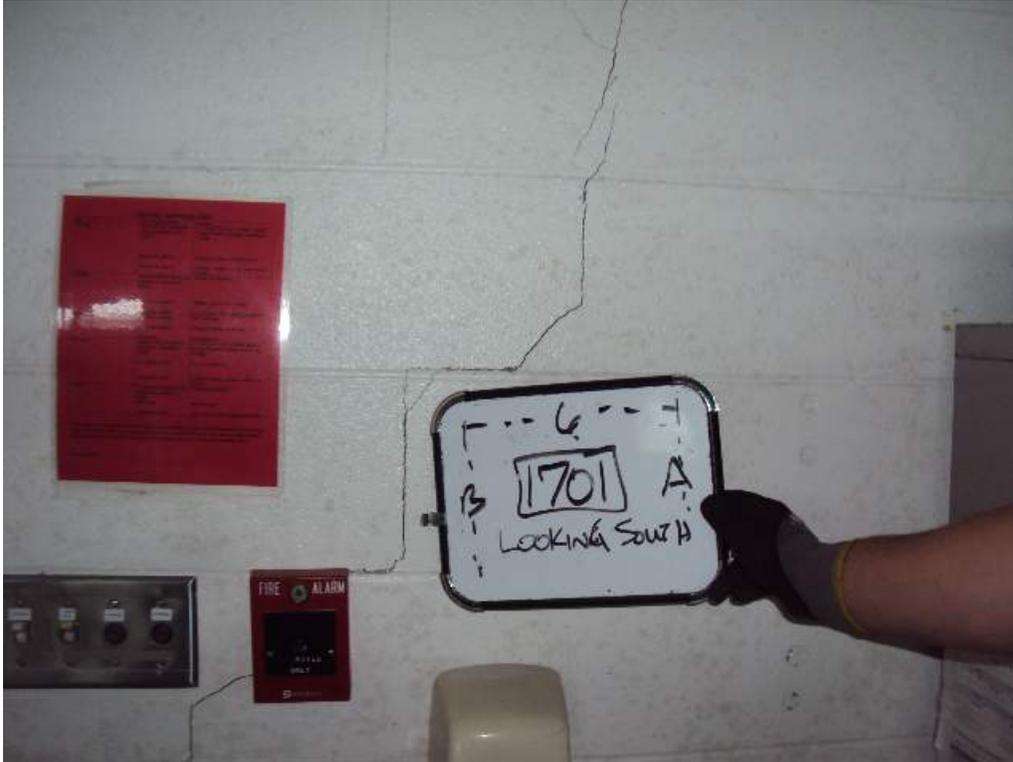
Photo 122: 1st Floor – Room 1701– Along col line 6 between A and B– Looking South– Stair step crack in CMU wall

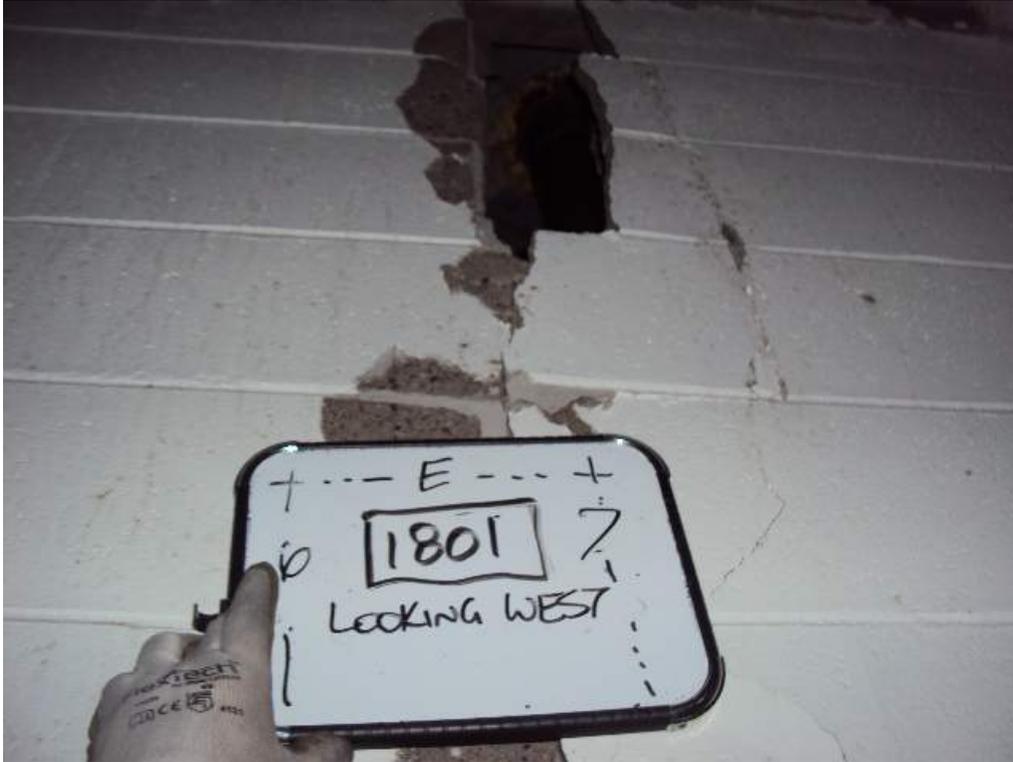
Photo 124: 1st Floor – Room 1801– Along col line E between 6 and 7– Looking North– Cracked, sheared and partially collapsed CMU wall

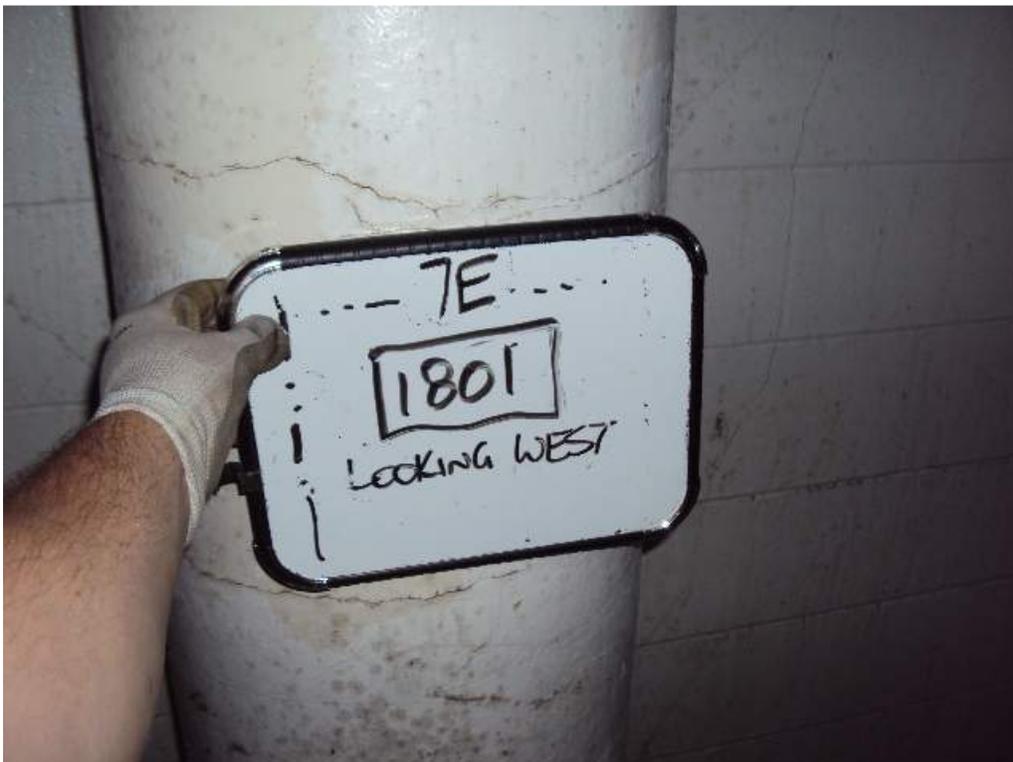
Photo 125: 1st Floor –Room 1801 – At col line 7E – Looking West – Cracked columns

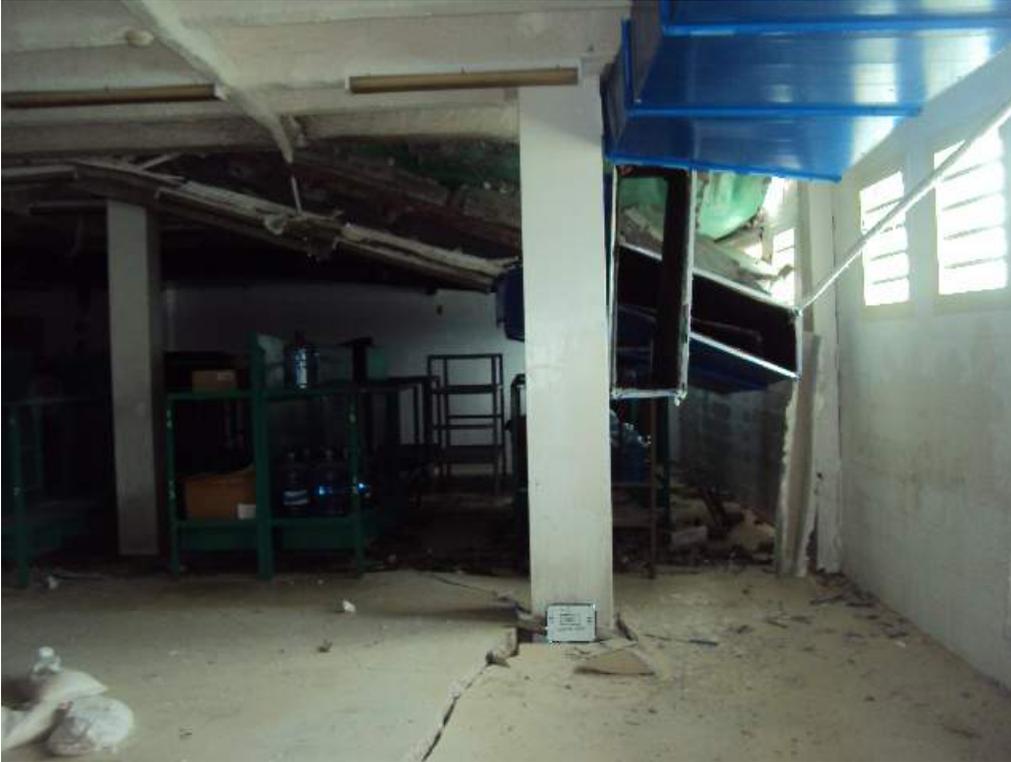
Photo 126: 1st Floor –Room 1801 – Between col lines D and E & 7 and 8 – Looking West – Collapsed roof

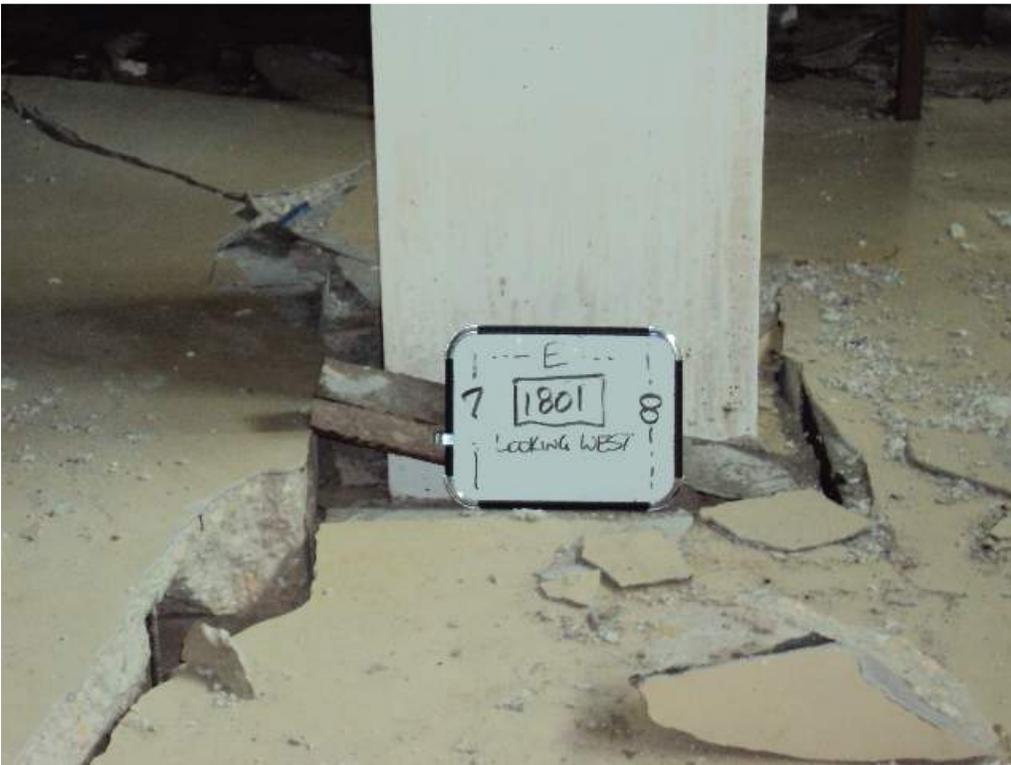
Photo 127: 1st Floor –Room 1801 – Along col line E between 7 and 8 – Looking West – Collapsed roof

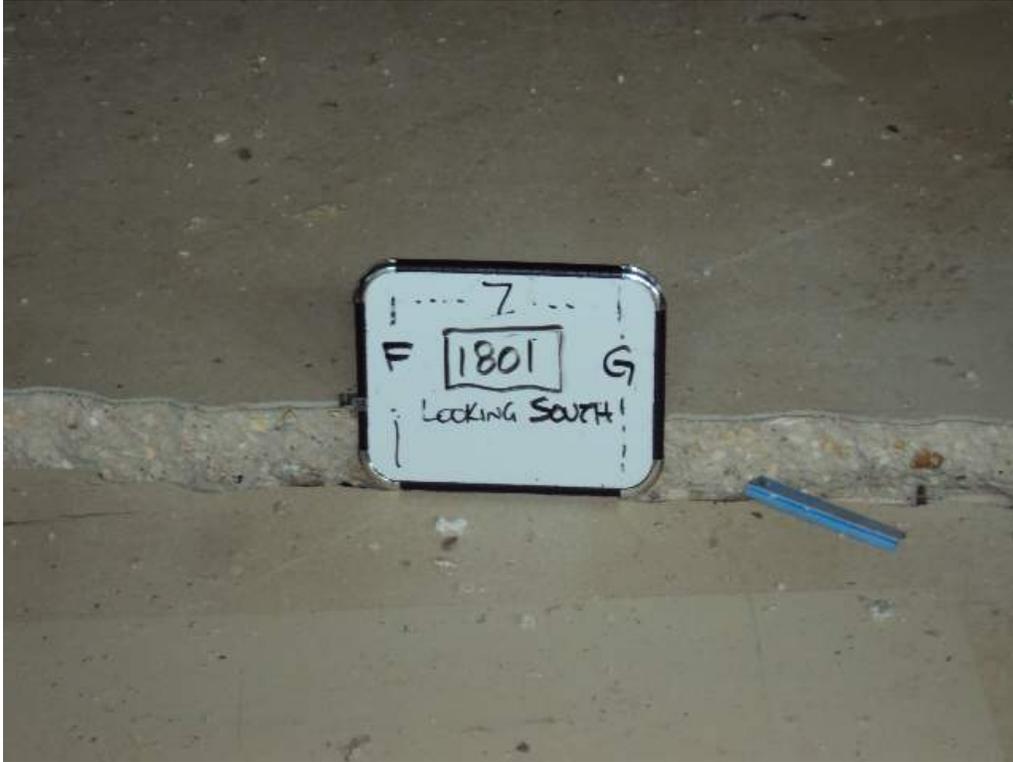
Photo 128: 1st Floor –Room 1801 – Along col line 7 between F and G – Looking South – Sheared concrete slab

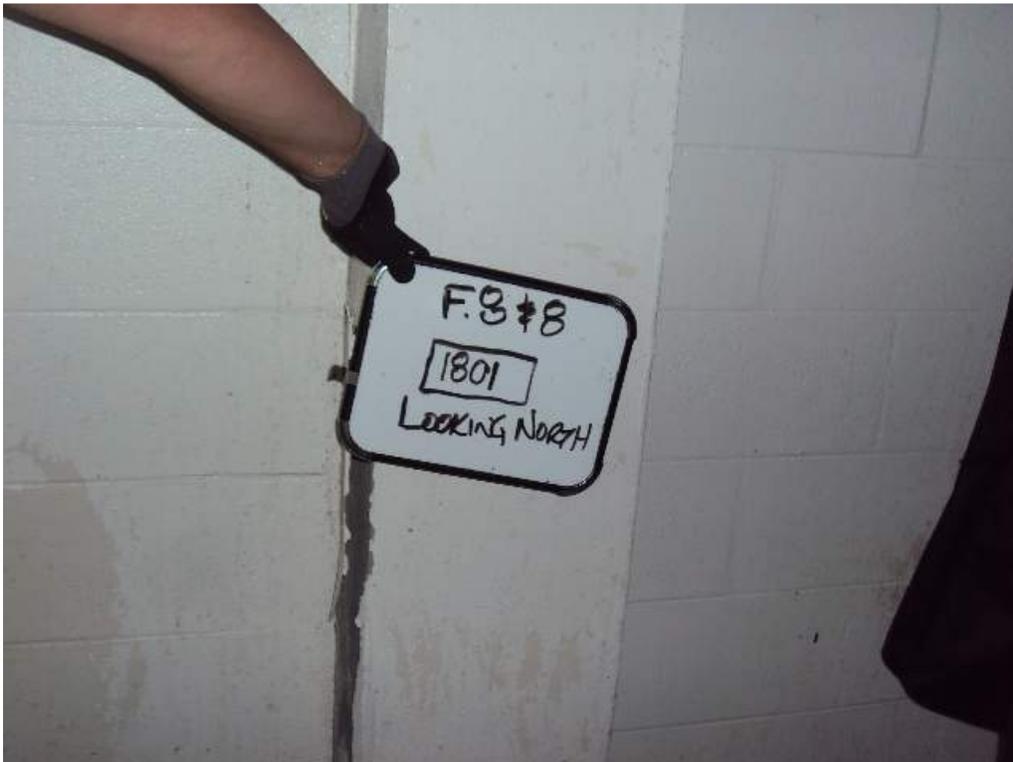
Photo 129: 1st Floor –Room 1801 – At col line F.8 & 8 – Looking North – Vertical crack between concrete col and CMU wall

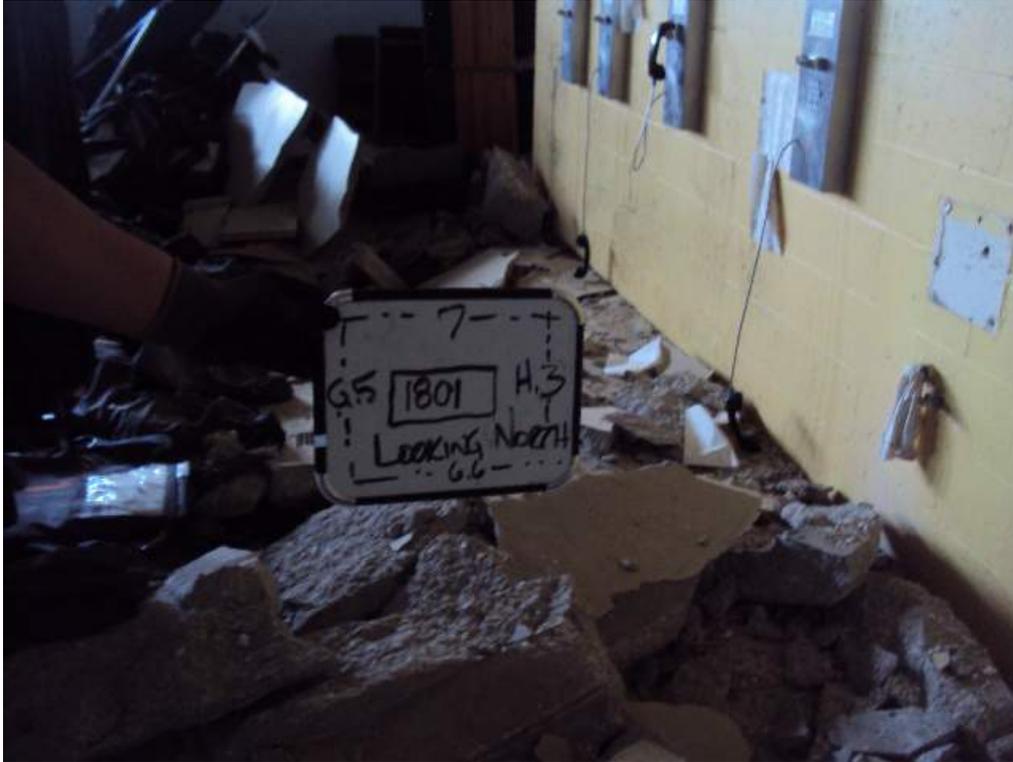
Photo 132: 1st Floor –Room 1801 – Between column lines 6.6 and 7 & G.5 and H.3 – Looking North – Buckled, sheared and collapsed concrete slab

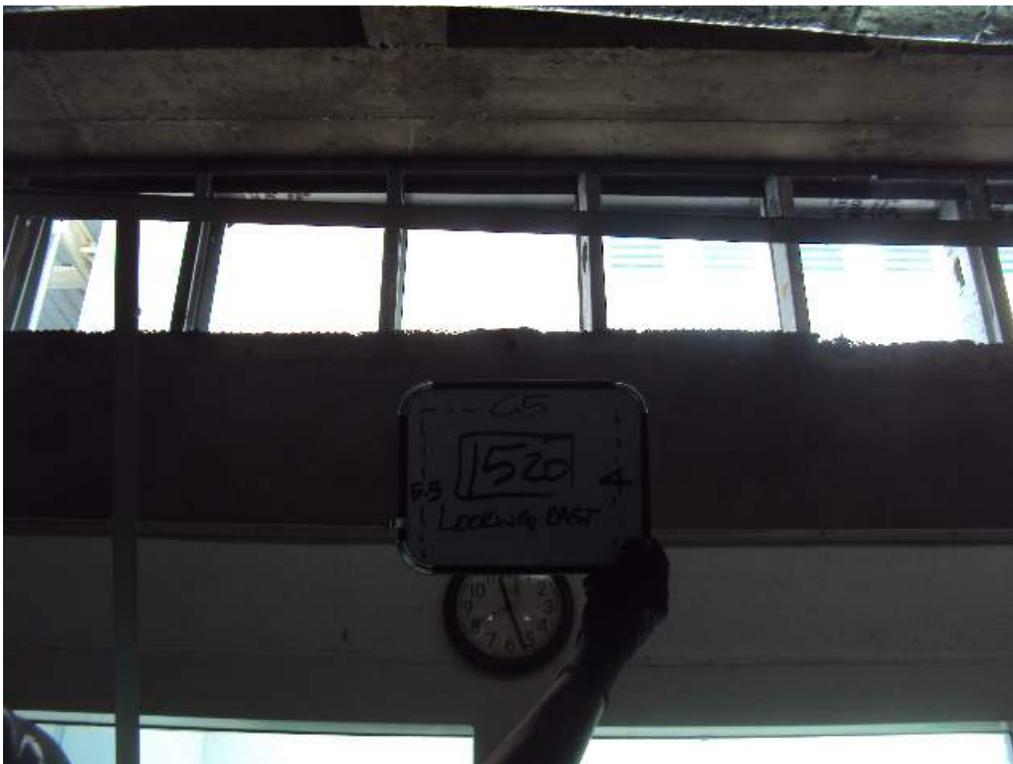
Photo 133: 1st Floor –Room 1520 – Along col line C.5 between col lines 4 and 5.5 – Looking East – Partially collapsed exterior light gage stud wall

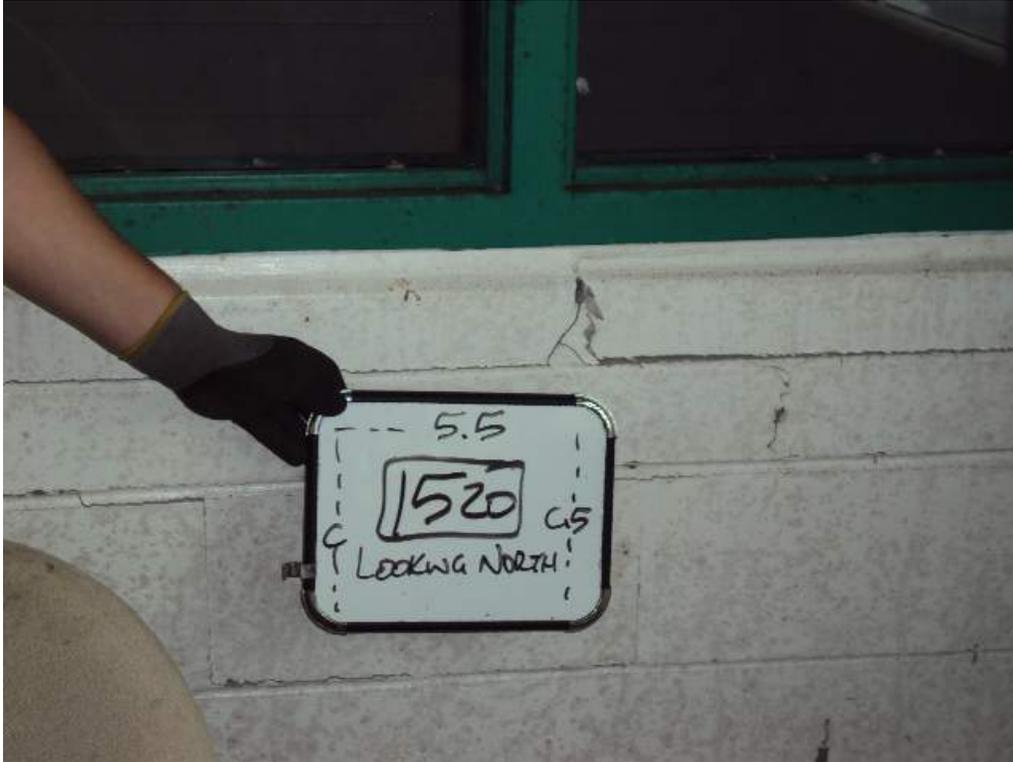
Photo 134: 1st Floor –Room 1520 – Along col line 5.5 between col lines C and C.5 – Looking North – Stair step crack in CMU wall

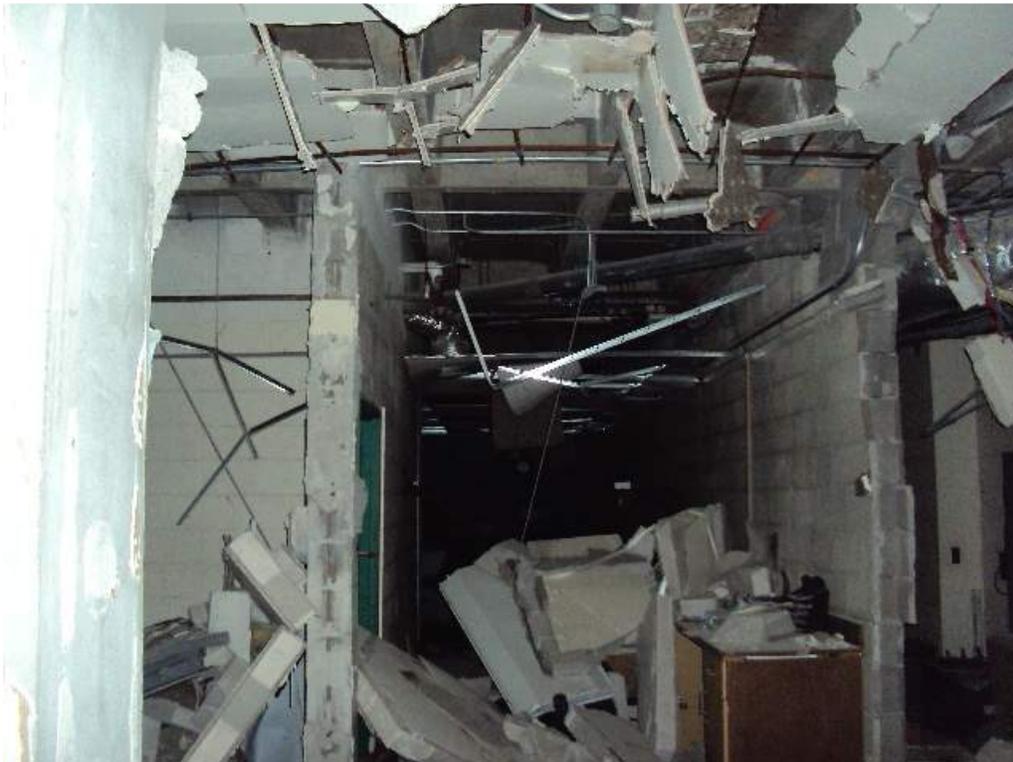
Photo 135: 1st Floor –Room 1501– Between col lines F and G & 4.3 and 5.5 – Looking South – Collapsed CMU walls

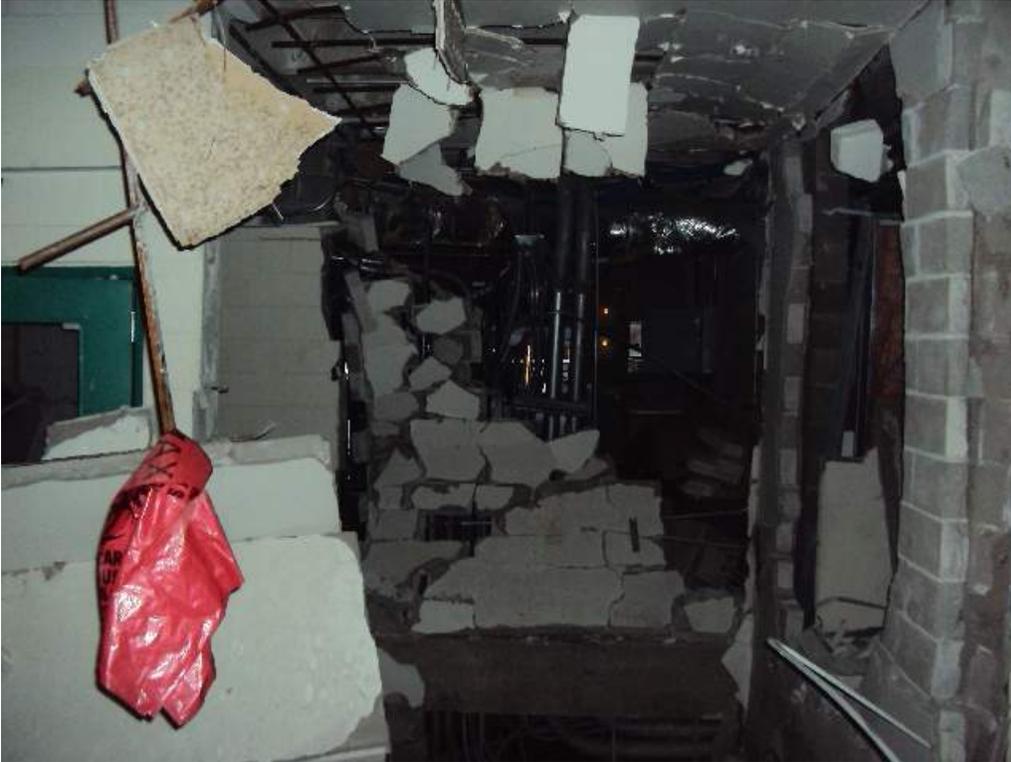
Photo 136: 1st Floor –Room 1106 – Along col line G between col lines 4.7 and 5.5 – Looking South – Collapsed CMU walls

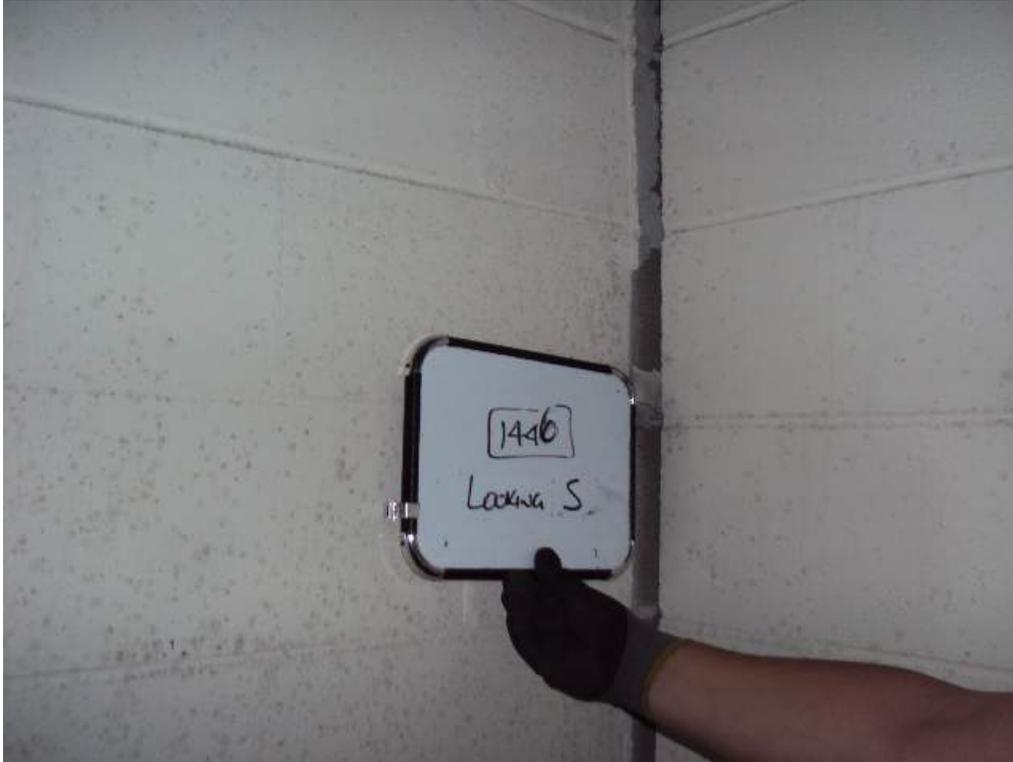
Photo 140: 1st Floor –Room 1446 – Between column lines G and H & 5 and 5.5 – Looking South– CMU wall with horizontal translation

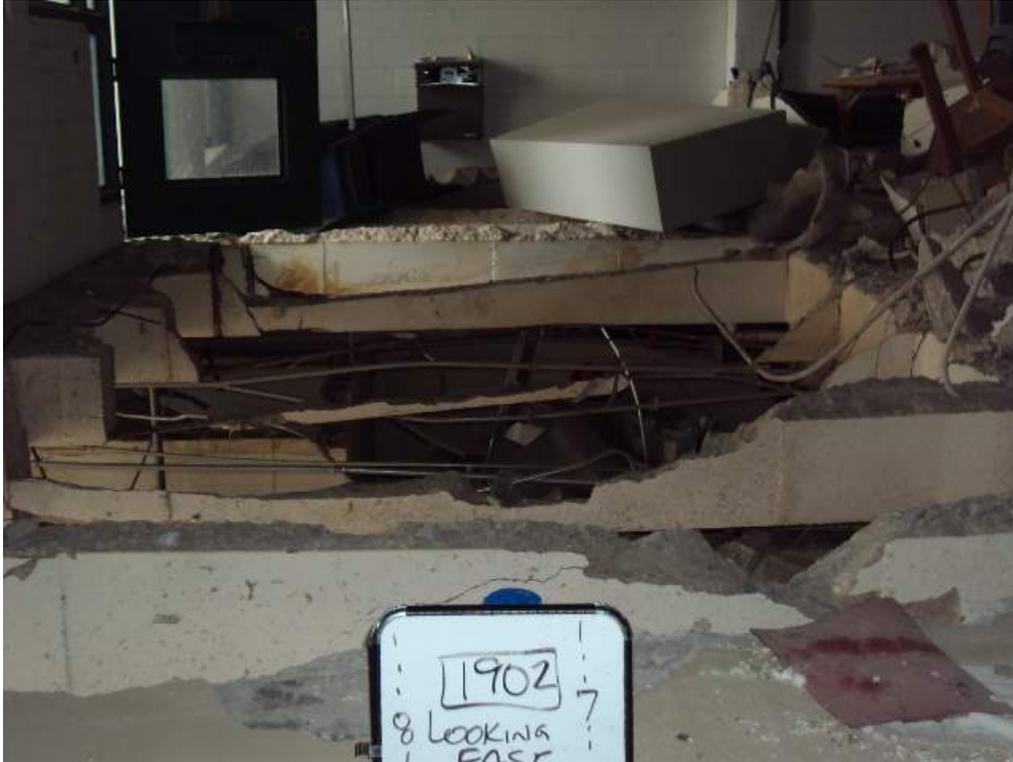
Photo 142: 1st Floor –Room 1902 – Between column lines J.5 and L & 6.6 and 8 – Looking East– Collapsed concrete floor

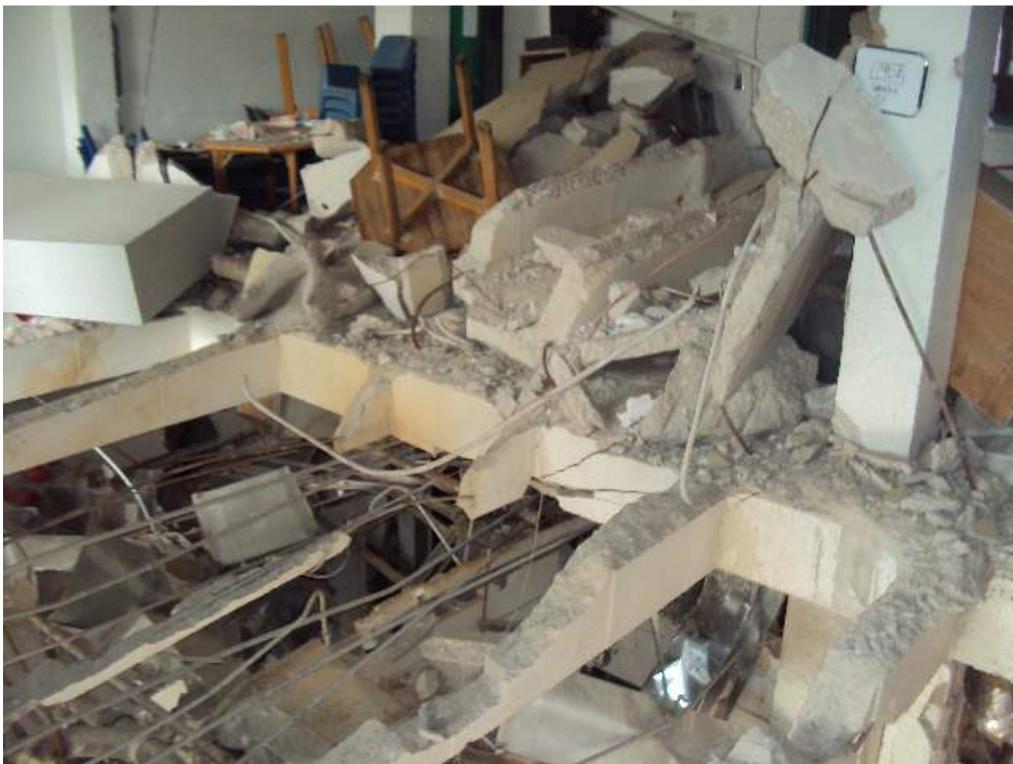
Photo 143: 1st Floor –Room 1902 – Between column lines J.5 and L & 6.6 and 8 – Looking Southeast– Collapsed concrete floor

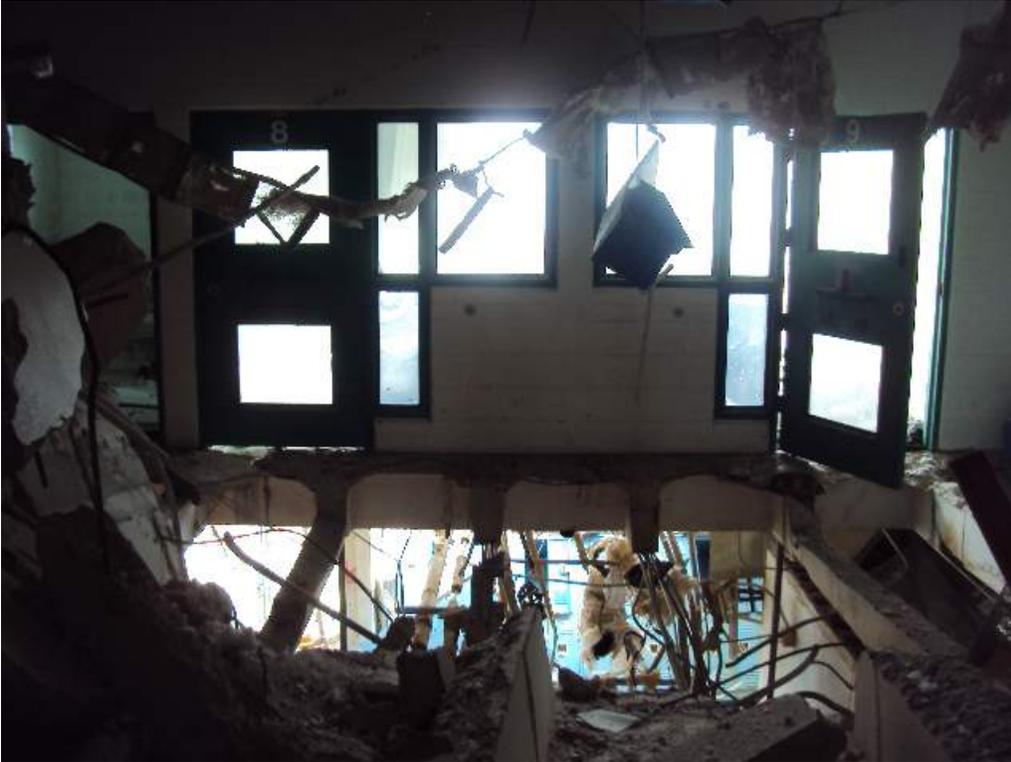
Photo 144: 1st Floor –Room 1902 – Between column lines J.5 and L & 6.6 and 8 – Looking North– Collapsed concrete floor

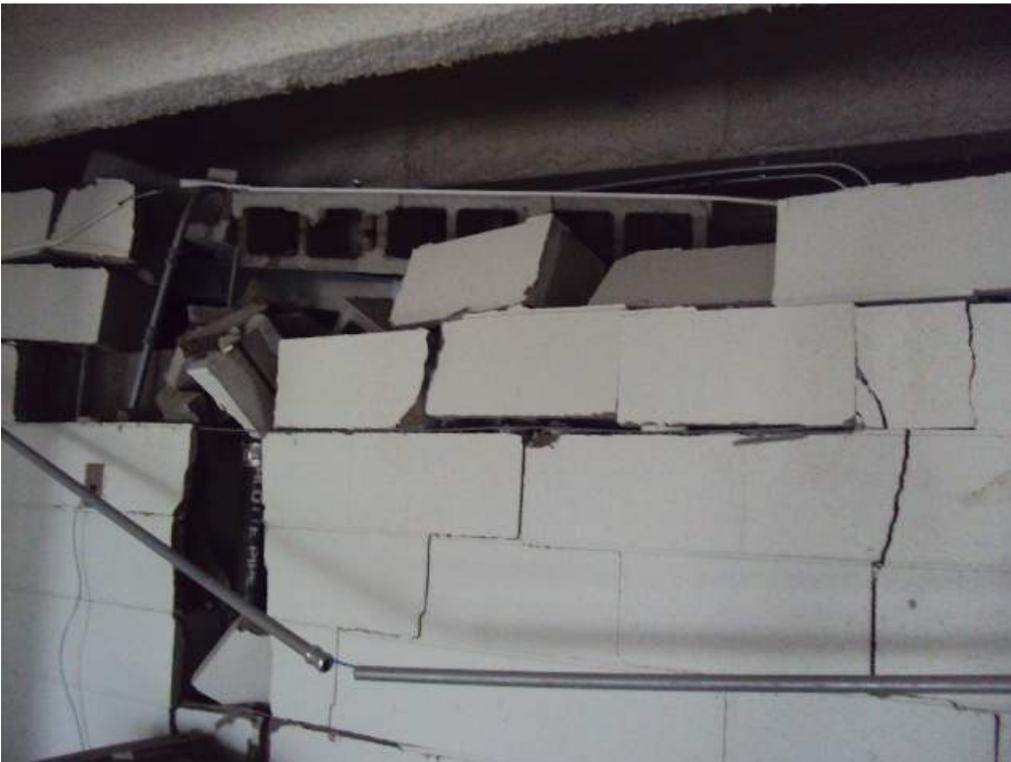
Photo 145: 1st Floor –Room 1902 – Along col line 6.6 between col lines J.5 and L – Looking South– Collapsed CMU wall

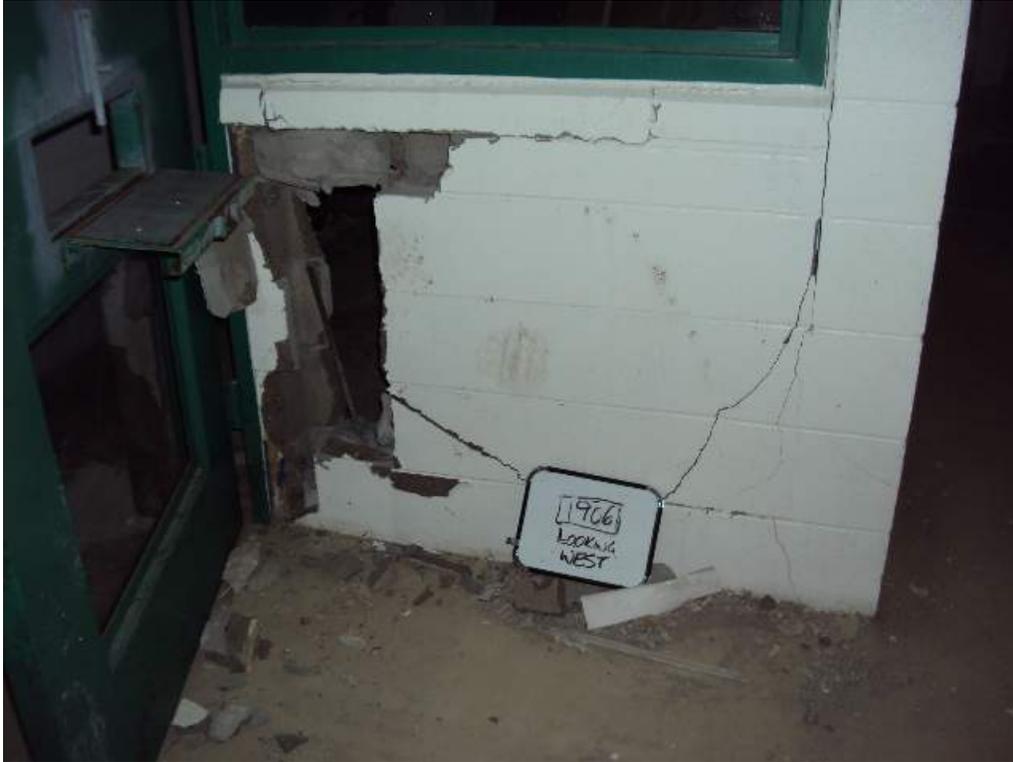
Photo 148: 1st Floor –Room 1906 – Between col lines H.5 and J.5 & 7 and 7.3 – Looking West– Partially collapsed CMU walls

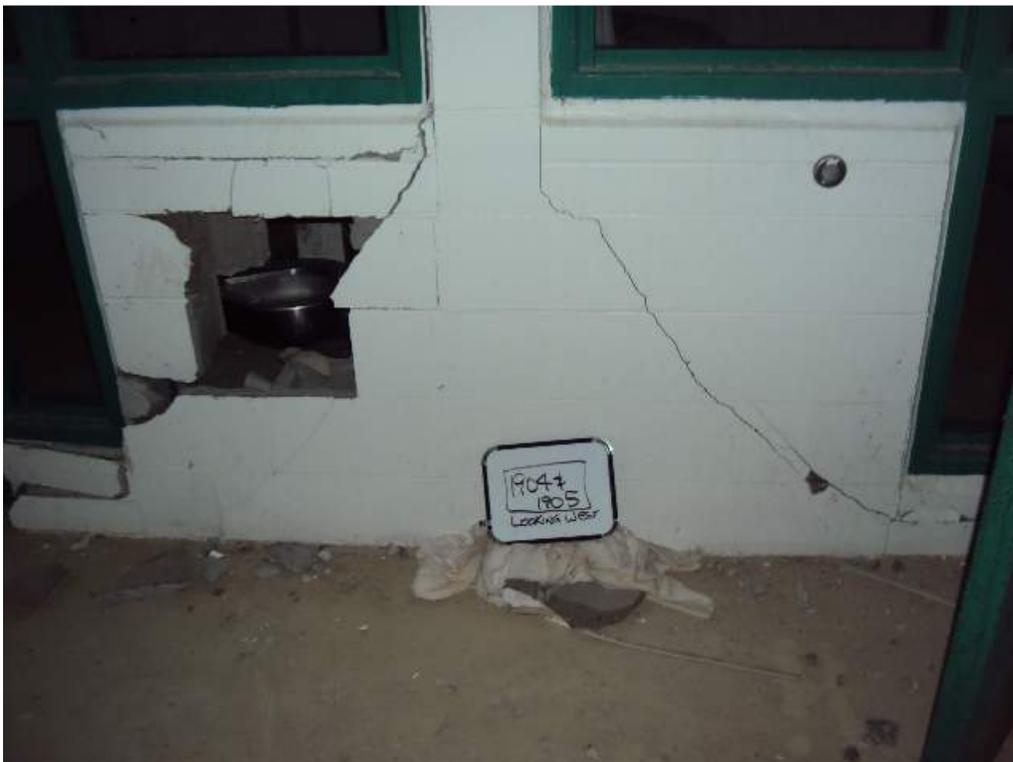
Photo 149: 1st Floor –Room 1904 and 1905 – Between col lines H.5 and J.5 & 6 and 7 – Looking West– Partially collapsed CMU walls

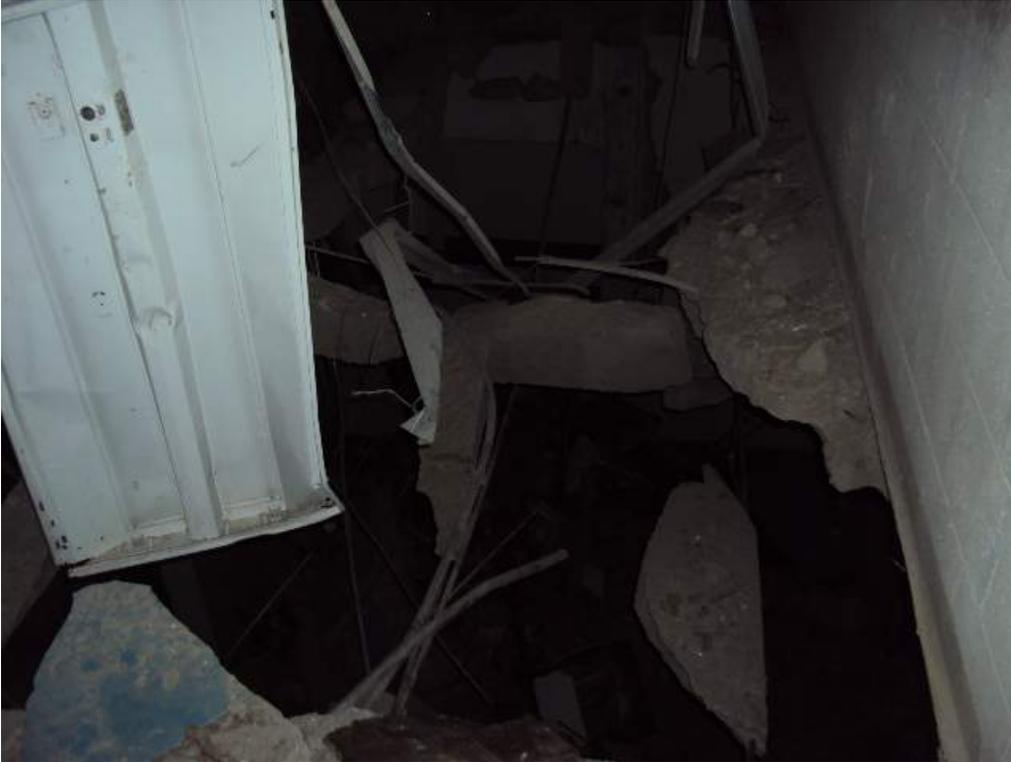
Photo 150: 1st Floor –Room 1226 – Between col lines L and M & 5.5 and 6 – Looking West– Collapsed floor slabs

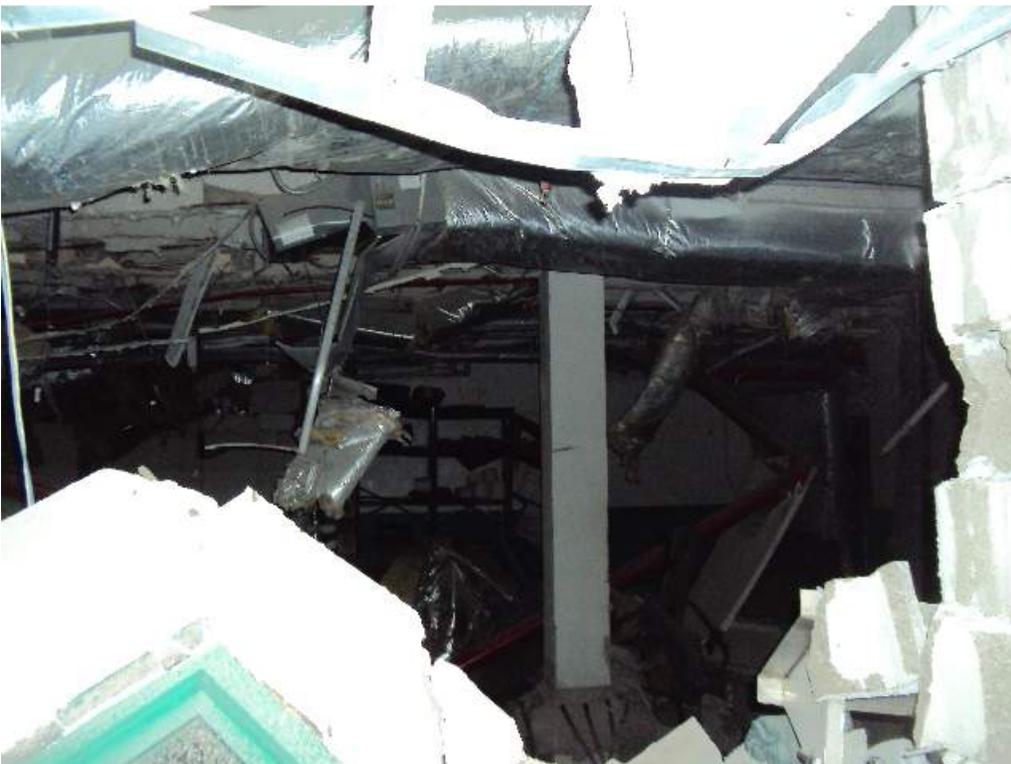
Photo 151: 1st Floor –Room 1250 to 1252– Between col lines K.4 and M & 3 and 5.5 – Looking South– Collapsed CMU walls and floor slabs

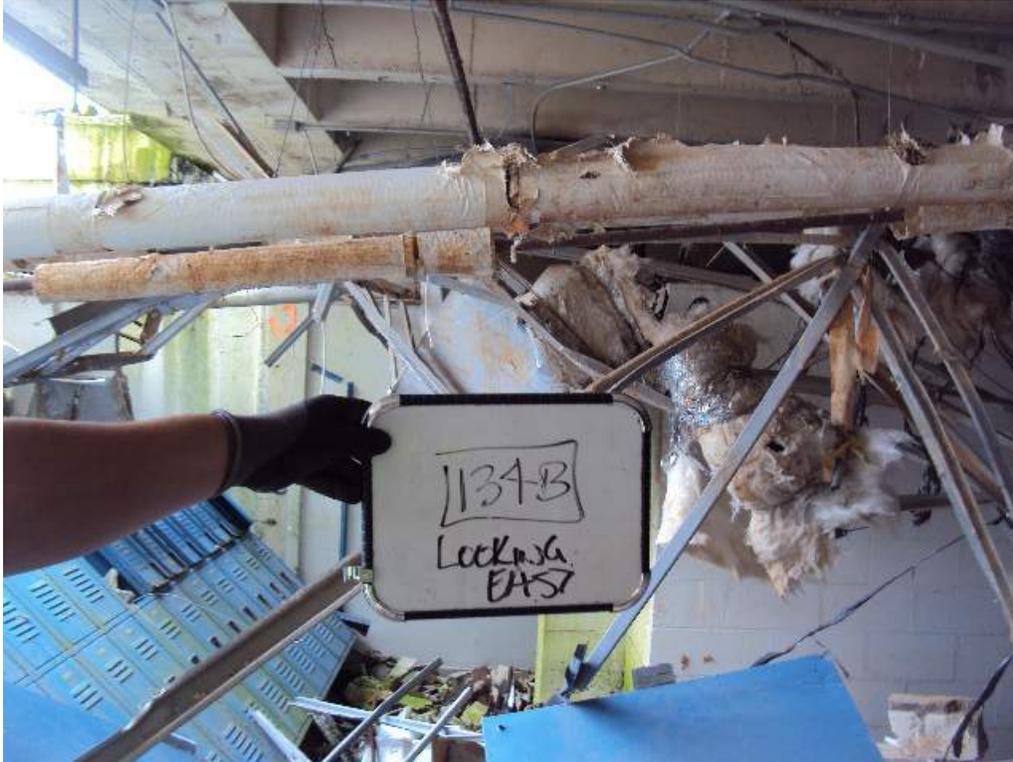
Photo 152: Basement –Room 134B– Between col lines K.2 and L & 7 and 8 – Looking East– Collapsed CMU walls

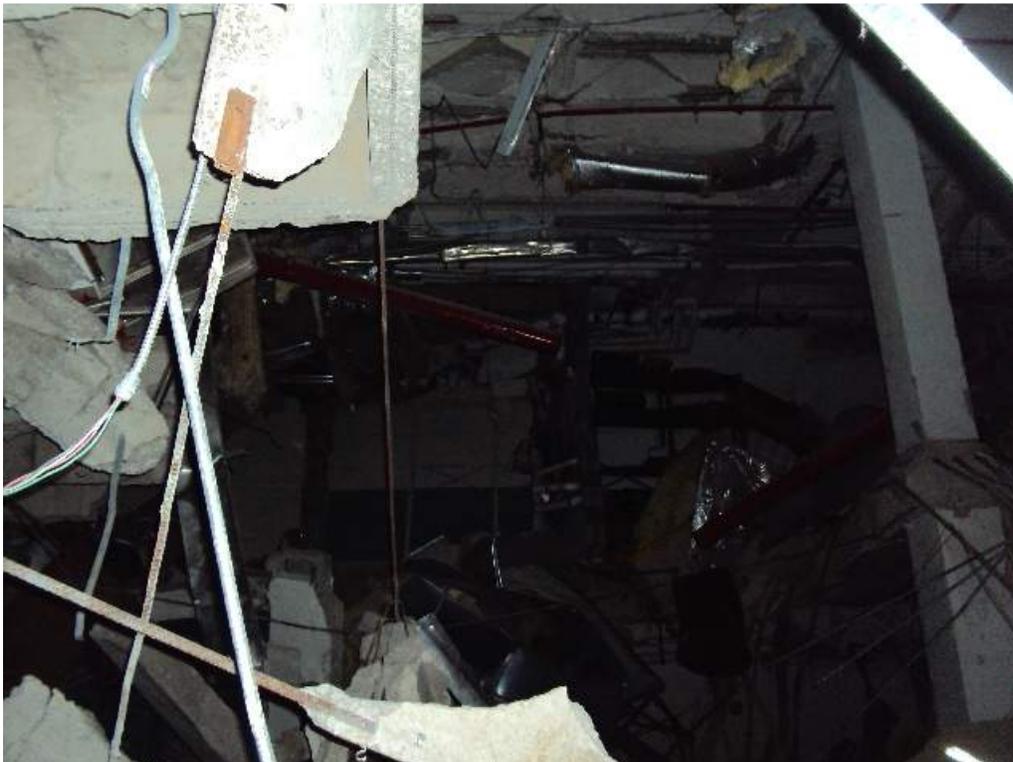
Photo 153: Basement –Room 132– Between col lines K.2 and M & 3 and 6 – Looking South– Collapsed CMU walls and floor slabs

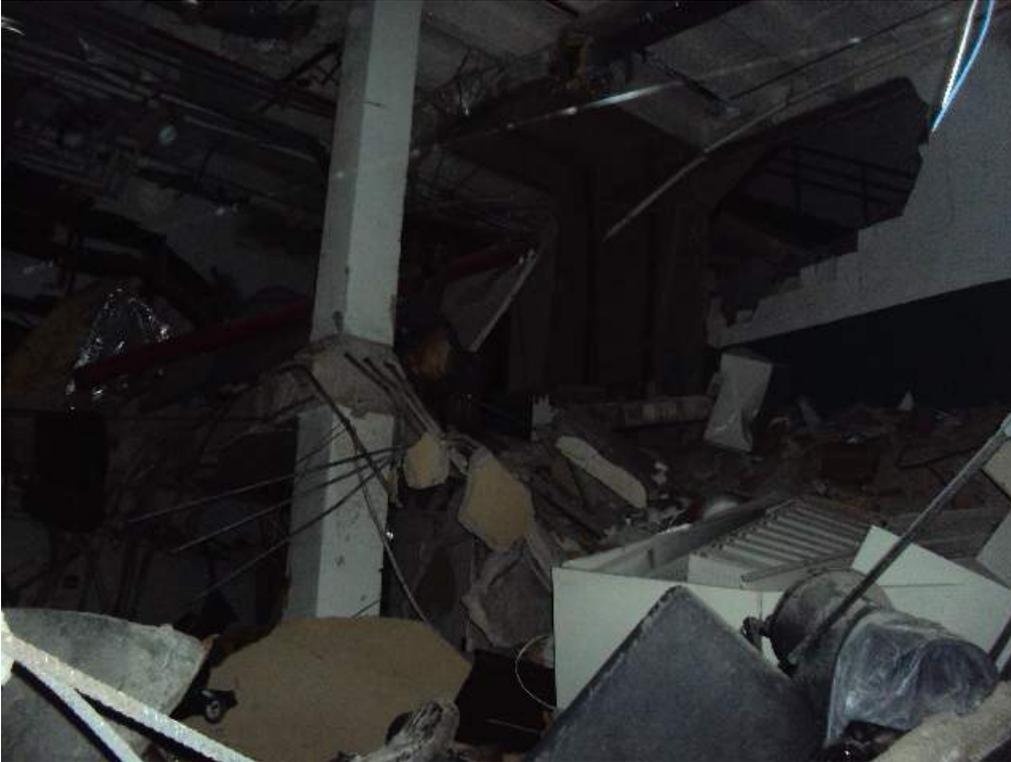
Photo 154: Basement –Room 132– Between col lines K.2 and M & 3 and 6 – Looking South– Collapsed CMU walls and floor slabs

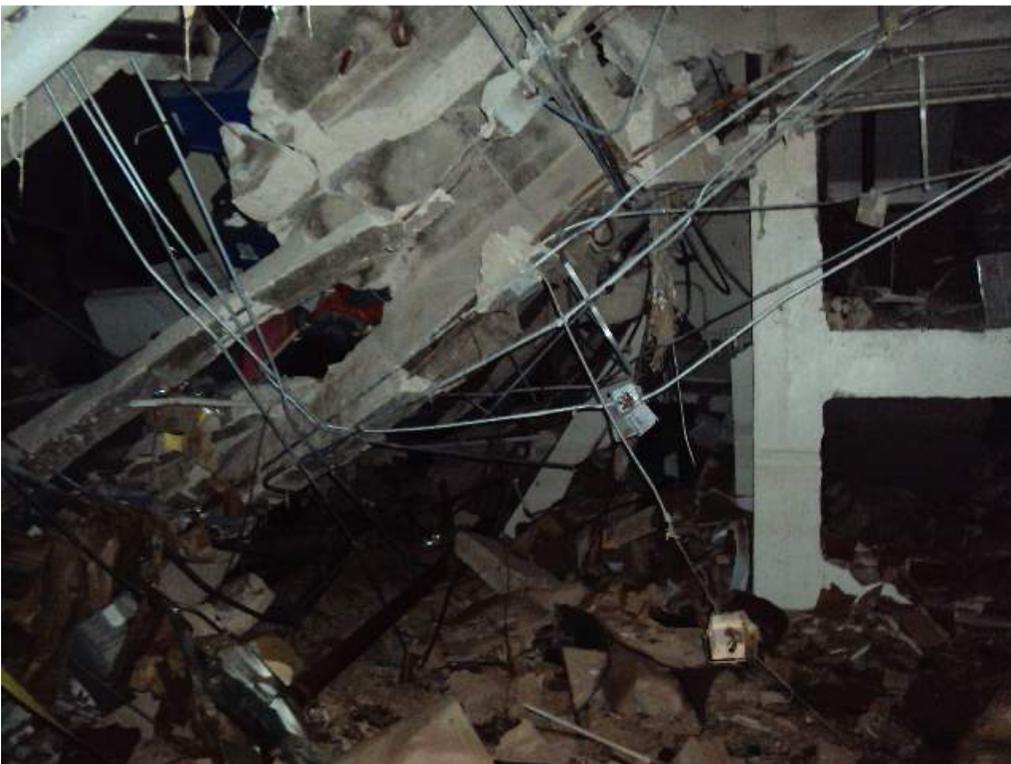
Photo 155: Basement –Room 128, 129 & 132– Between col lines J.5 and K.8 & 3 and 5 – Looking South– Collapsed CMU walls and floor slabs

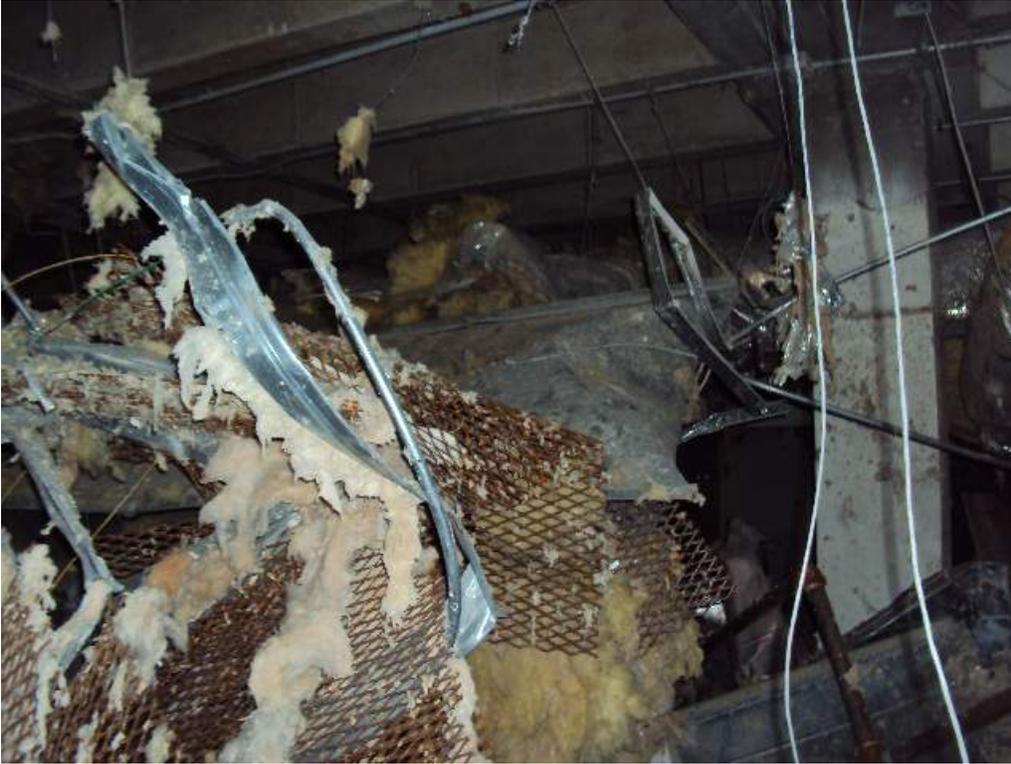
Photo 156: Basement –Room 102, 103, 104 & 127– Between col lines H.3 and K.2 & 3 and 4 – Looking South– Collapsed ceiling structure

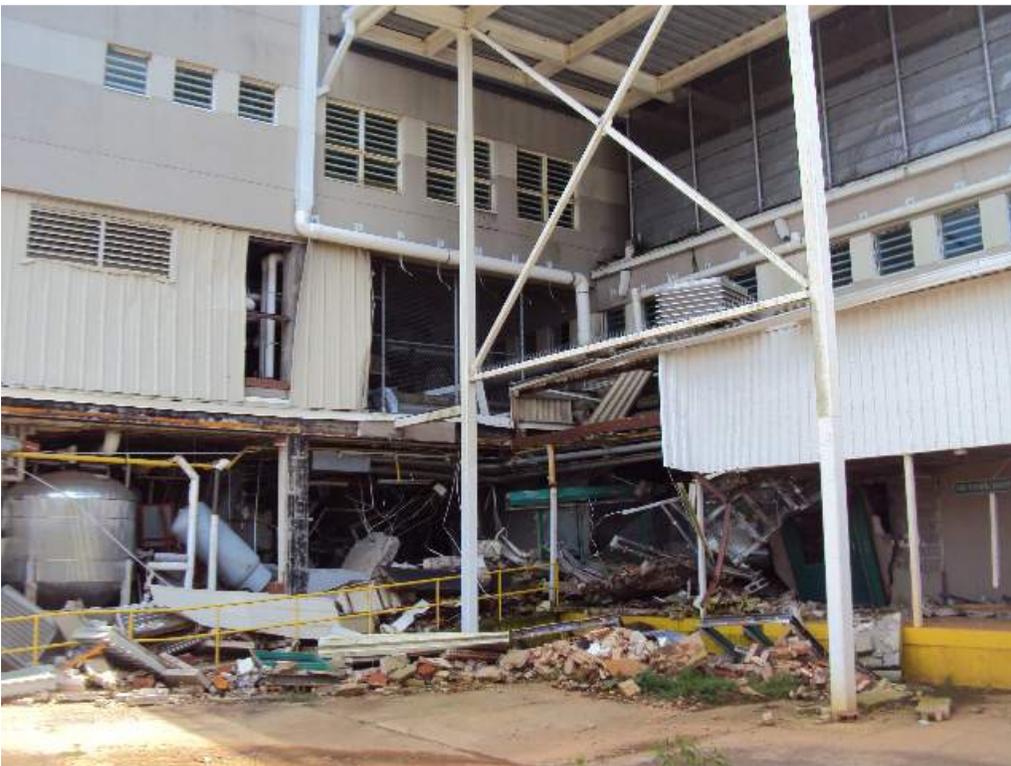
Photo 157: Basement –Room 140, 141 and 143– Between col lines G.5 and H.3 & 8 and 10 – Looking Southeast– Collapsed CMU walls and walkway roofs

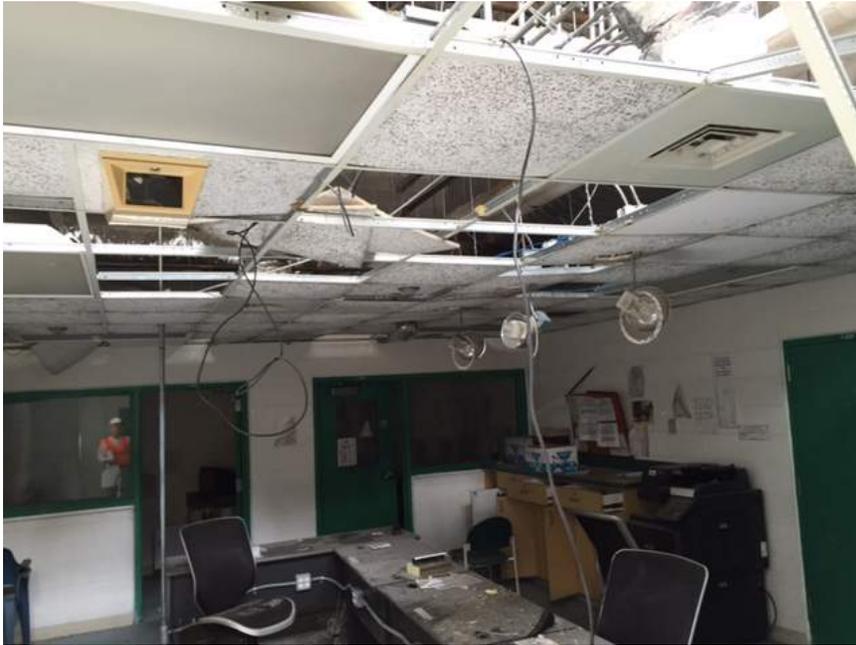
First floor- Exposed duct work to be reinsulated.

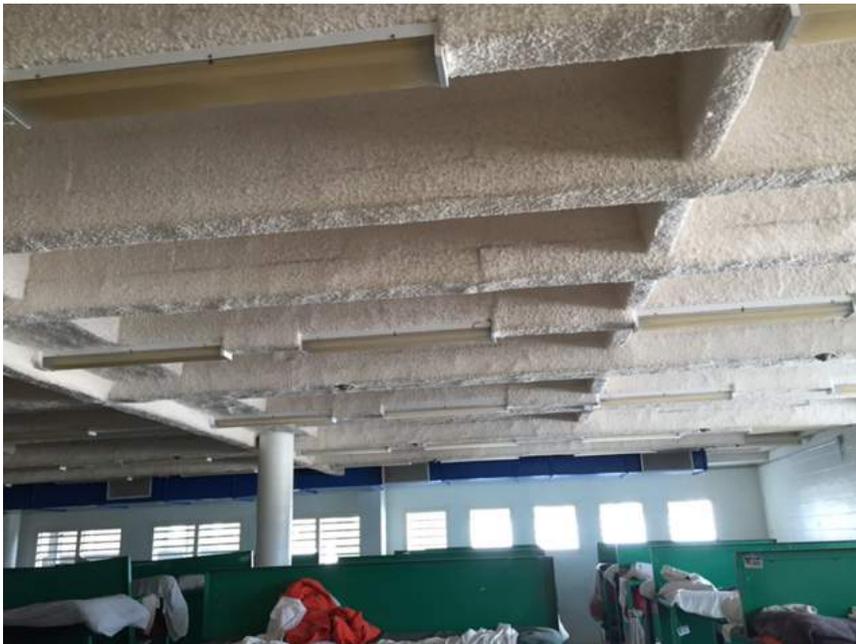
Duct work with internal insulation to be replaced- Typical for east and west wing detention areas.
