Existing Condition Assessment Report

DEMOLITION OF CENTRAL BOOKING FACILITY

Escambia County Central Booking and Detention Facility
Condition Assessment Report - June 11, 2015

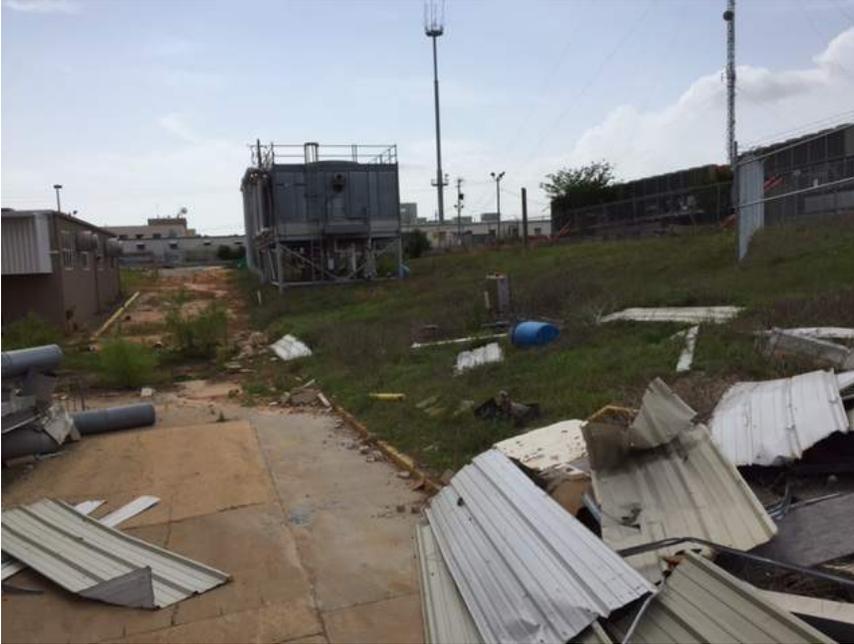
Dormant cooling towers.

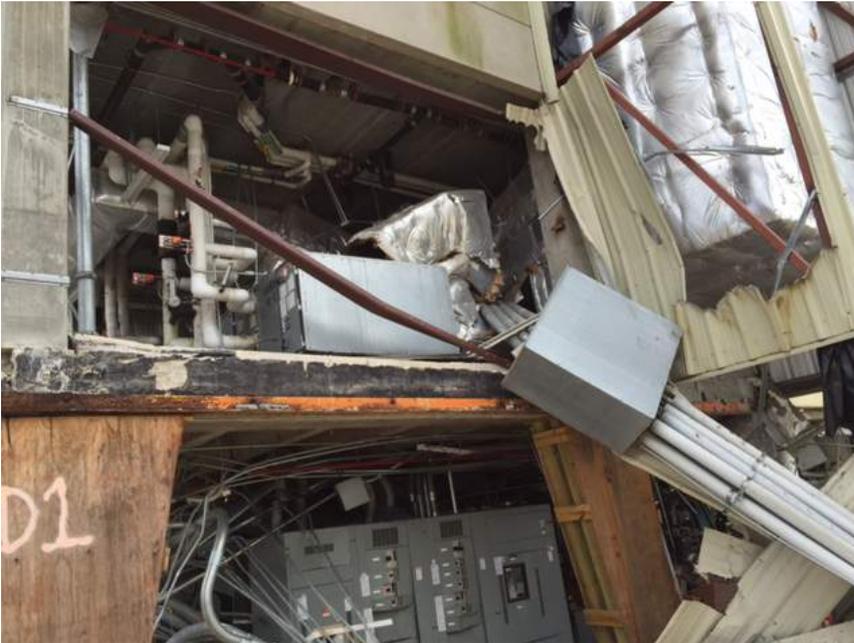
HVAC equipment to be replaced on basement first floor level.

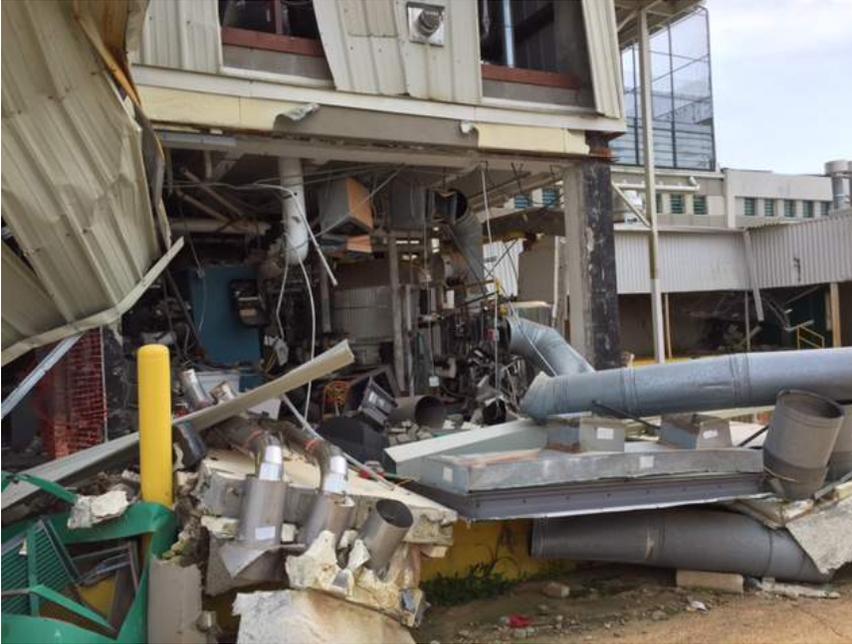
Basement level- Main boiler and pump room to be replaced.

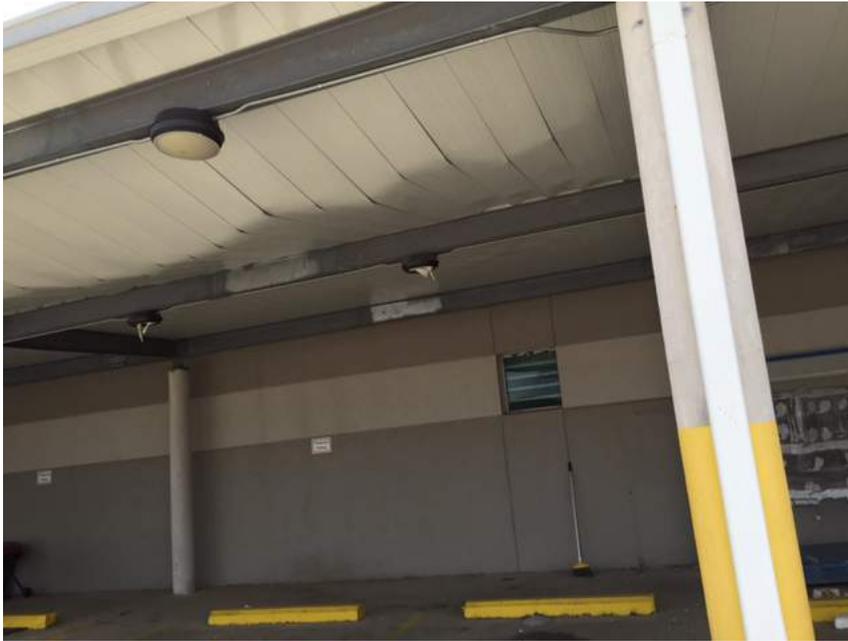
Transportation gally port lighting fixture damage.

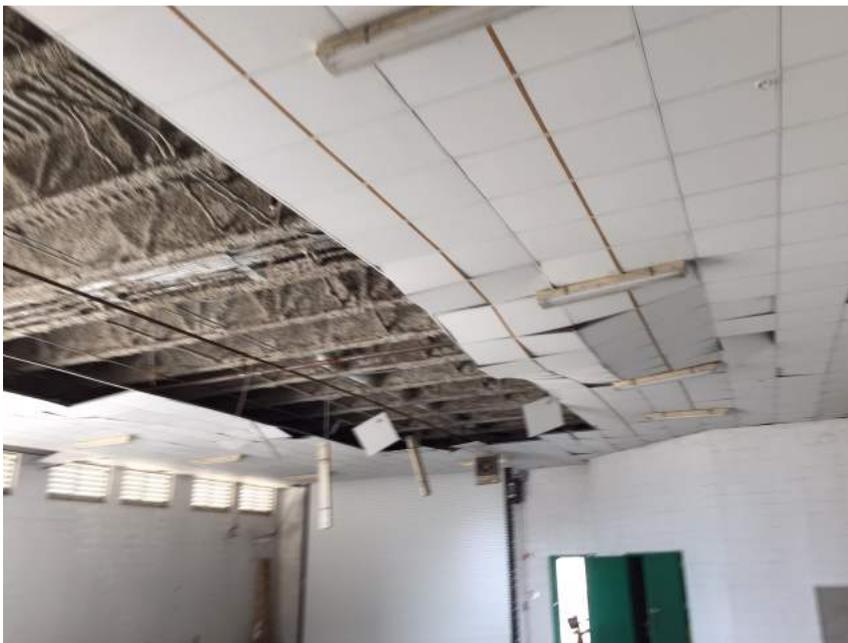
Vehicle gally port lighting fixture damage.

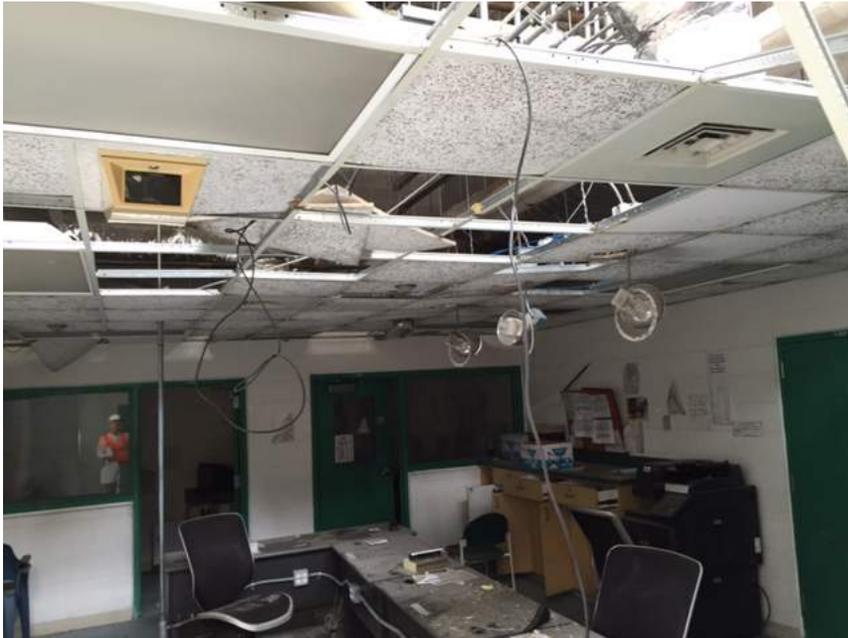
First floor control area lighting fixture damage.

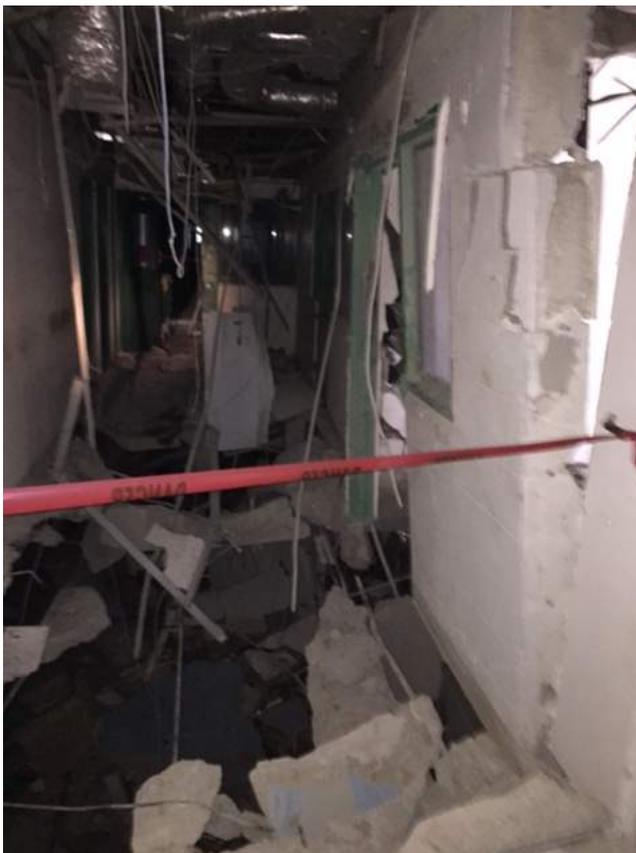
First floor corridor indicating branch circuit damage.

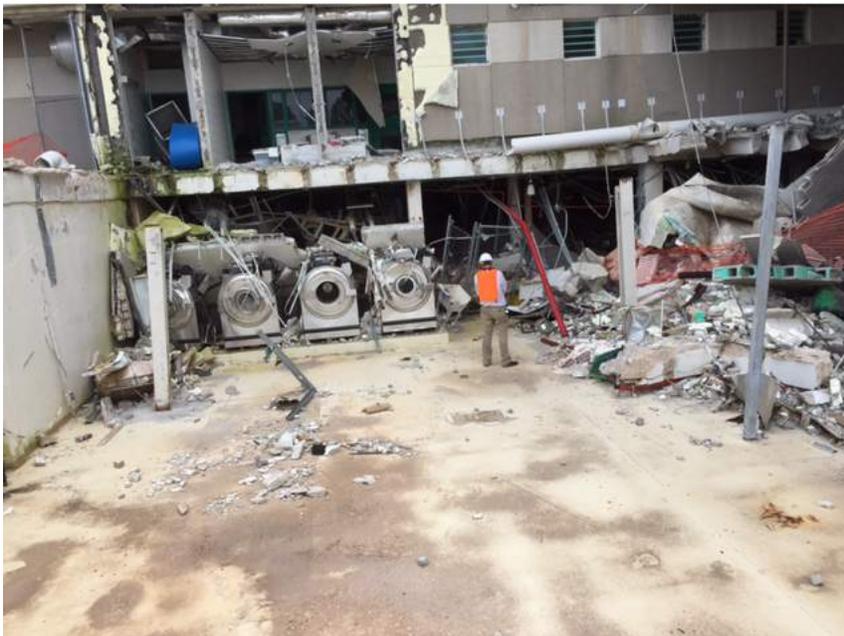
View looking north in laundry room. Laundry power panel buried in the debris to the west.

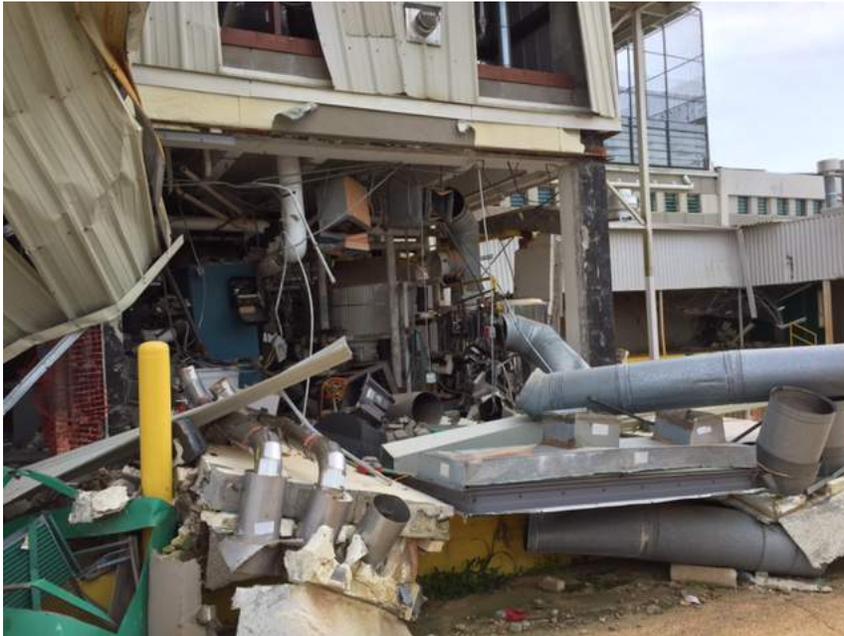
Base view looking north into boiler room.
