Asbestos containing black mastic associated with non-asbestos containing floor tile designated as F2 and F4 (Approximately 600 sf). Please know that the black mastic is underlying 1 layer of floor tile in the corridor and record room and underlying two layers of flooring in the kitchens.

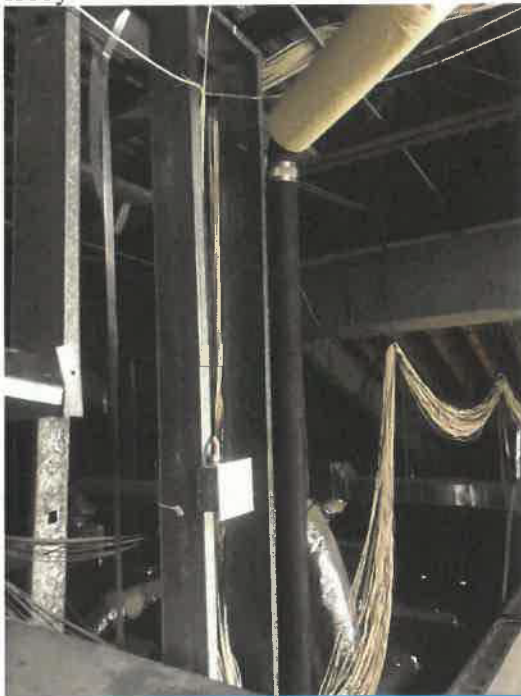
HVAC system above ceiling tiles in public lobby

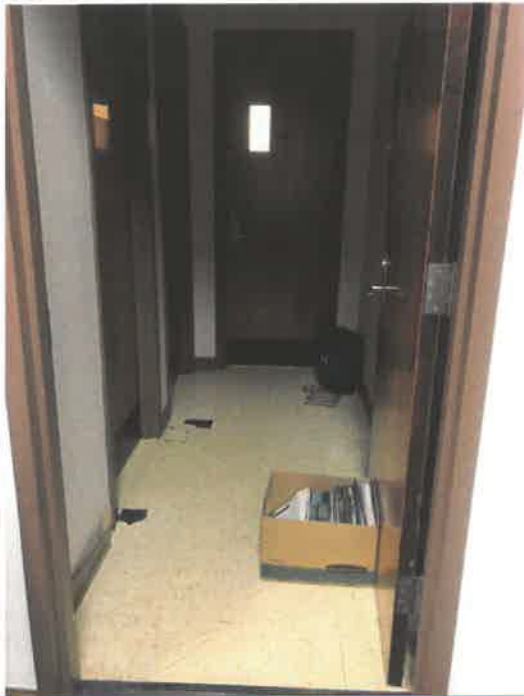
Women's restroom sheet floor in corridor C

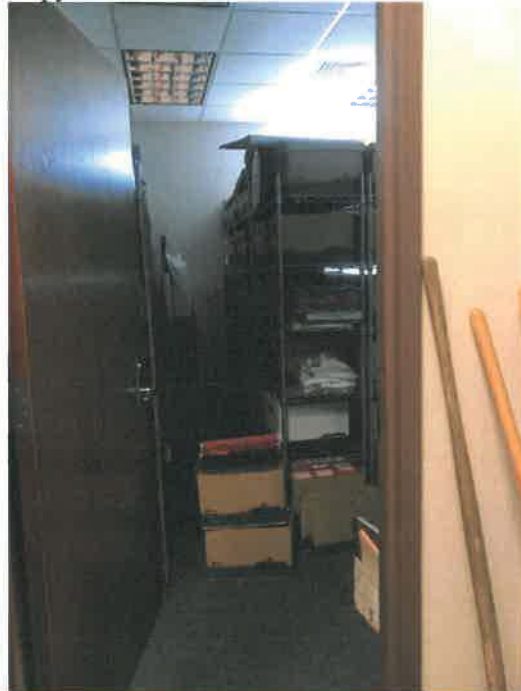
Breakroom with F4 over F2 on right side of lobby
