**ASBESTOS INSPECTION REPORT**  
**GEORGETOWN CITY HALL**  
Georgetown, South Carolina  
Asbestos Inspections, LLC Project # 2018-152  
*Performed in general accordance with SCDHEC regulation 61-86.1  
along with OSHA regulation 29 CFR 1926*

**Inspection Completed On – June 18, 2018**  
**Report Prepared On – June 27, 2018**

Subject: Asbestos Inspection Report  
Georgetown City Hall  
120 North Fraser Street  
Georgetown, South Carolina  
Asbestos Inspections, LLC Project # 2018-152

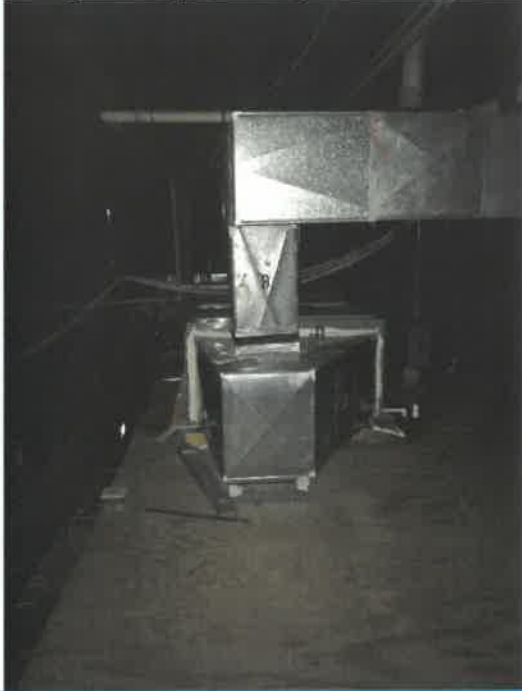
HVAC system and insulation piping above ceiling tiles in public lobby

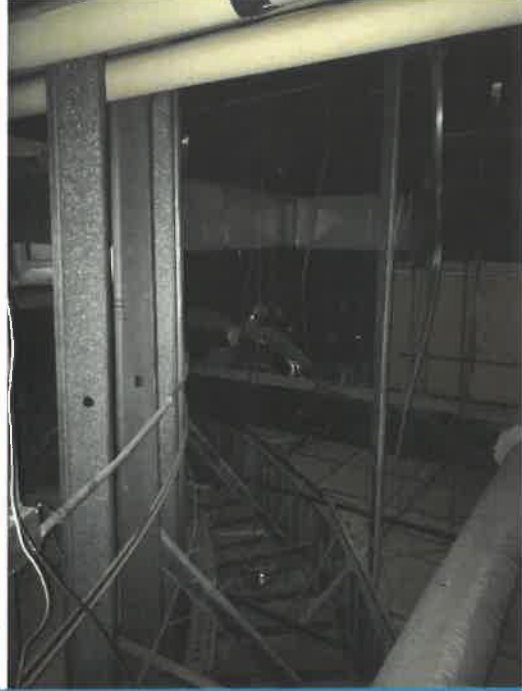
HVAC system and insulation piping above ceiling tiles in public lobby

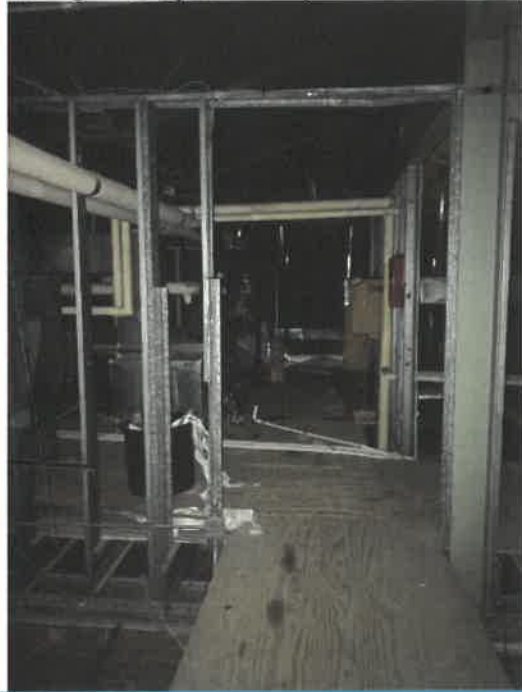
HVAC system and insulation piping above ceiling tiles in public lobby

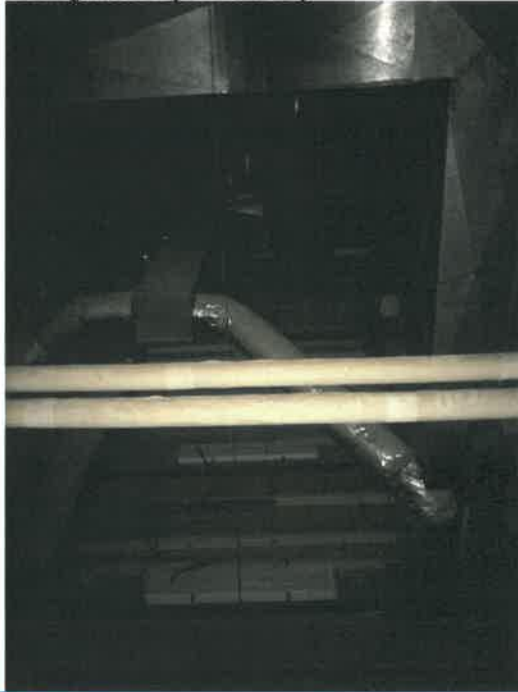
HVAC system and insulation piping above ceiling tiles in public lobby

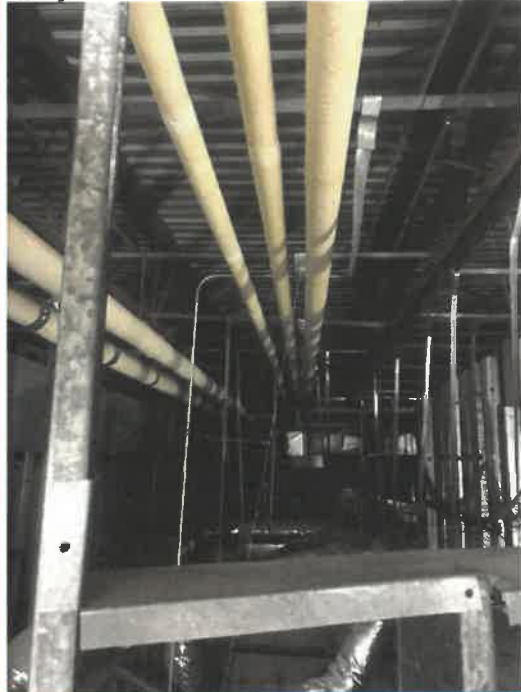
Pipe insulation above ceiling tiles in public lobby

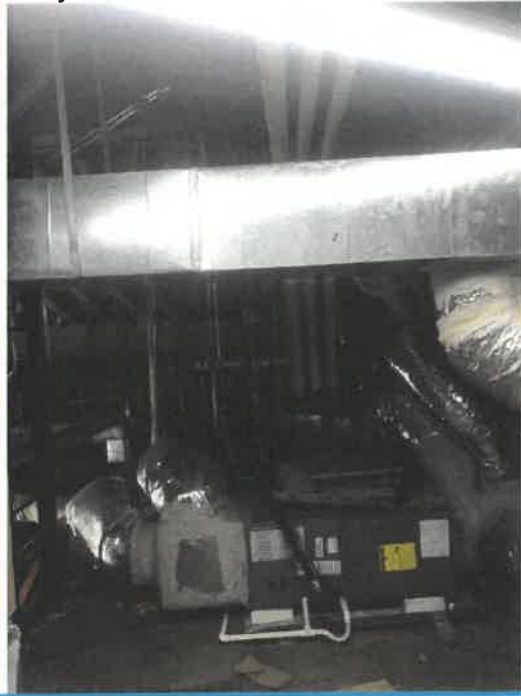
HVAC system above ceiling tiles in public lobby

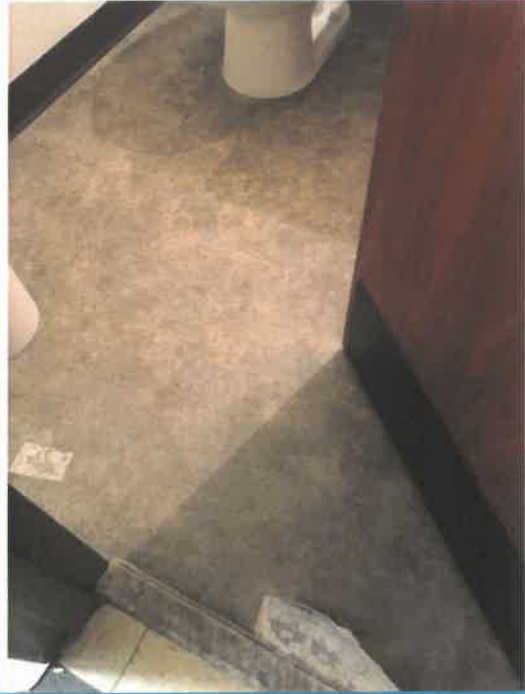
Women's restroom sheet floor in corridor C

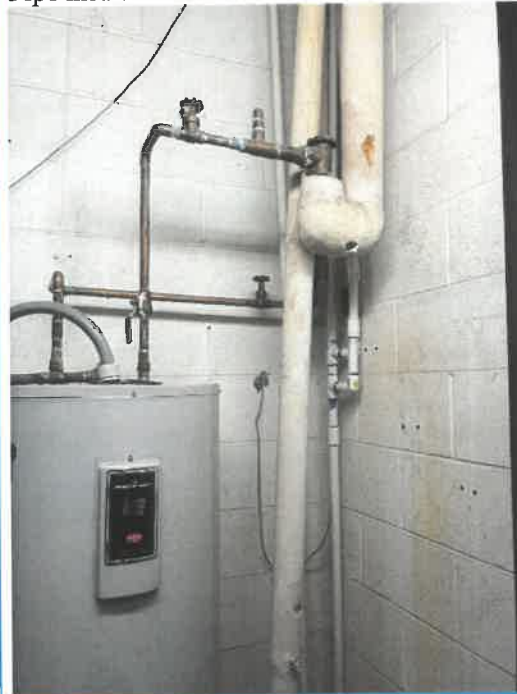
Pipe insulation

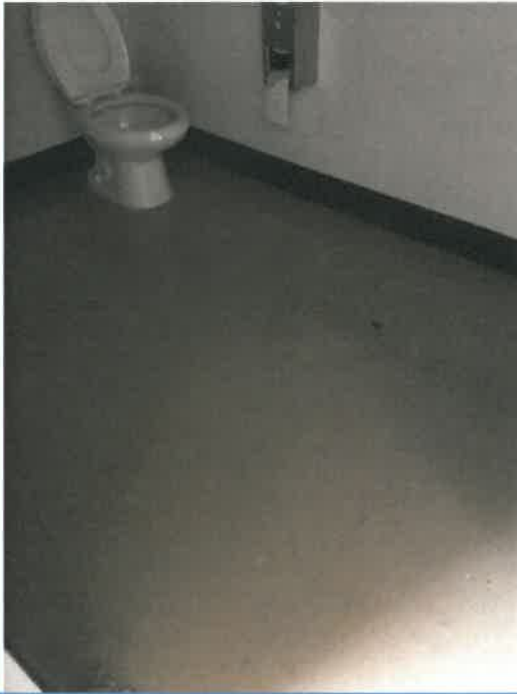
Women's restroom with F5 floor tile

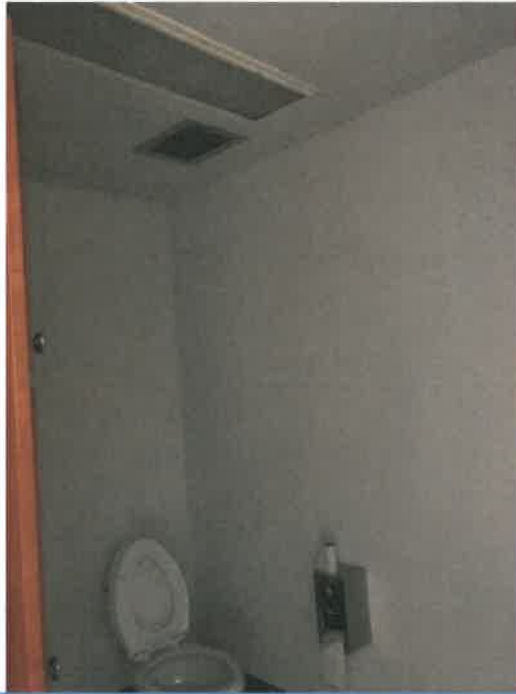
Women's restroom with F5 floor tile
